<b>COA # 2010-COA-174 (WD)</b>	<b>INDIANAPOLIS HISTORIC PRESERVATION COMMISSION STAFF REPORT</b>	Hearing Date <b>JUNE 2, 2010</b>
<b>105 S. Meridian St. Wholesale District</b>		NEW CASE
<b>Applicant</b>	<b>RATIO ARCHITECTS FOR 105 S. MERIDIAN, INC.</b>	
mailing address:	107 S. Pennsylvania, Suite 100 Indianapolis, IN 46204	
<b>Owner:</b>	<b>105 South Meridian, Inc.</b>	
	105 S. Meridian Indianapolis, IN 46225	
<b>CASE</b>		
<b>IHPC COA:</b>	<b>2010-COA-174 (WD)</b>	• Replace the steel windows on floors 2 through 9 of the north and west elevations with new aluminum windows
<b>STAFF RECOMMENDATION: Approval</b>

**Historic and Existing Windows**

## Window Condition Survey

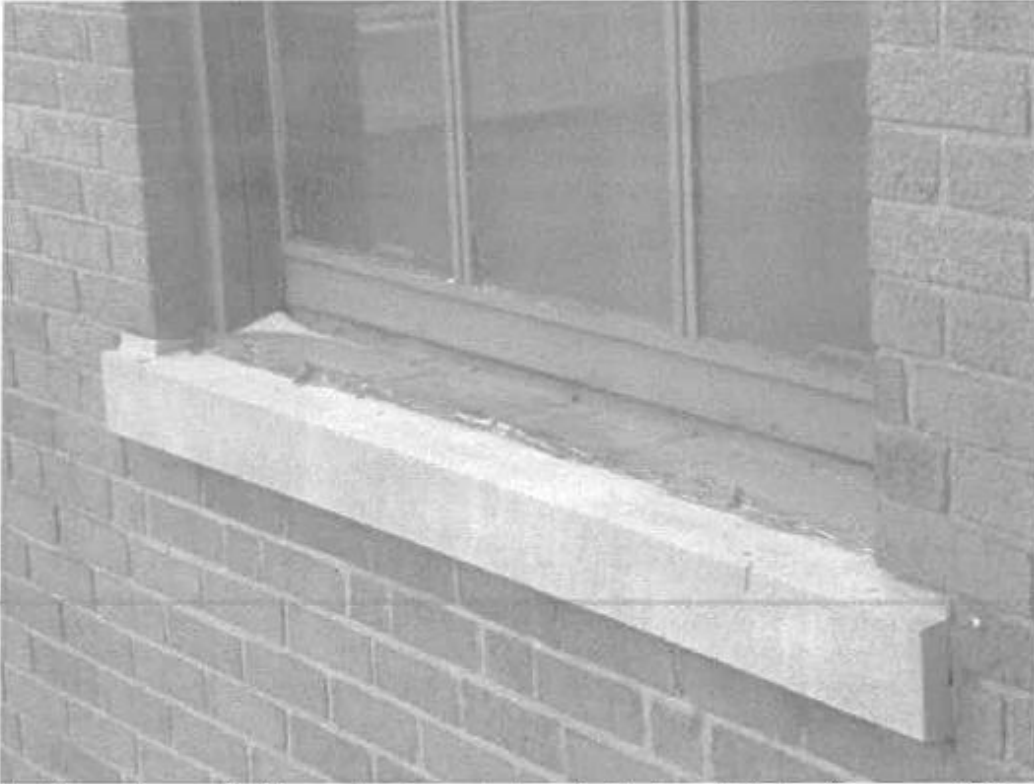
Peeling paint and failing sealant at exterior of window. Exterior faces are difficult to reach due to height and location above sidewalks.

- All window frames need to be recaulked to the masonry rough opening. The sealant at the juncture between the masonry rough opening and the steel window frames has dried and cracked and is falling out. This is allowing noise, wind and weather into the wall cavity. All remaining sealant should be removed, backer-rod installed as needed and a high quality caulk installed to seal the joint.

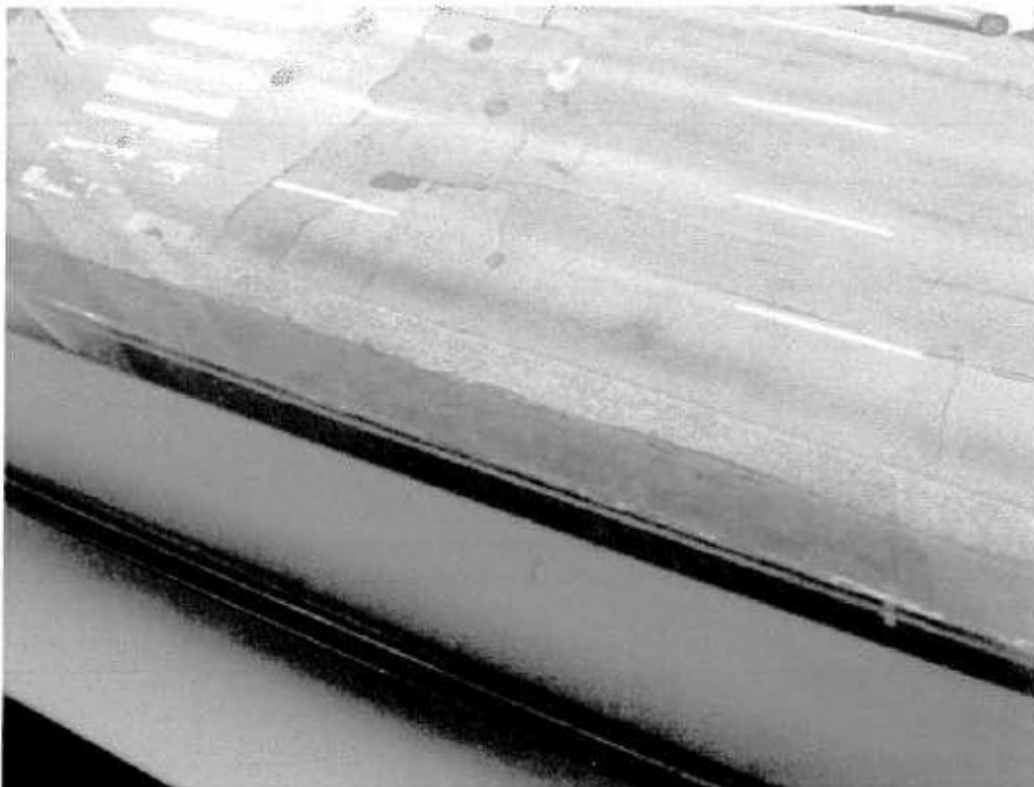
Corrosion at exterior sill

- All windows are in need of repainting. The frames and sash need to be scraped, sanded and primed prior to the application of two finish coats.
- Approximately 5% of the window frames and sash viewed on Tuesday exhibit extensive surface corrosion which may require their total replacement.

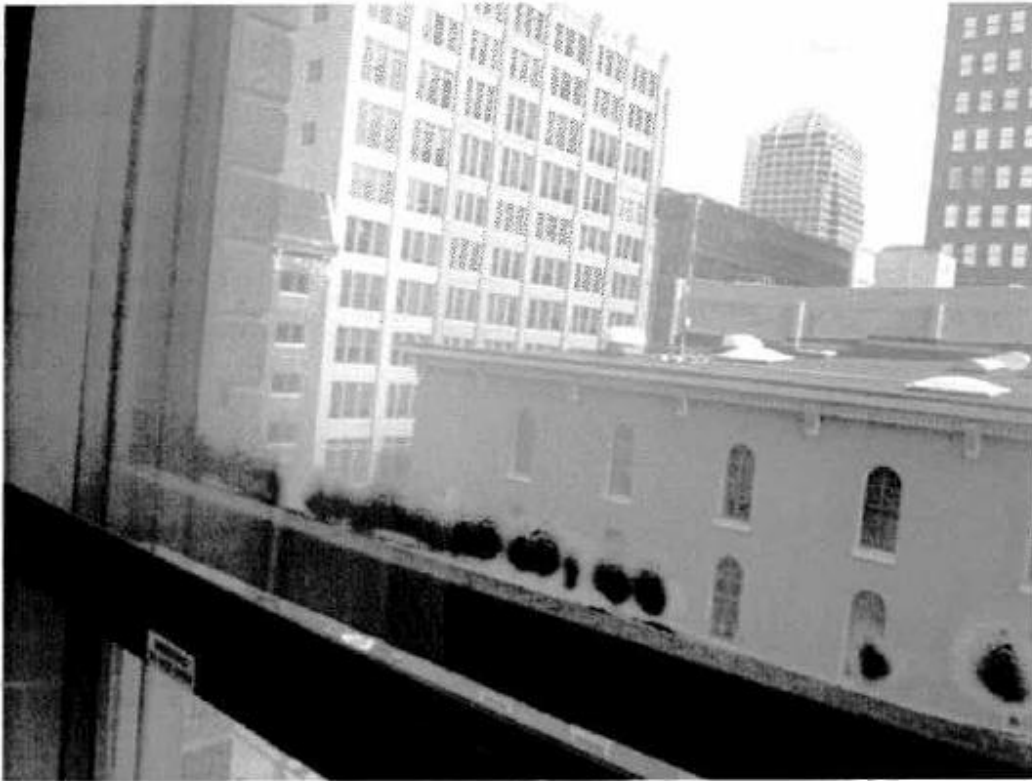
Mold growth between interior storm and window.

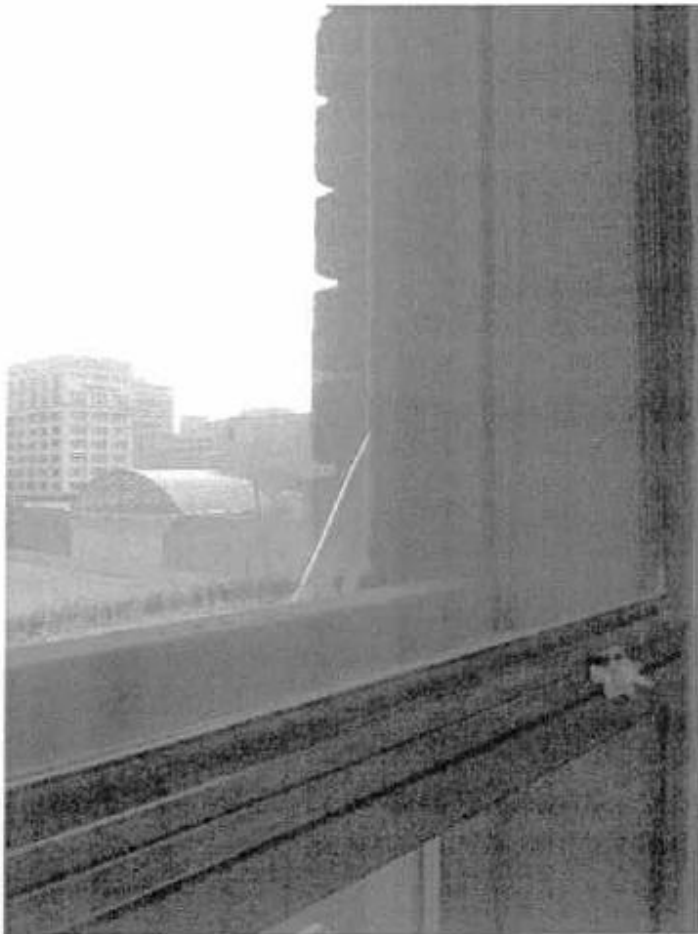
Broken Glass – Corroded steel is expanding, putting pressure on the panes of glass which then fracture.
