<b>COA # 2010-COA-412 (WP)</b>	<b>INDIANAPOLIS HISTORIC PRESERVATION COMMISSION STAFF REPORT</b>	<b>Hearing Date DEC. 1, 2010</b>
<b>915-917 Woodruff Place West Drive WOODRUFF PLACE</b>		Continued from: November 3, 2010  Center Township Council District: 16 Brian Mahern
<b>Applicant</b>	<b>TAD BOHLSEN FOR PINE FINANCIAL</b>	
<b>Mailing address:</b>	151 N. Delaware, #1835 Indianapolis, IN 46204	
<b>Owner: Same as above</b>		
<b>CASE</b>		
<b>IHPC COA: 2010-COA-412 (WP) Demolish fire-damaged house</b>		
<b>STAFF RECOMMENDATION: Approval of a Certificate of Authorization</b>

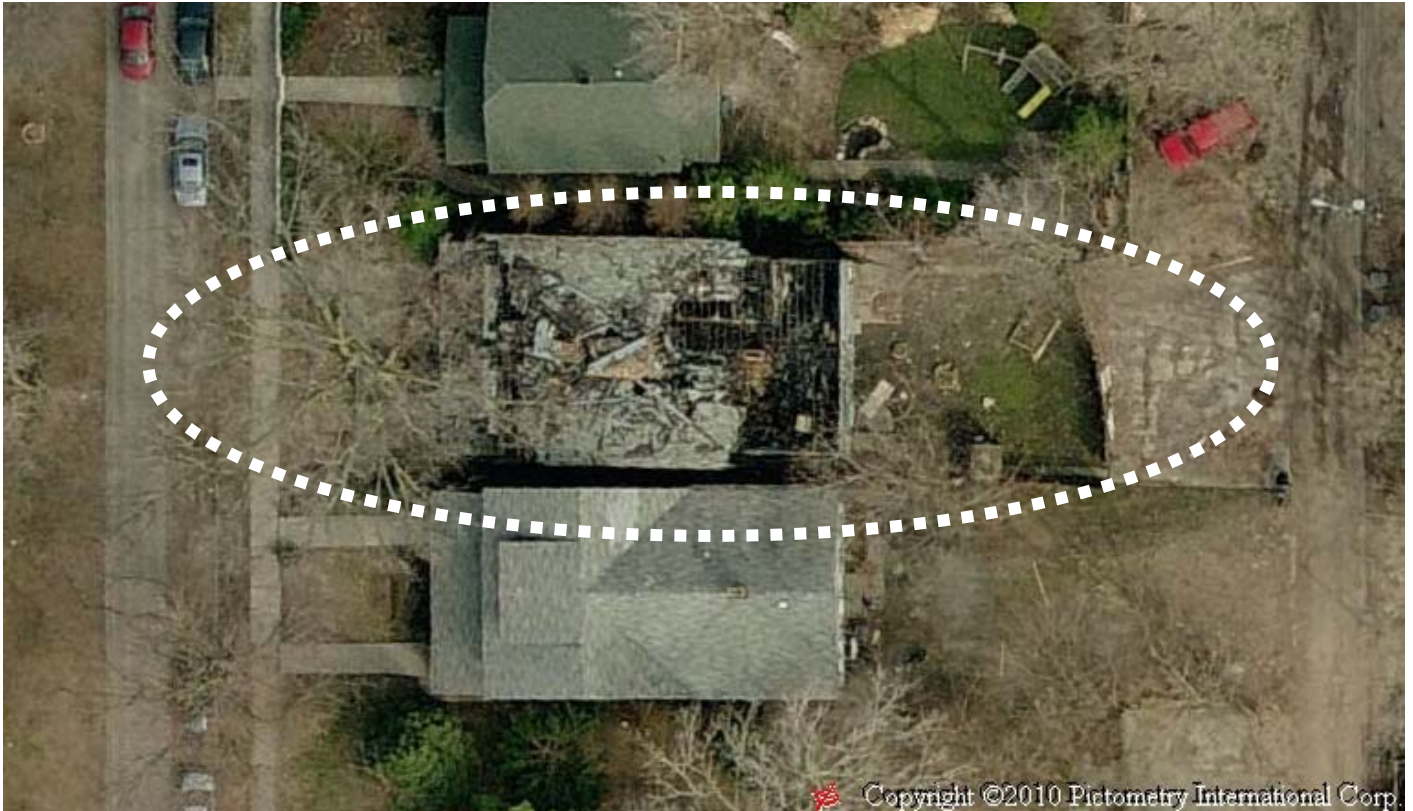
Aerial photo showing roof shortly after the fire, but prior to the remainder of the roof being removed as part of the emergency demolition.

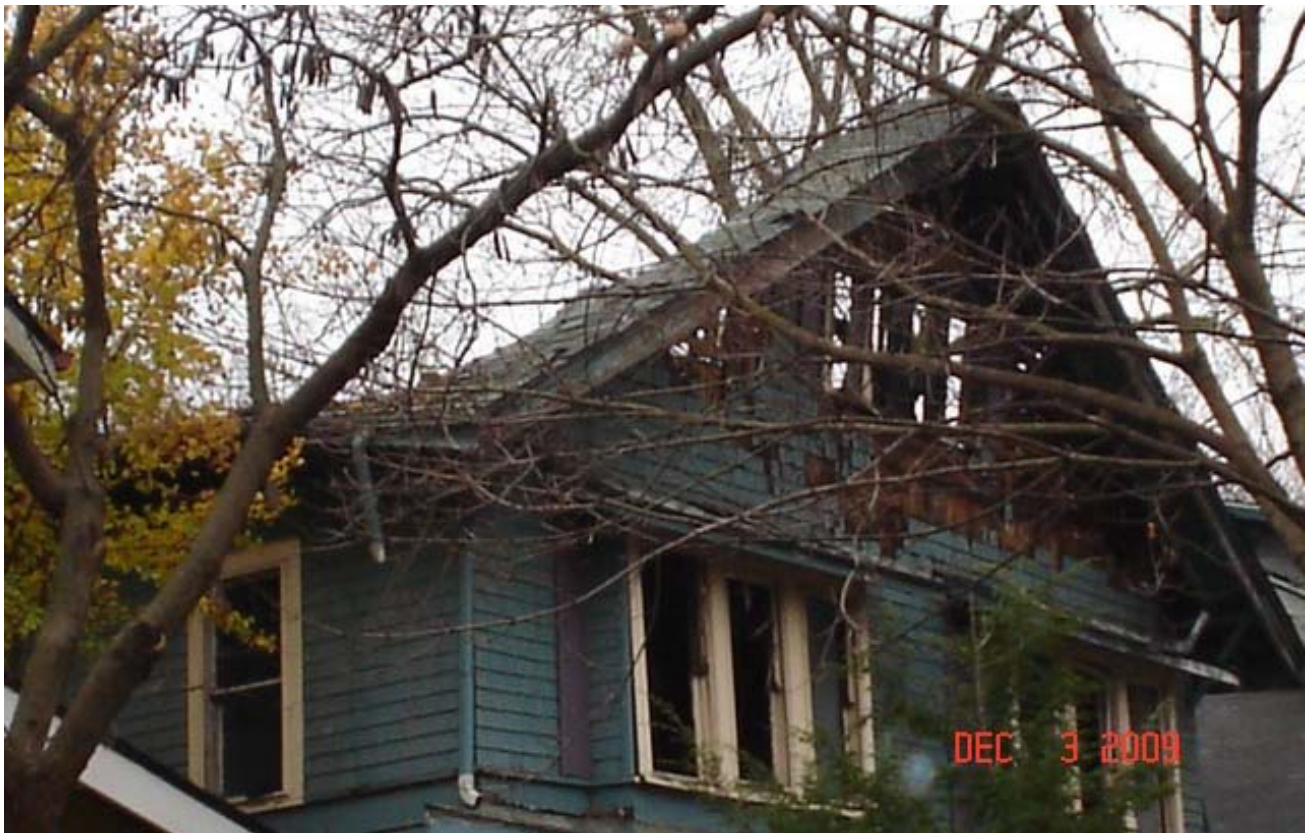
**December 2009 – front gable required emergency demolition**

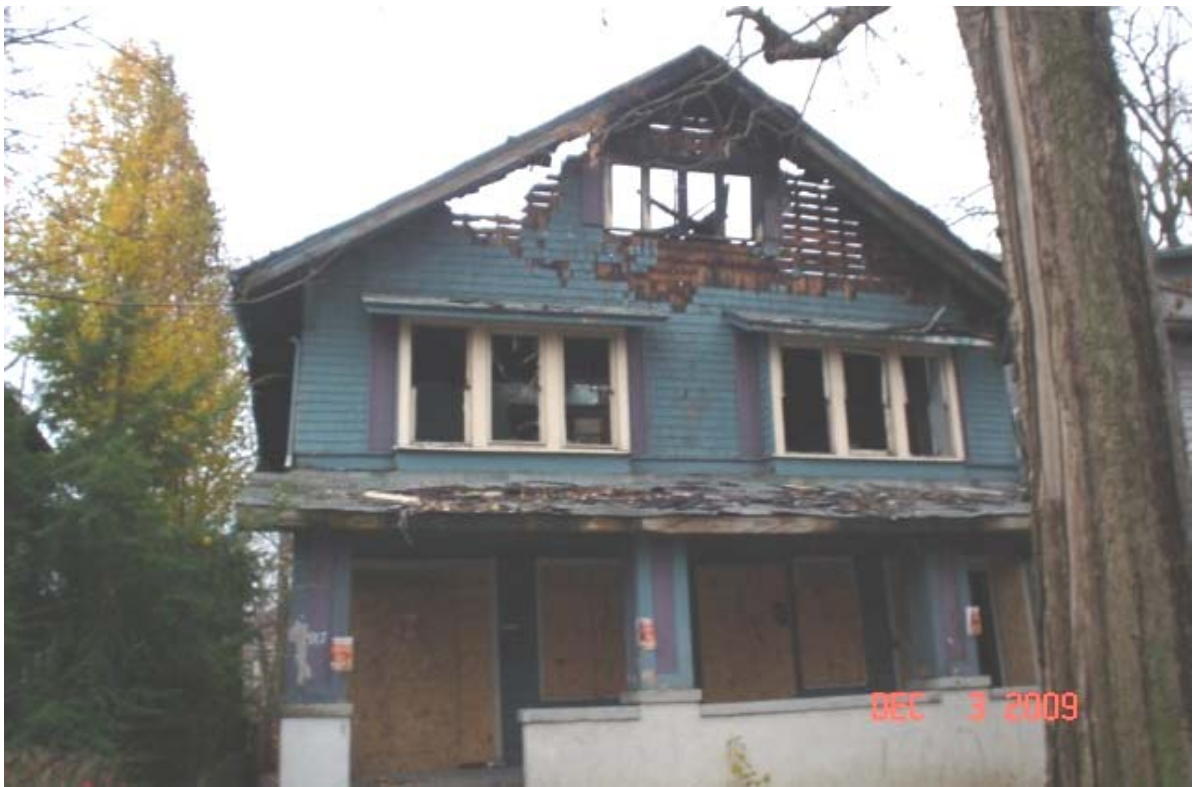
**Decemer 2009- front of house before gable was removed by emergency demolition**

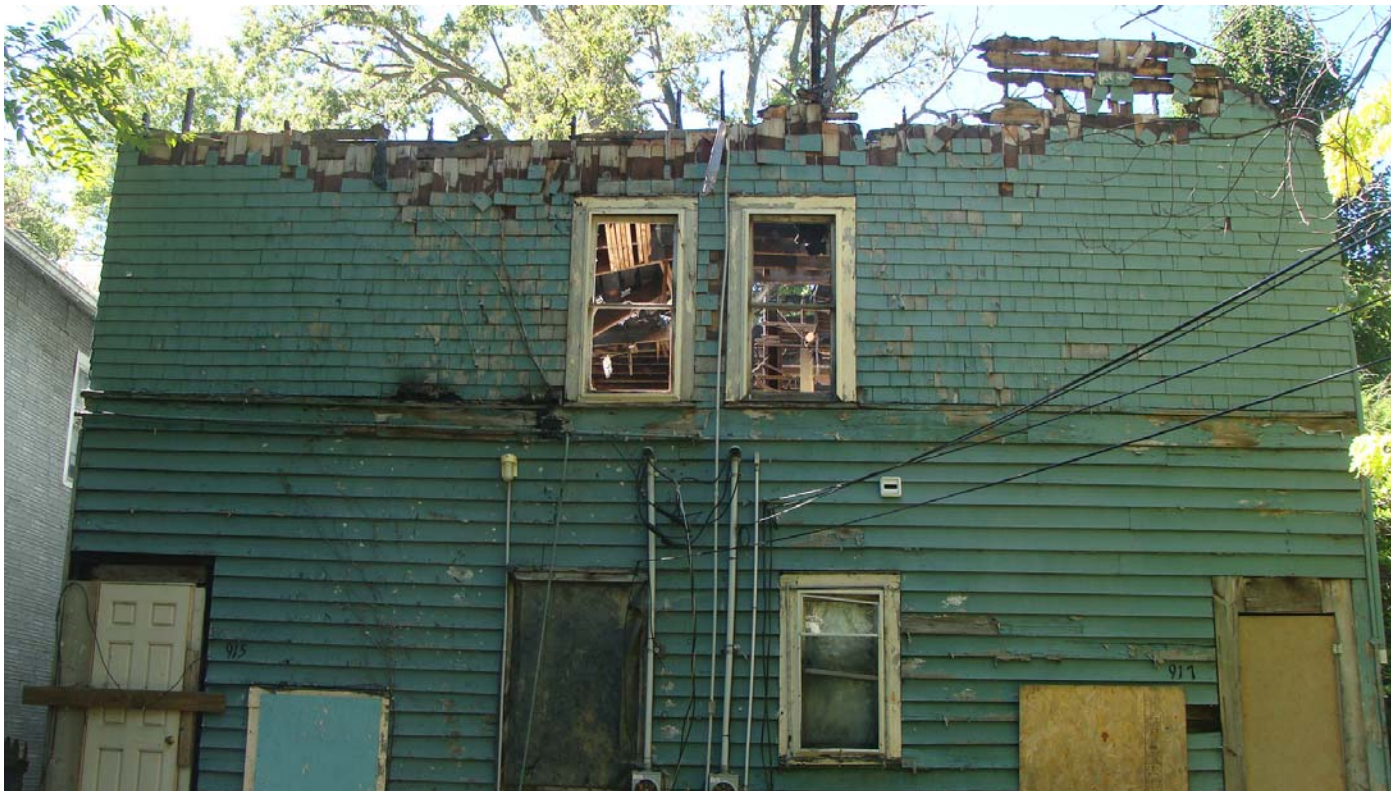
1. The damage and subsequent deterioration is extensive. The entire roof structure is gone, making it impossible to take any effective temporary or short-term actions to "mothball" this structure. This situation poses an increasing threat to the neighborhood as deterioration progresses. The fact that rain and snow cannot be kept out of the structure guarantees fast deterioration.

**Rear of building- No roof exists**

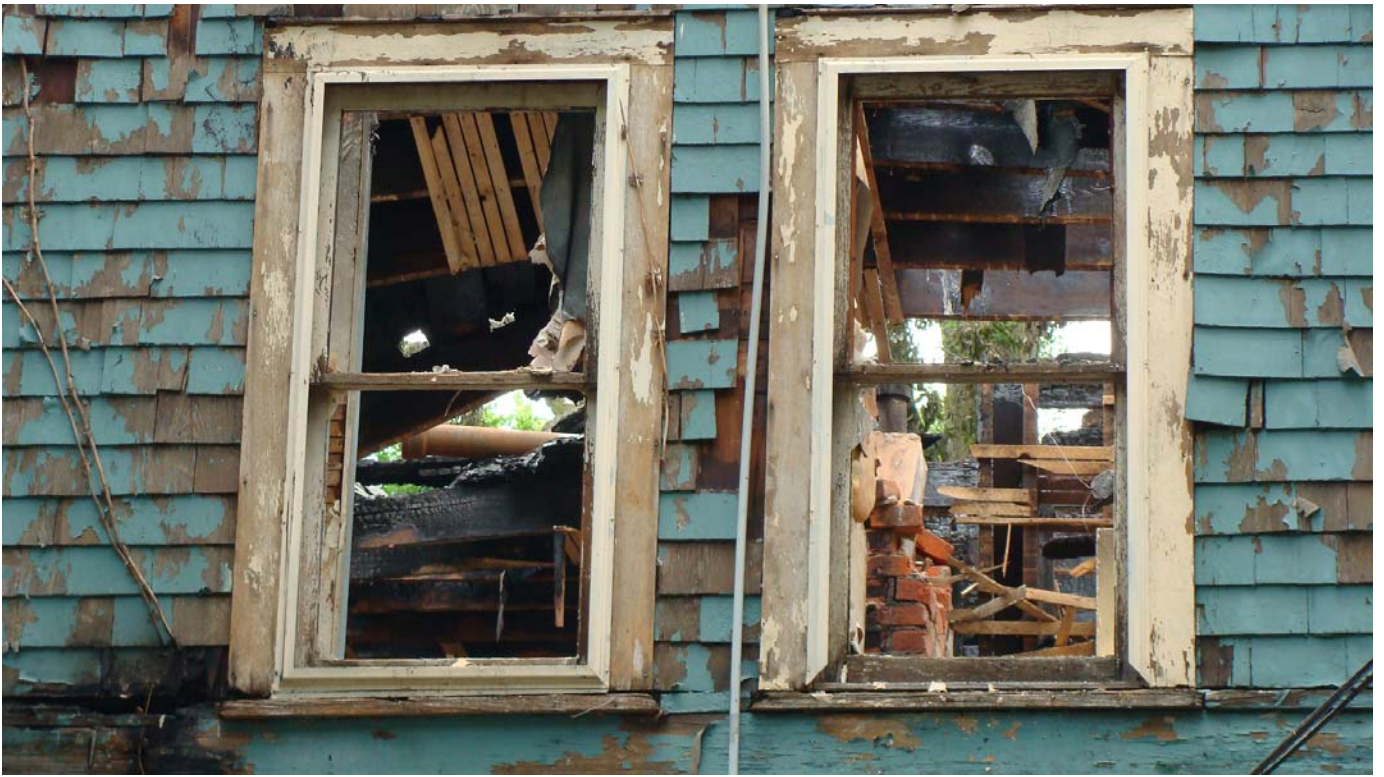
**Close up of second floor rear windows- windows were blown out**

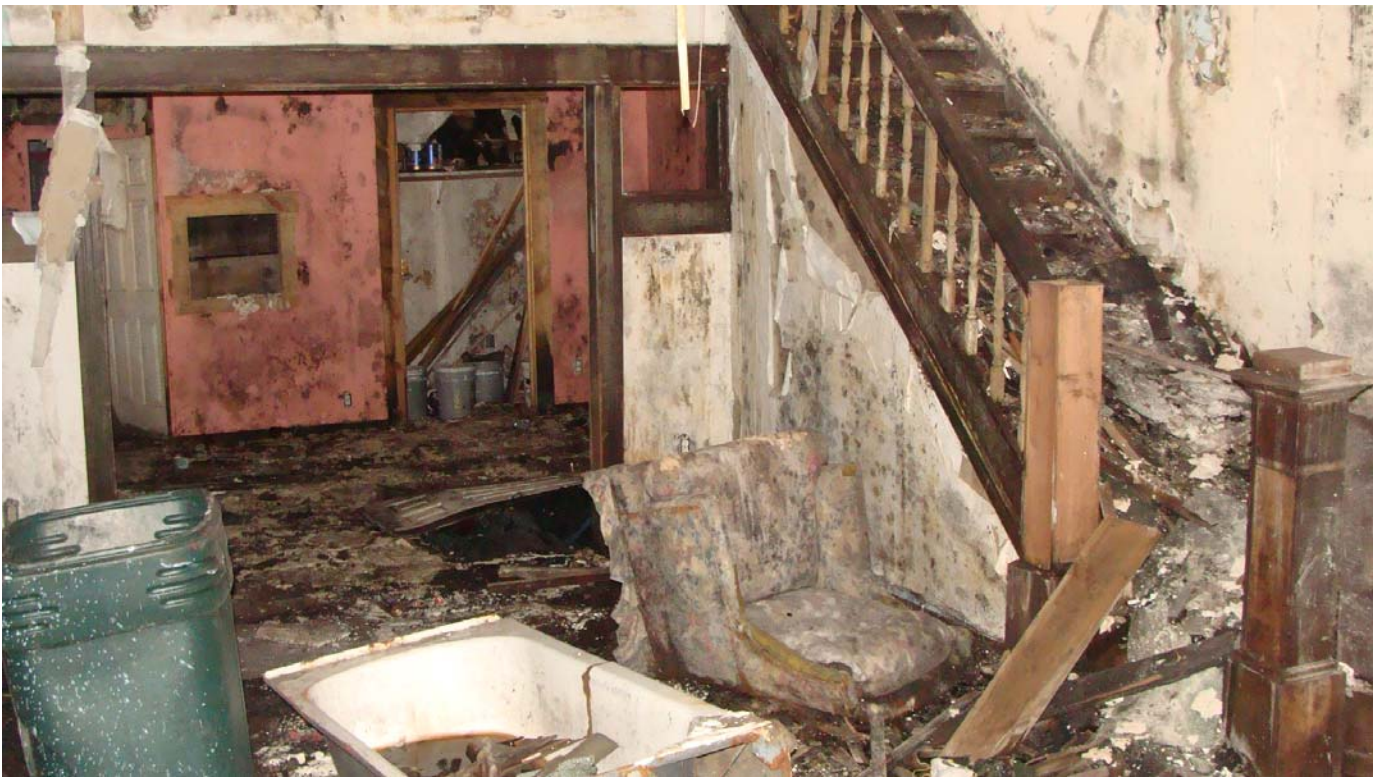
**Interior at first floor- Black mold covers the area**

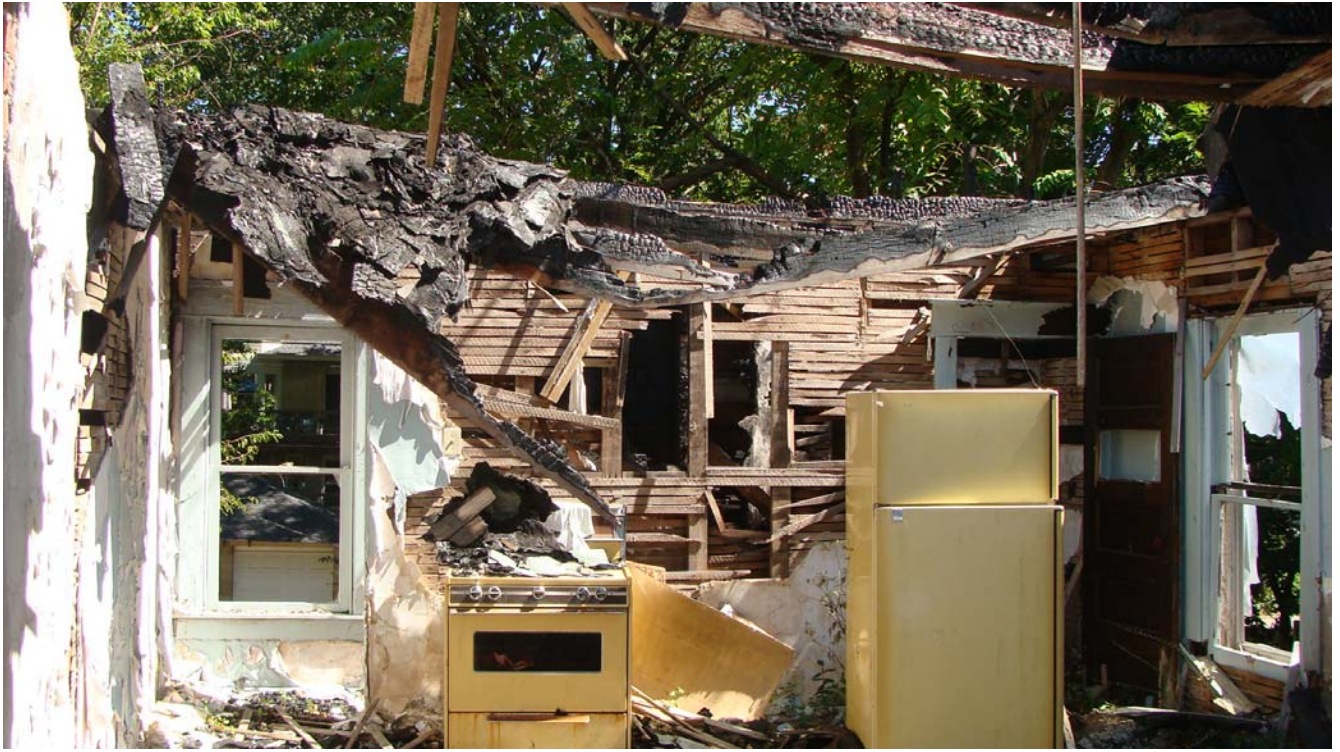
**Interior at second floor- No roof remains**
