COA # <b>2010-COA-412 (WP)</b>	<b>INDIANAPOLIS HISTORIC PRESERVATION COMMISSION STAFF REPORT</b>	Hearing Date <b>NOV. 3, 2010</b>
<b>915-917 Woodruff Place West Drive WOODRUFF PLACE</b>		<i>New Case</i>
<b>Applicant</b> TAD BOHLSSEN FOR PINE FINANCIAL mailing address: 151 N. Delaware, #1835 Indianapolis, IN 46204		Center Township Council District: 16 Brian Mahern
<b>Owner:</b> Same as above		
<b>CASE</b>		
<b>IHPC COA: 2010-COA-412 (WP)</b> Demolish fire-damaged house		
<b>STAFF RECOMMENDATION: Approval of Certificate of Authorization</b>

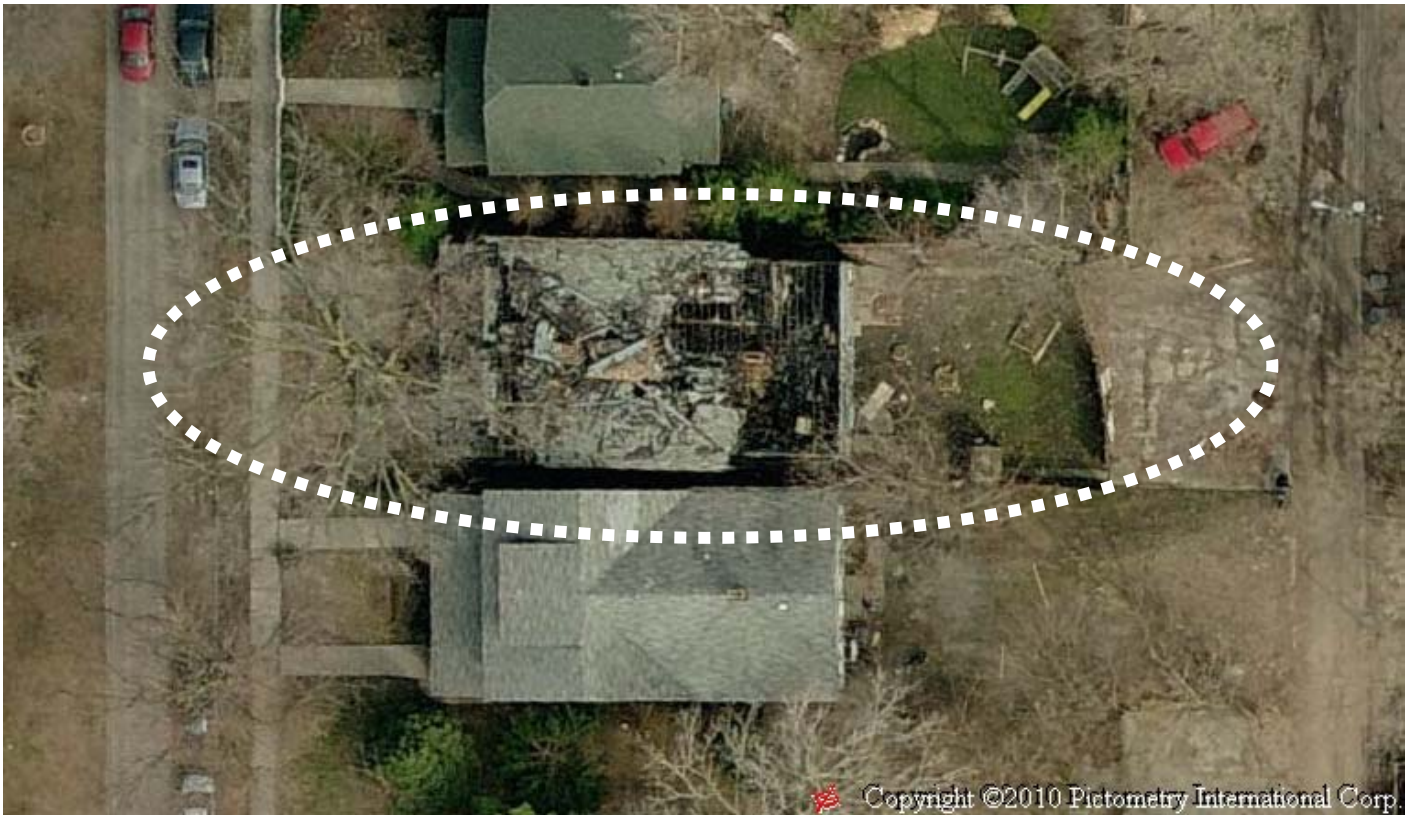
**Aerial photo showing roof shortly after the fire, but prior to the remainder of the roof being removed as part of the emergency demolition.**

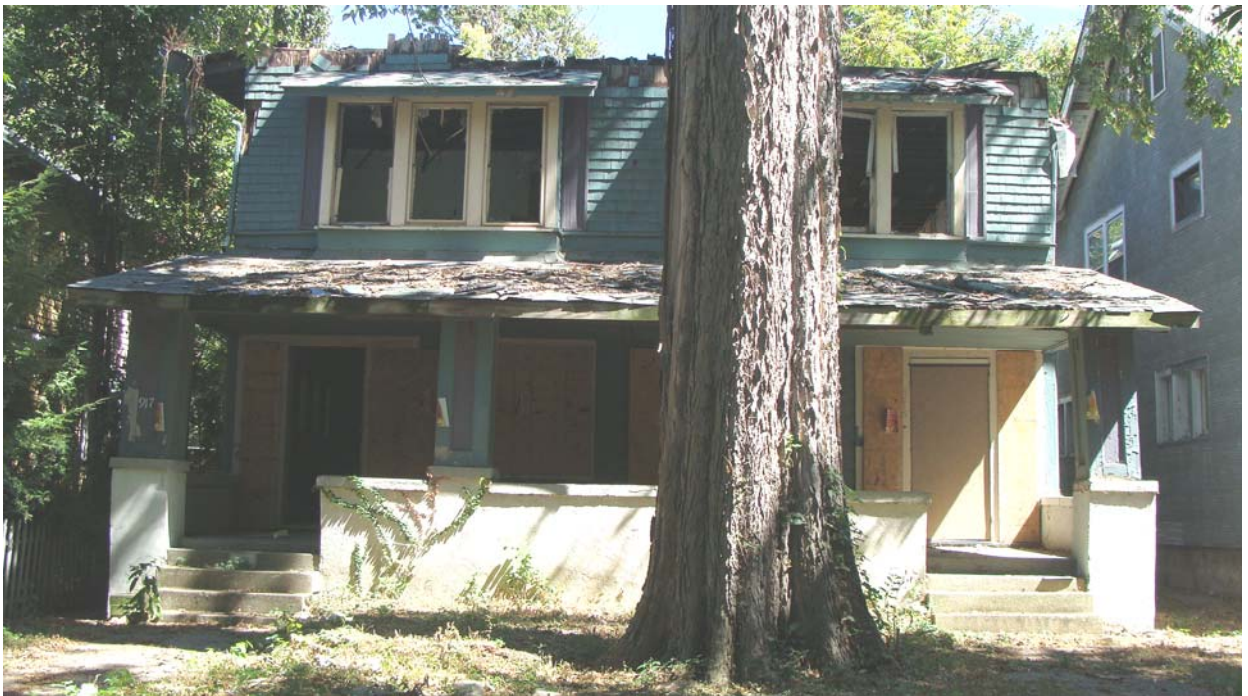
**Front of house today**

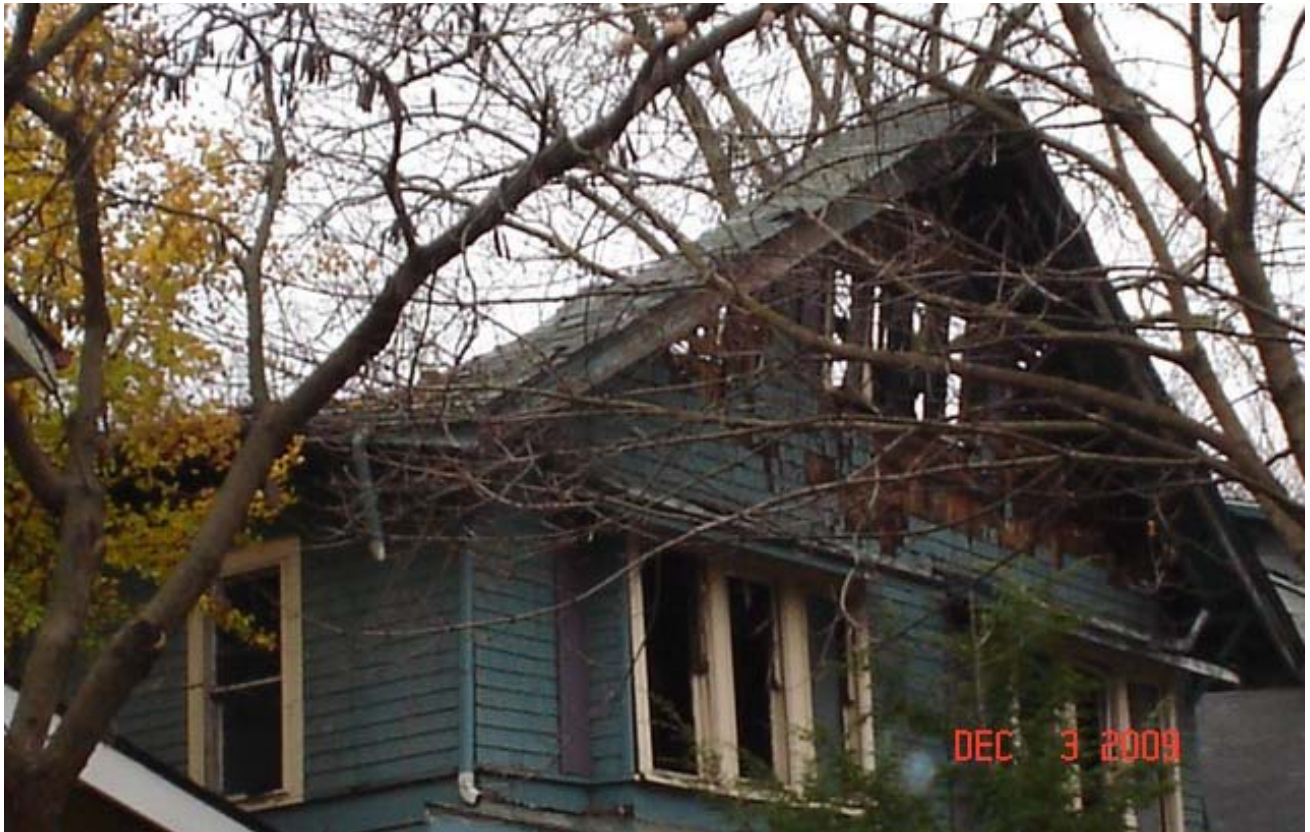
In December of 2009, IHPC staff became aware of a citizen complaint made to City-County Councillor Brian Mahern, stating that the front gable was a safety concern. The concern was also forwarded to Tim McMillan with Health and Hospital's Unsafe Building Division. Tim submitted a written request to the IHPC to allow emergency demolition of the leaning front gable. Staff visited the site and found the leaning of the gable was both precarious and obvious. Staff agreed that the condition appeared to be a threat to public safety. In accordance with the IHPC statute, the Director of the Department of Metropolitan Development declared an immediate threat to public safety and the unsupported front gable was removed.

**December 2009 – front gable required emergency demolition**

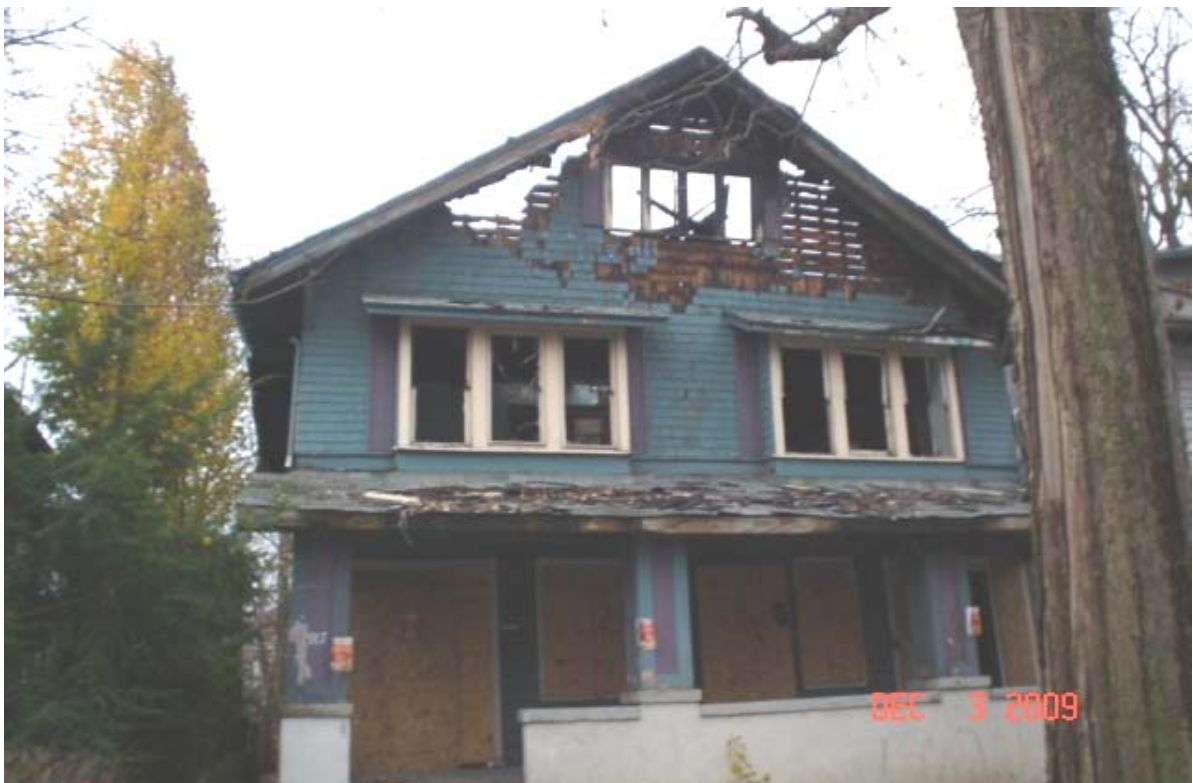
**Decemer 2009- front of house before gable was removed by emergency demolition**

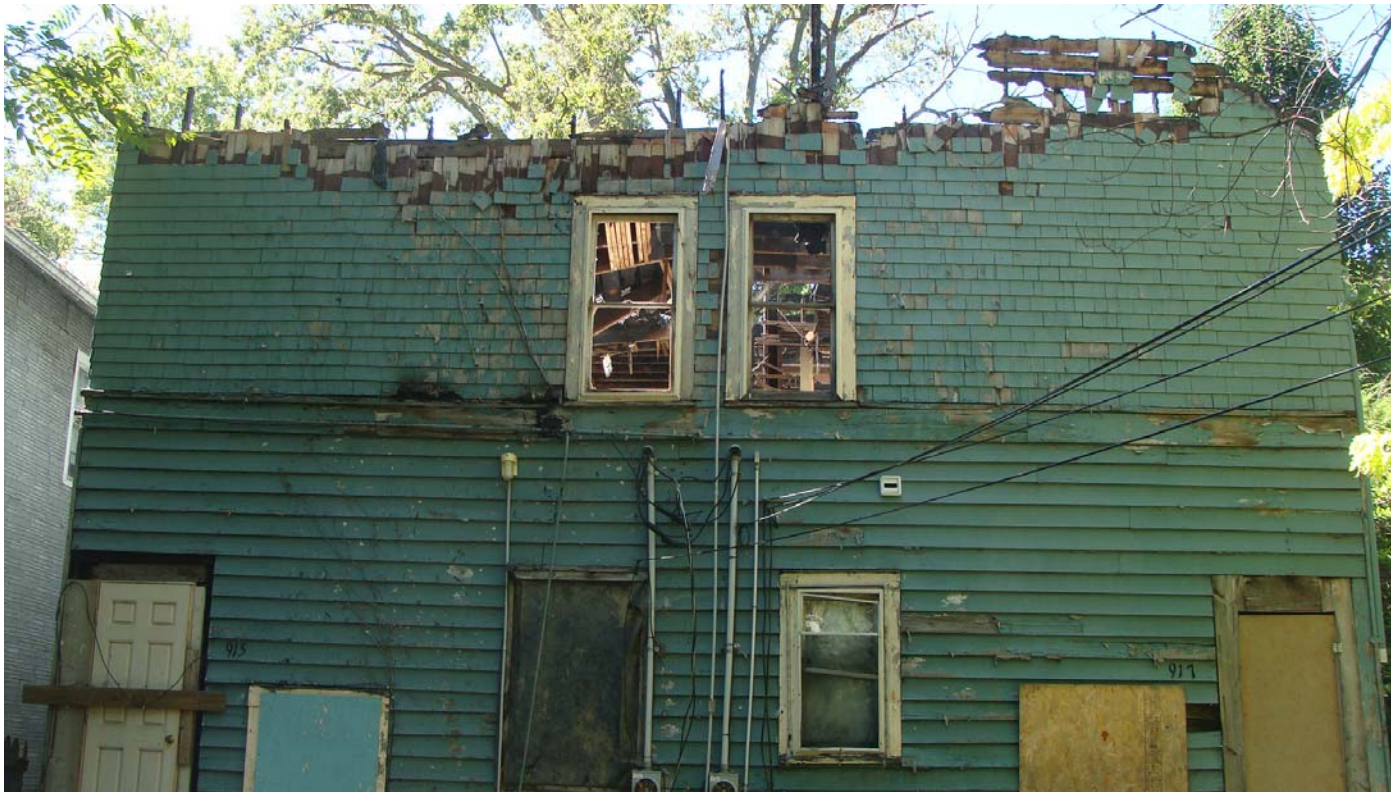
1. The damage and subsequent deterioration is extensive. The entire roof structure is gone, making it impossible to take any effective temporary or short-term actions to "mothball" this structure. This situation poses an increasing threat to the neighborhood as deterioration progresses. The fact that rain and snow cannot be kept out of the structure guarantees fast deterioration.

**Rear of building- No roof exists**

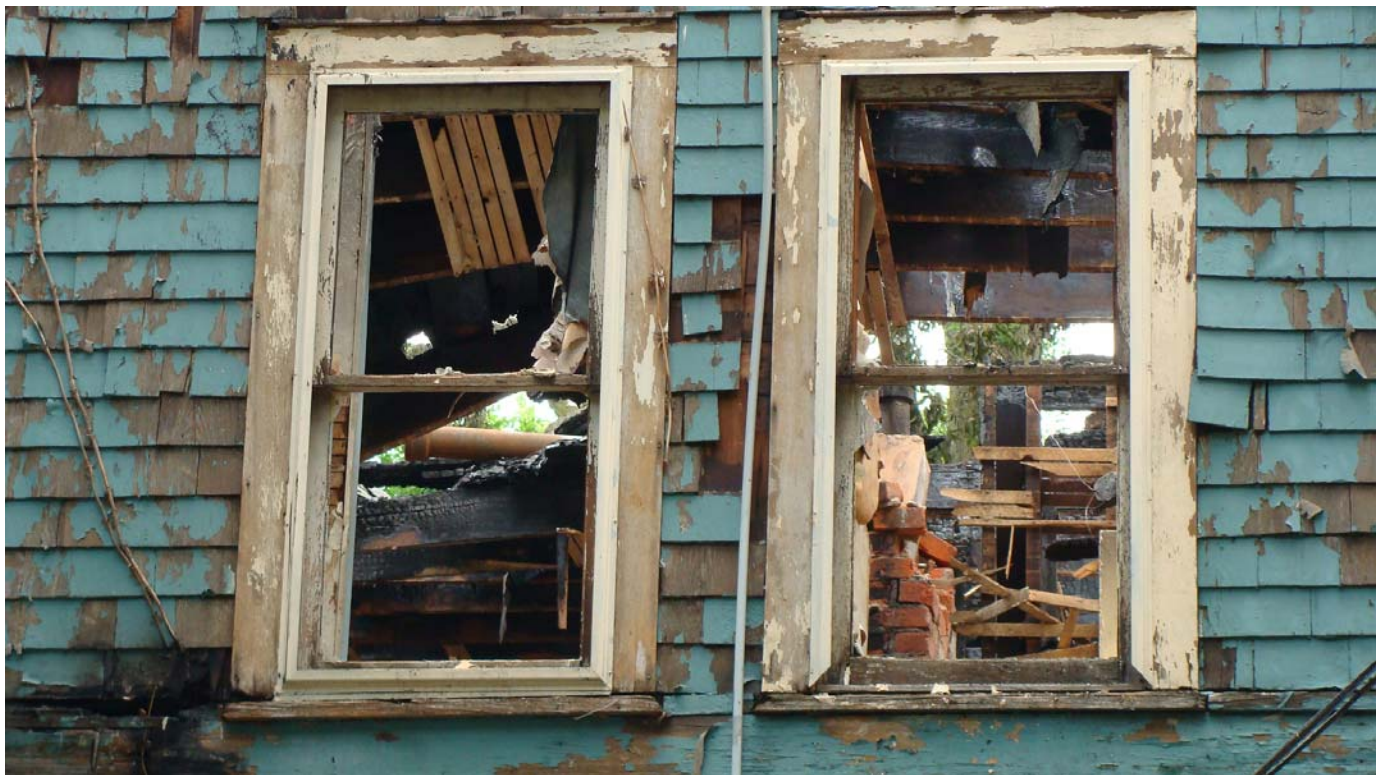
**Close up of second floor rear windows- windows were blown out**

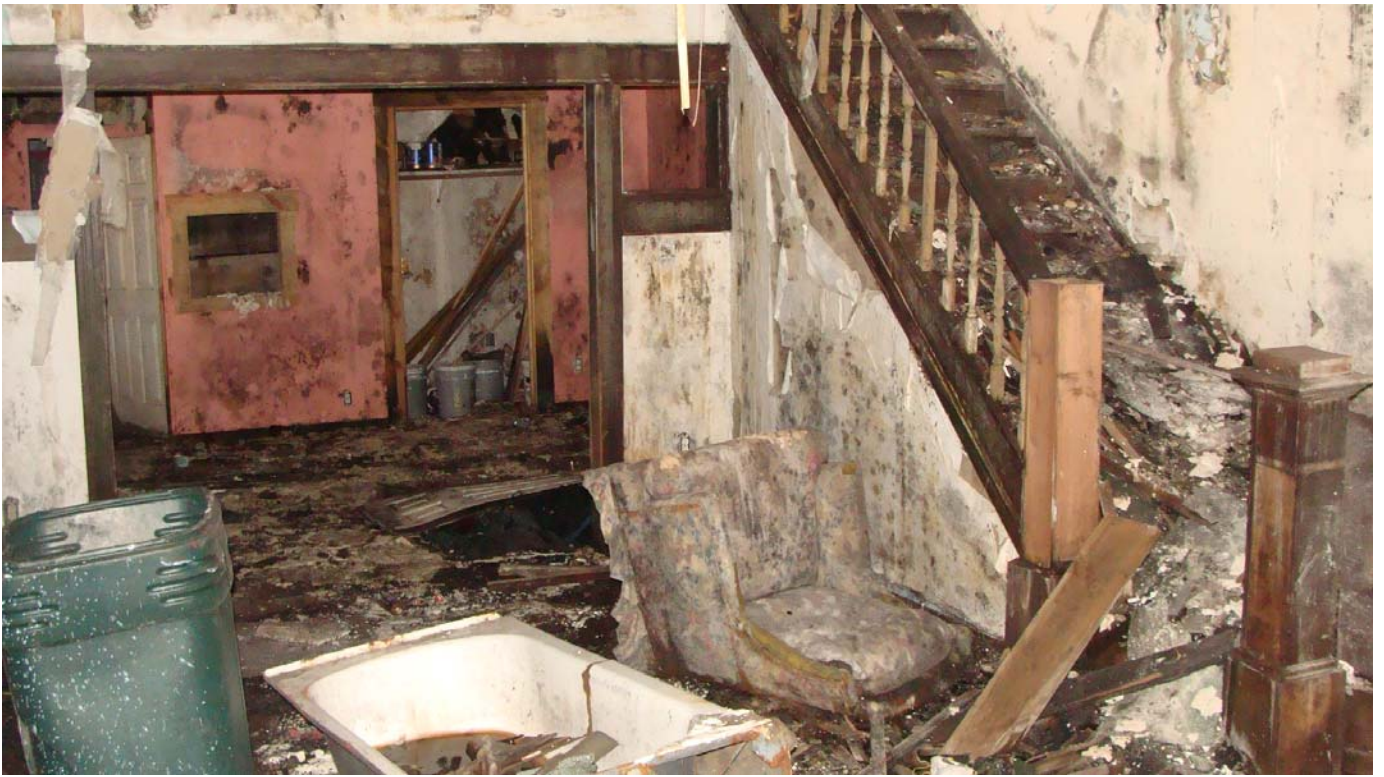
**Interior at first floor- Black mold covers the area**

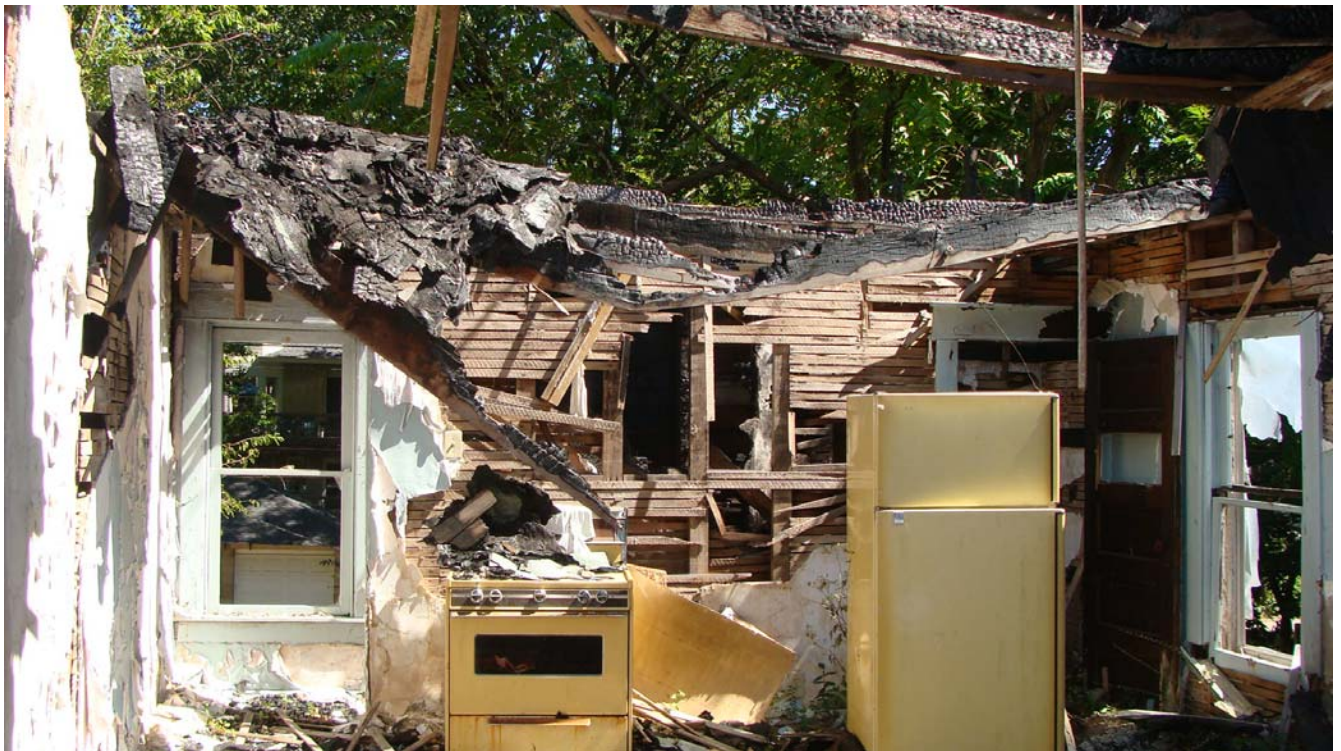
**Interior at second floor- No roof remains**
