2010-COA-583 (LS)	INDIANAPOLIS HISTORIC PRESERVATION COMMISSION STAFF REPORT	Hearing Date APRIL 6, 2011
621 VERMONT ST. AKA. 619 E. VERMONT PL LOCKERBIE SQUARE		Continued for 2 months from: Feb. 2, 2011
Applicant SCOTT PERKINS, BLACKLINE mailing address: 1043 Virginia Avenue, Studio 211 Indianapolis, IN 46203		
Owner: KEN ADAMS, ADAMS INVESTMENTS LLC		Center Township Council District: 15
CASE		Doris Minton McNeil
IHPC COA: 2010-COA-583 (LS) To retain all windows installed without approval		
STAFF RECOMMENDATION: Continue to May 4, 2011

New Aluminum Slider Windows – installed without approval

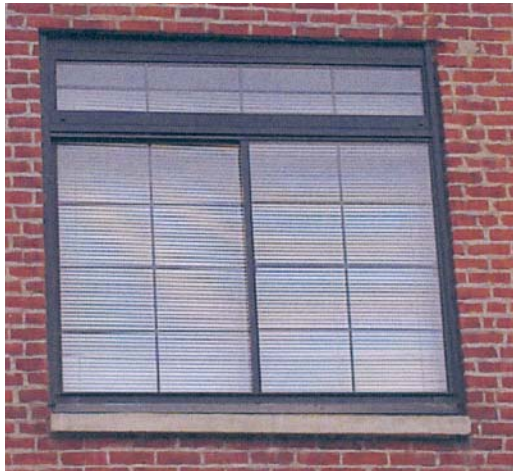
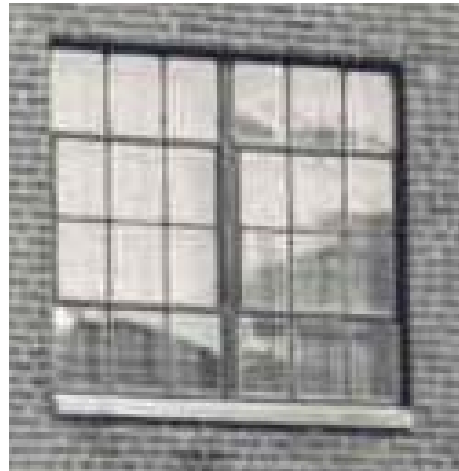
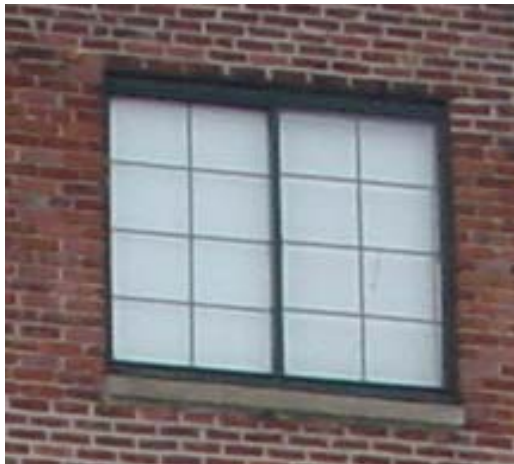
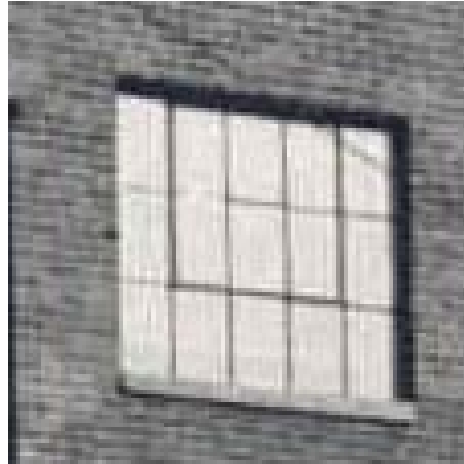
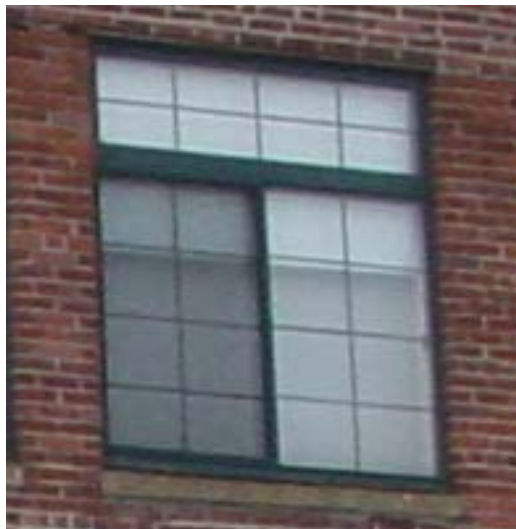
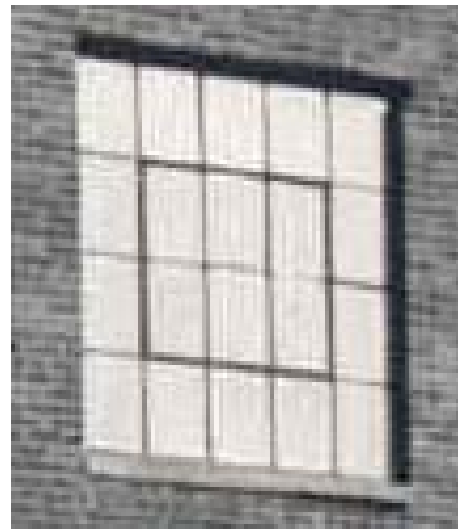
The previous photos display the following problems with the new aluminum slider windows:

- The steel windows were all on the same plane, while the slider replacement windows have movable sections that are on different planes.
- The plane differentiation is more similar to a modern sliding glass door than to a traditional double-hung window, which accentuates the visual incongruity of these windows.

- The use of a transom with wide separation bar is at significantly dissimilar to the original configuration of the steel windows.
- The windows include grids sandwiched within the insulated glass, which gives a different visual effect than the true divided lites of the steel windows.

- The grids in the new windows create “panes” that are oriented horizontally, while the panes on the steel windows were oriented vertically.
- Exterior screens on the new slider windows emphasize the window in two planes and alter the color and appearance significantly from the original aesthetic.

- As a material, the aluminum on the new windows is an appropriate replacement for steel. However the dimensional differences are greater than would be desired.

1. Find a more appropriate replacement window. Staff has identified one option that may be more appropriate, but the owner must explore that option and others that may exist.
2. Determine if some of the windows have less impact on the overall character of the building and consider allowing them to remain, focusing limited resources on those windows that will make the biggest impact on overall character.
3. Consider phasing the replacement to spread out the economic impact.
4. Consider replacing windows when apartments become empty, to reduce the economic impact.

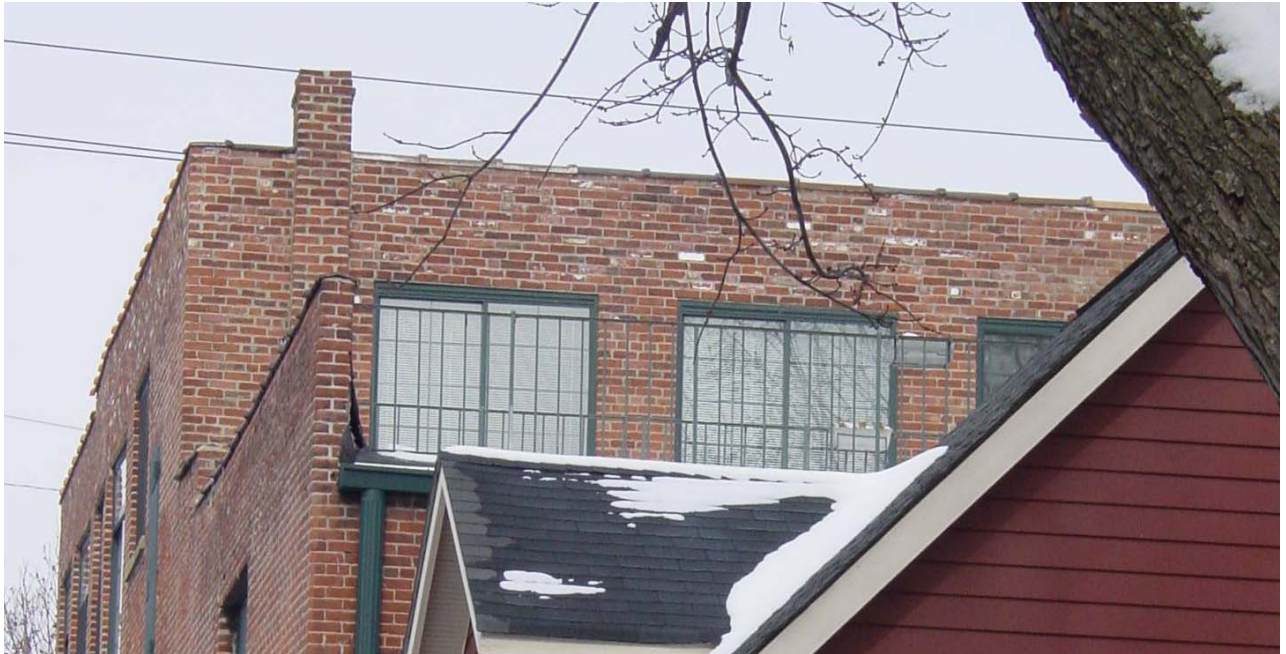
Above: View of windows at third floor (south elevation).

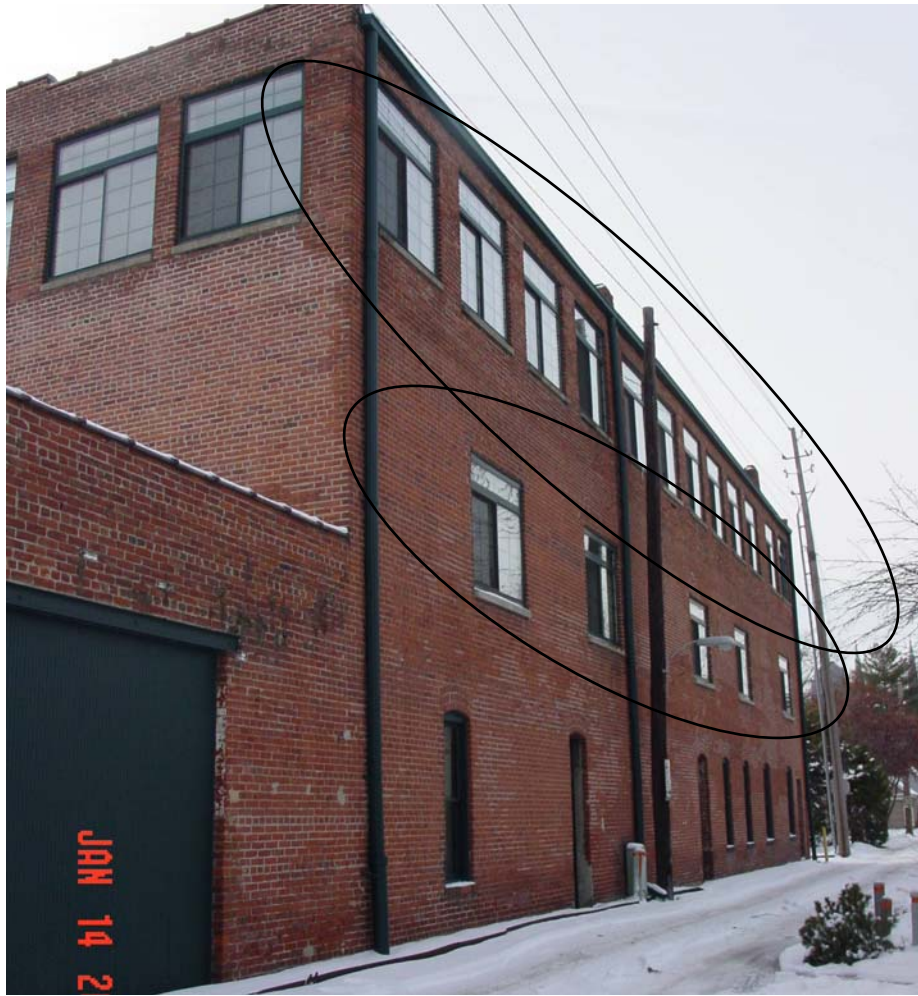
Above: View of the 17 windows replaced on the north elevation

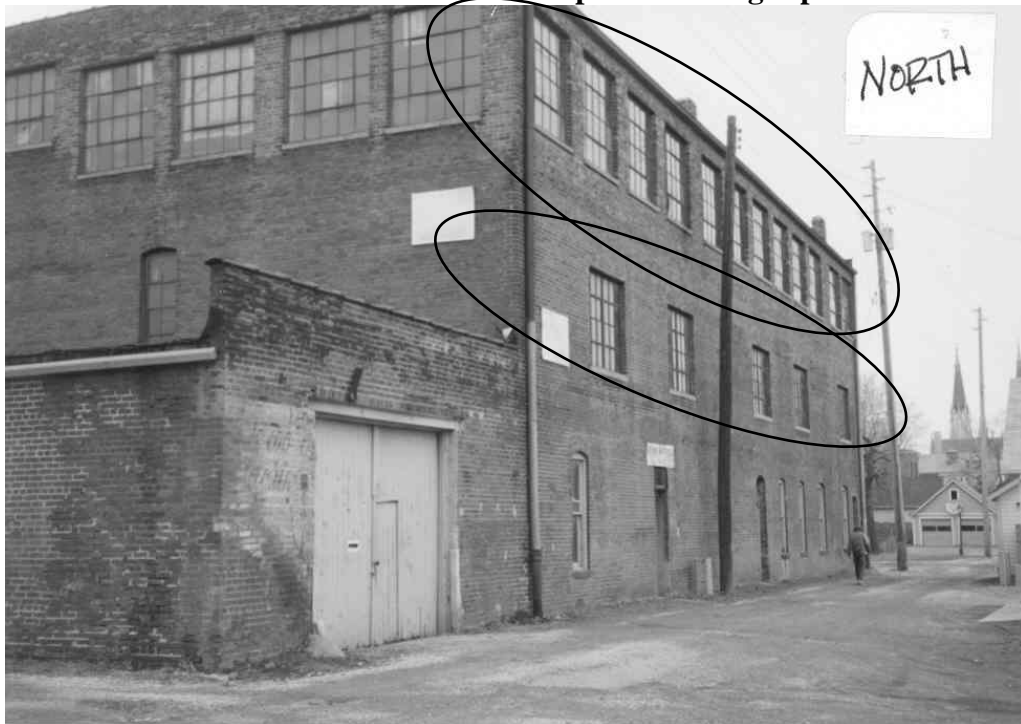
Below: View of the 17 windows prior to being replaced.

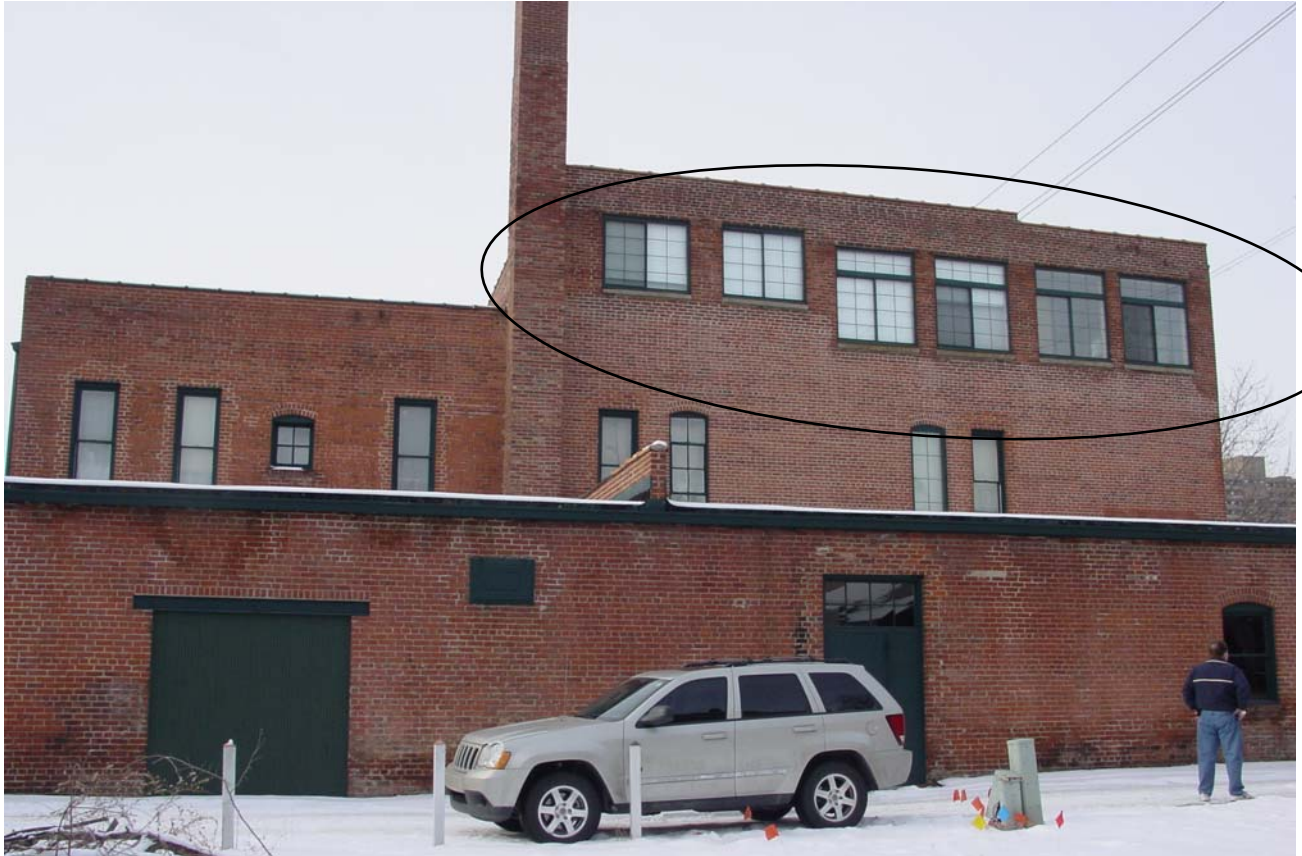
Above: View of the windows replaced on the east elevation

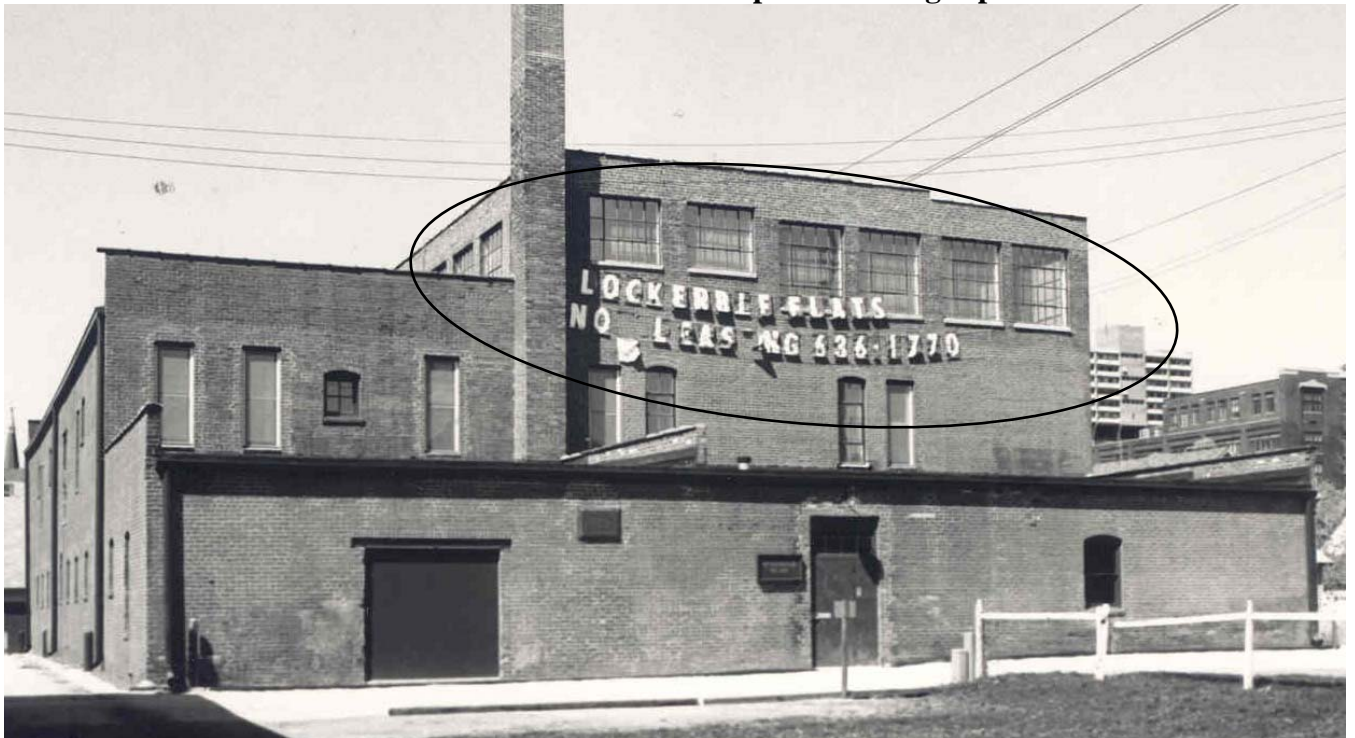
Below: View of the same windows prior to being replaced.

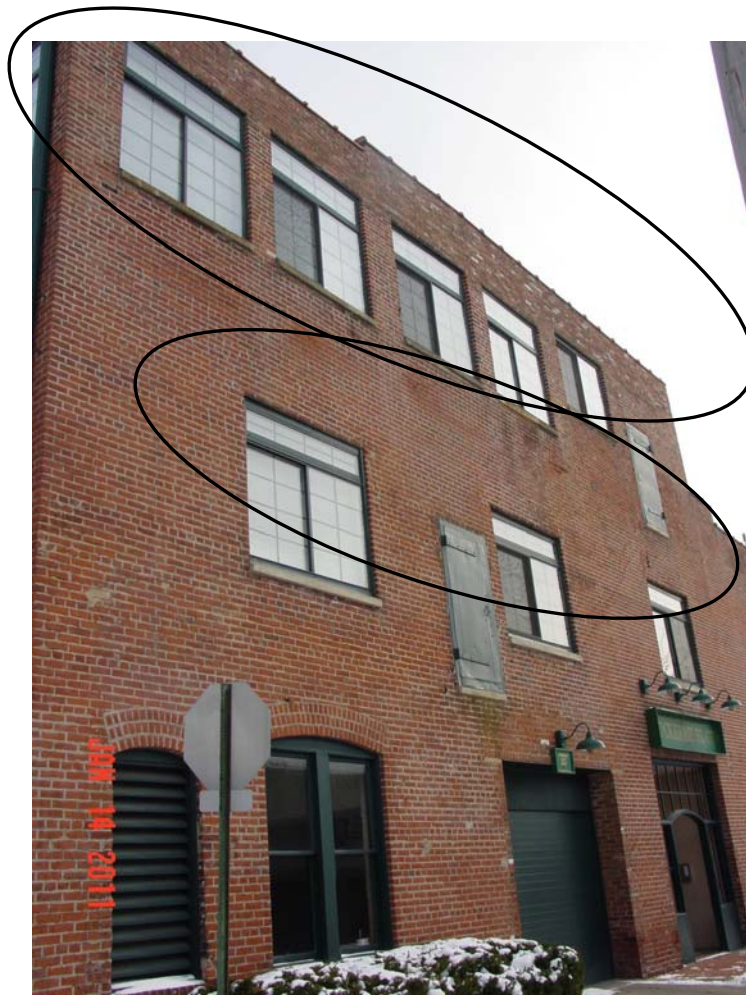
Above: View of windows on the west elevation that were replaced.

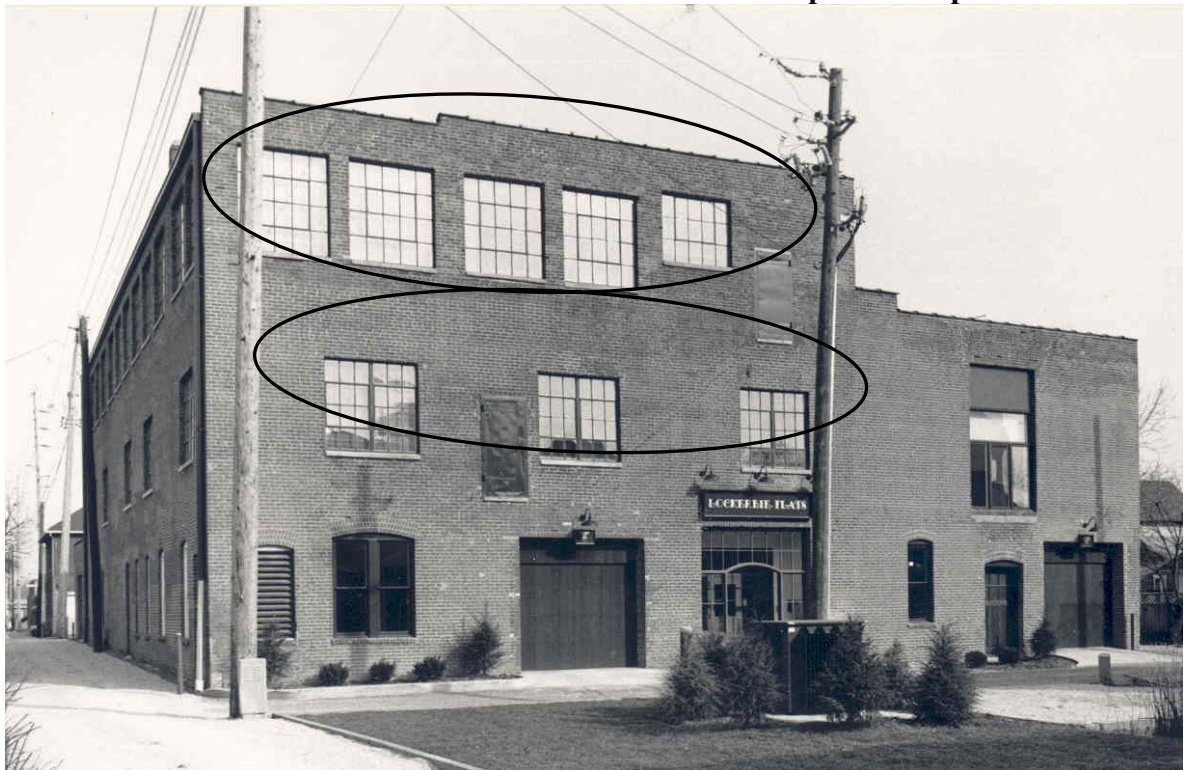
Below: View of same windows on the west elevation prior to replacement.
