COA # 2011-COA-255 (FP)	INDIANAPOLIS HISTORIC PRESERVATION COMMISSION STAFF REPORT	Hearing Date SEPT. 7, 2011
646 Virginia Ave FLETCHER PLACE		Continued from: August 3, 2011
Applicant HAROLD MILLER mailing address: 646 Virginia Ave Indianapolis, IN 46203		Center Township Council District: 19 Dane Mahern
Owner: Same		
CASE		
IHPC COA: 2011-COA-255 (FP)	<ul style="list-style-type: none"> • Modify storefront openings as per plans • Modify window openings on rear of building (work already started). • Restore original front entry 	
STAFF RECOMMENDATION: Approval with stipulations		
STAFF COMMENTS

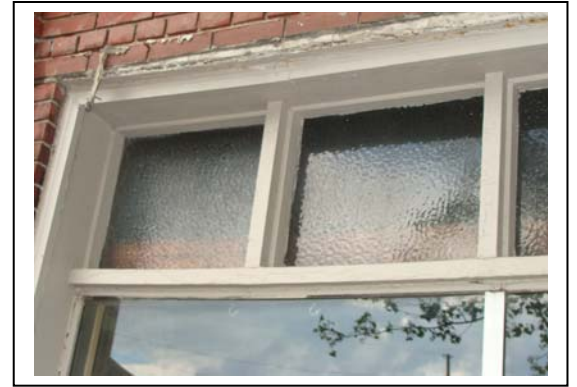
The owner wishes to replace the non-original aluminum storefront window and original wood transom with a new aluminum storefront window and transom. It is difficult to ascertain how much of the “original” transom is actually original, as there appears to have been replacement pieces added over the years. It is warped, requires much repair and some replacement. The original transom has frosted dimpled glass and deeply profiled mullions between each pane. The original large storefront windows (below the transom) were replaced many years ago, using flat metal strips to divide the large sheets of glass. The brick mold and concrete bulkhead appear to be intact.

Staff agrees that the best solution in this case is to build an entirely new storefront (show windows and transom) out of the aluminum. Reasons include:

The owner’s architect believes that a profile to match the existing could be easily duplicated. Since the storefront window and transom need to be rebuilt, a new unit should be considered. The original glass has been salvaged and could be reused, or new glass to resemble the original could be used.

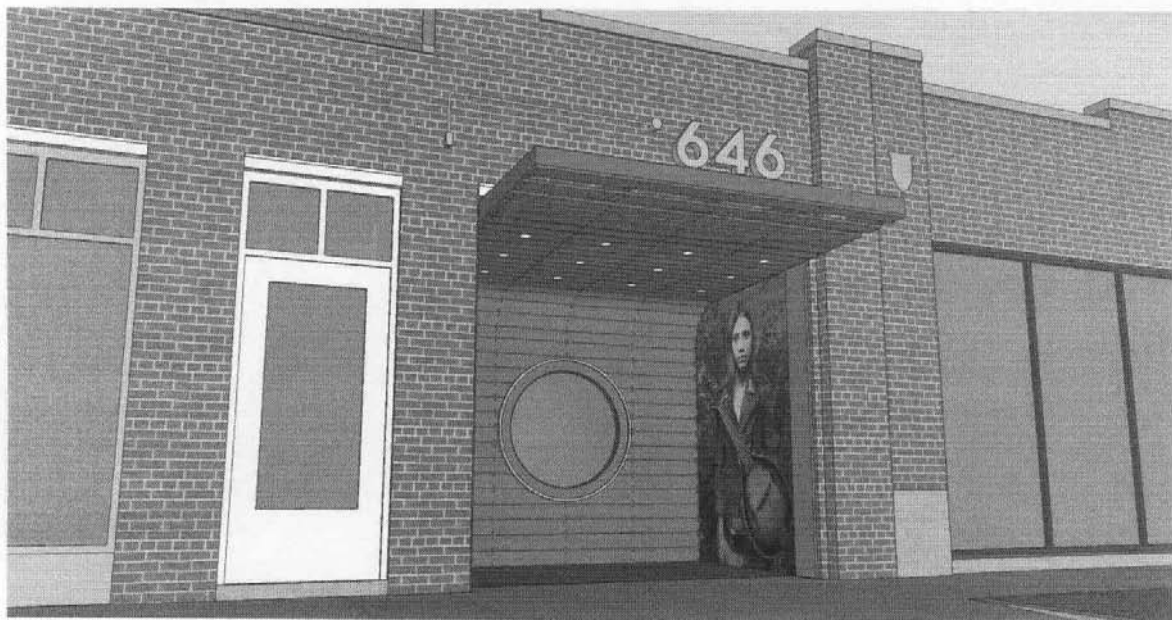
PROPOSED COVERED ENTRY, CANOPY AND PHOTOGRAPHY FEATURE WALL

Staff’s believes the garage door is probably not original. The proposal is to remove it and replace it with a new recessed entry with a new door on one side wall, an unpainted redwood wall with round window at the back and a panel to display an oversized photograph on the other side wall. The new entry is for ADA compliance. The plans also show a wooden canopy projection.

1. **Round Window**. This has been the source of discussion between staff and the architect. While staff believes the contemporary design of this entry is generally compatible with the building, we find the round window element to be a visual distraction, as it becomes the first element one sees and is entirely at odds with all other elements of the building. Staff believes a square window would achieve the same practical need and also echo the squared off features found in the transom windows and the brick panel in the raised parapet.

2. Unfinished Redwood. Staff has expressed a preference for painting the redwood, but the owner wishes to keep the redwood unpainted as proposed. This issue is not as important to staff as the round window, but we believe the IHPC should take it into consideration.

It is staff’s understanding that the owner still prefers the round window, but may be willing to change to a square window if the IHPC requires it. Staff recommends that it be removed.

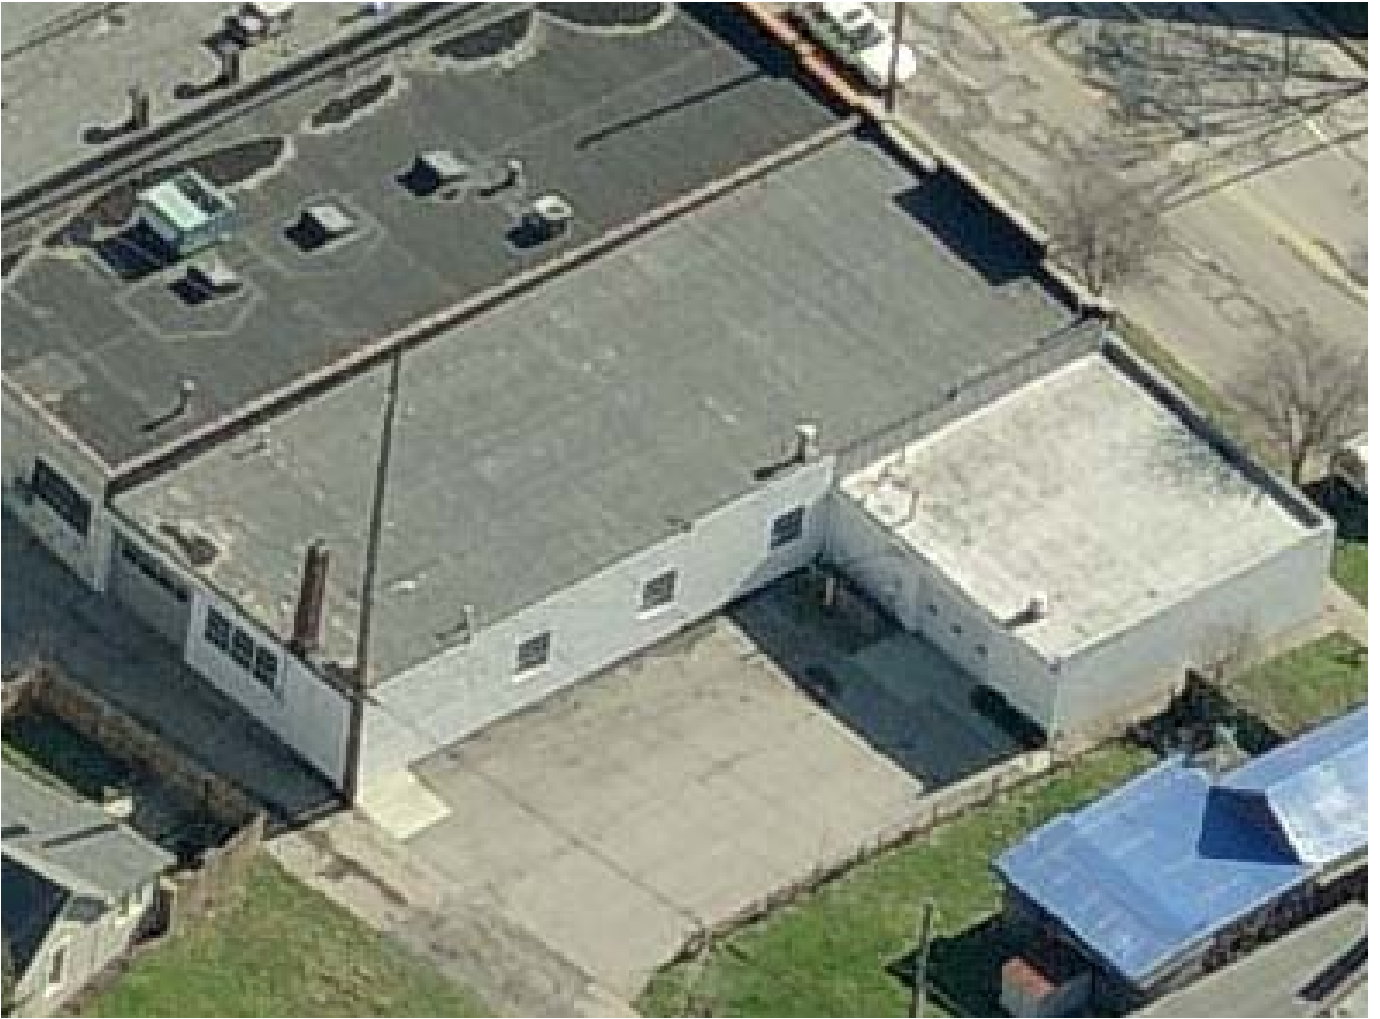
Near the rear of the building, there are three steel factory sash windows. The owner’s contractor started to enlarge one of the openings when a building inspector issued a Stop Work Order. That opening remains altered with plywood over the enlarged portion. The original window is still in the opening. However, the intent was to enlarge all three openings and install new windows and doors as per the drawings. Staff believes the steel windows are interesting, but because they are not visible from most angles, they don’t contribute significantly to the architecture of the building despite their age and character. Staff believes that the proposed alteration is appropriate and a reasonable way to convert this building for a new use, even though the work was started without approval.

This image shows the rear of the building and the three openings that are being requested to be enlarged and replaced with new windows.

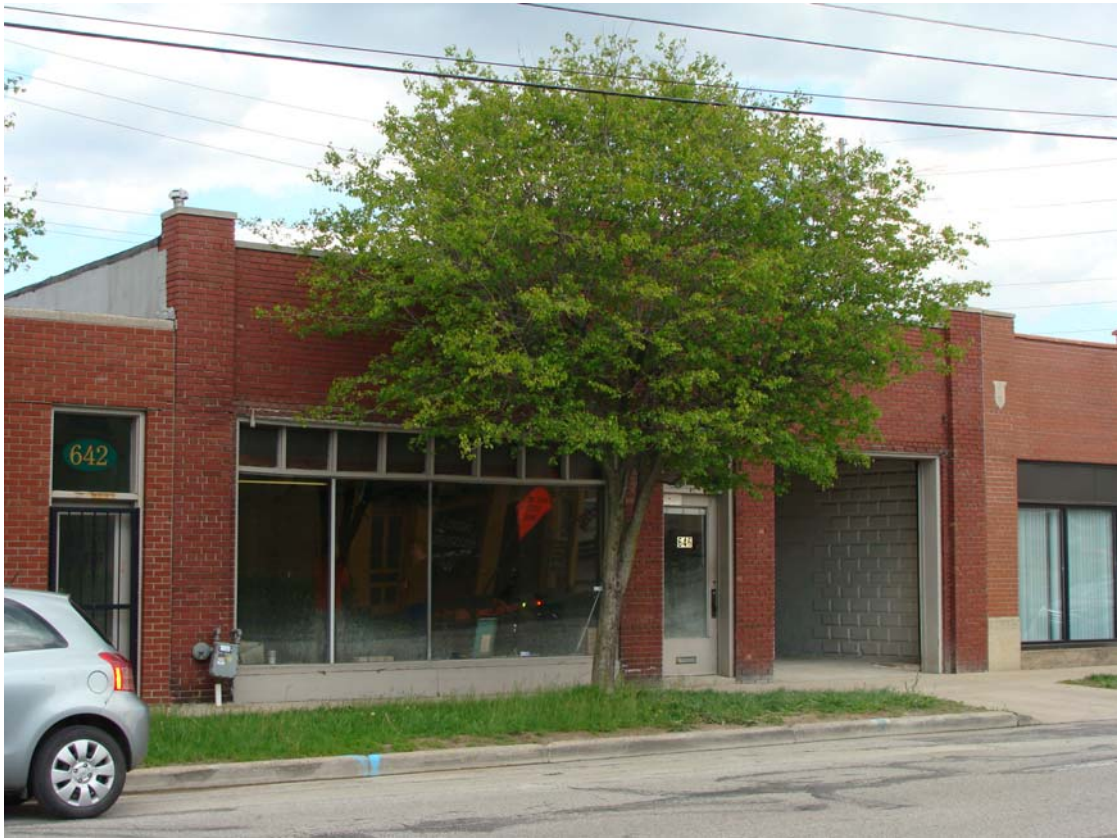
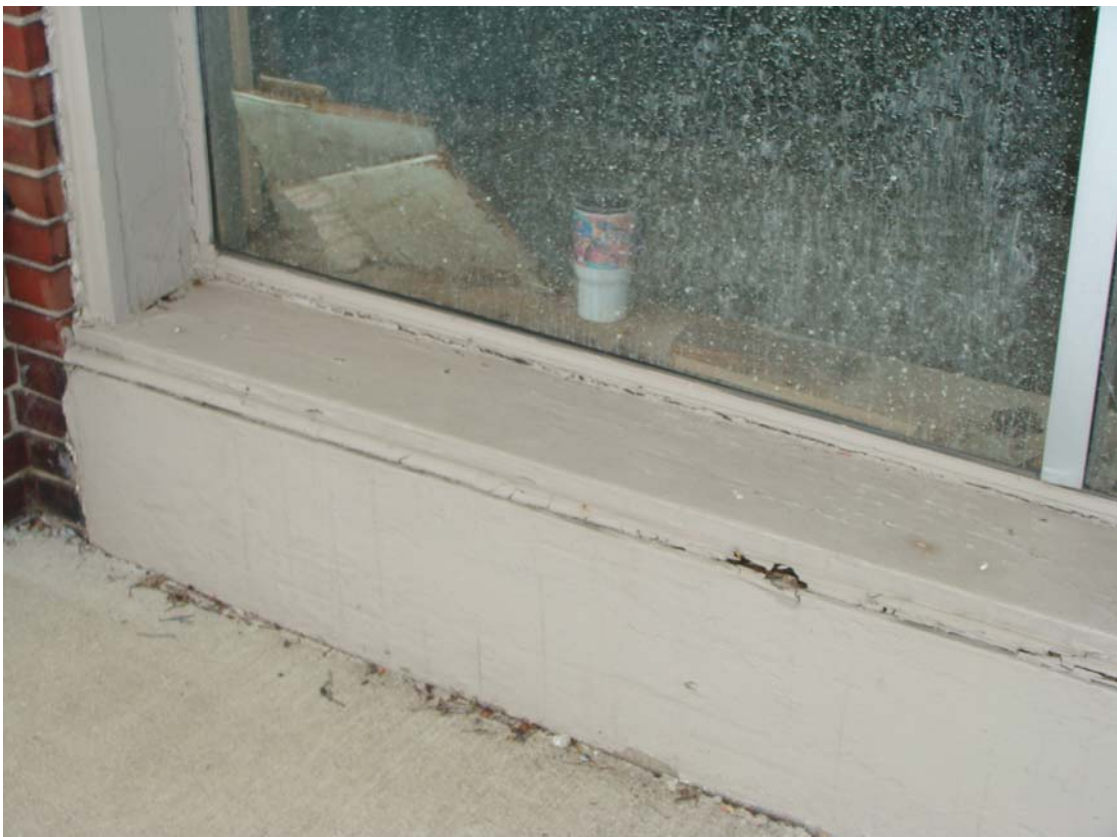
Above: Front Elevation
Below: Bulkhead below storefront window

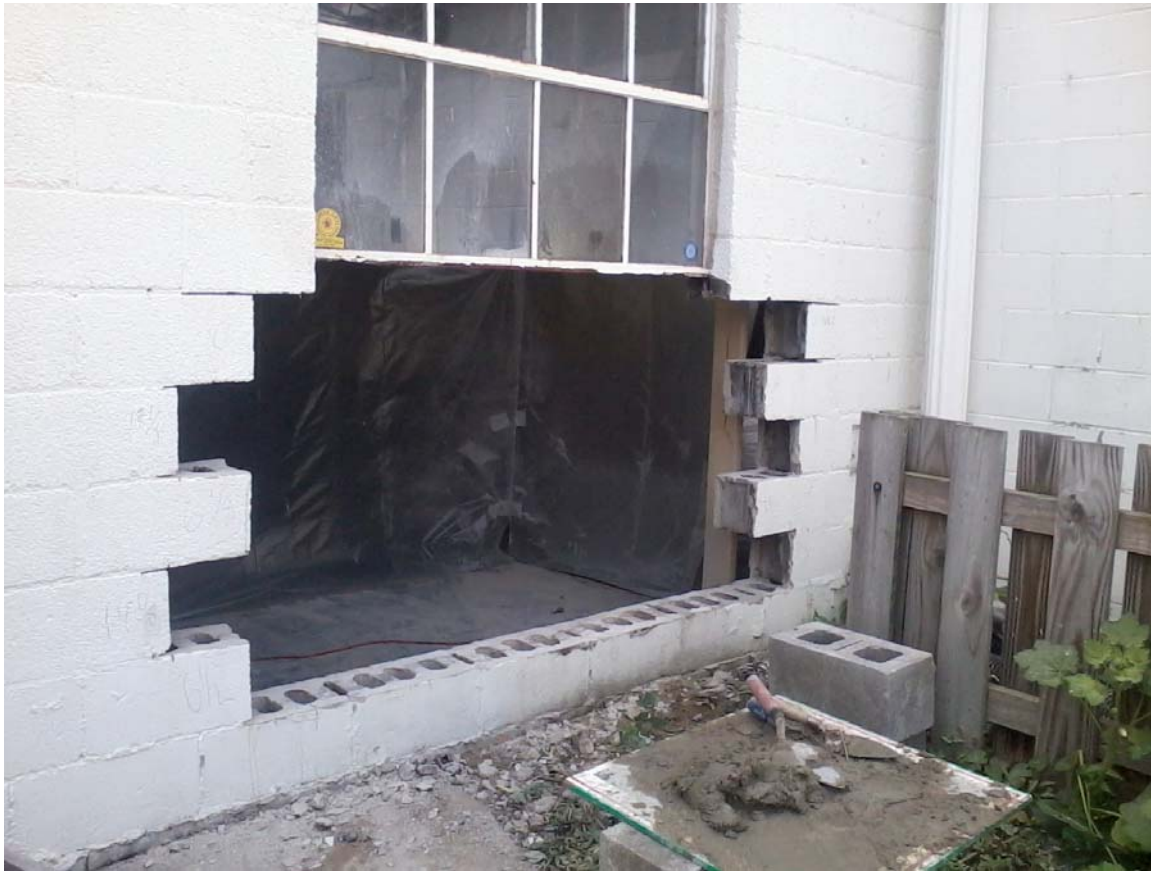
Above: View of window at rear of building that has been altered
Below: View of front entry (being repaired only)

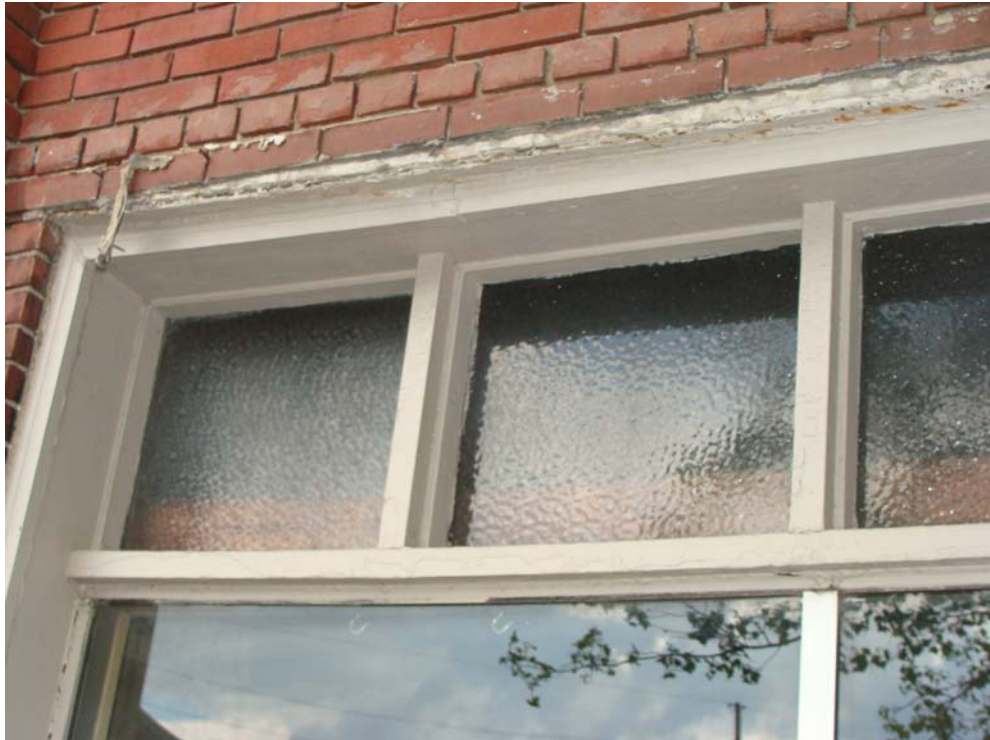
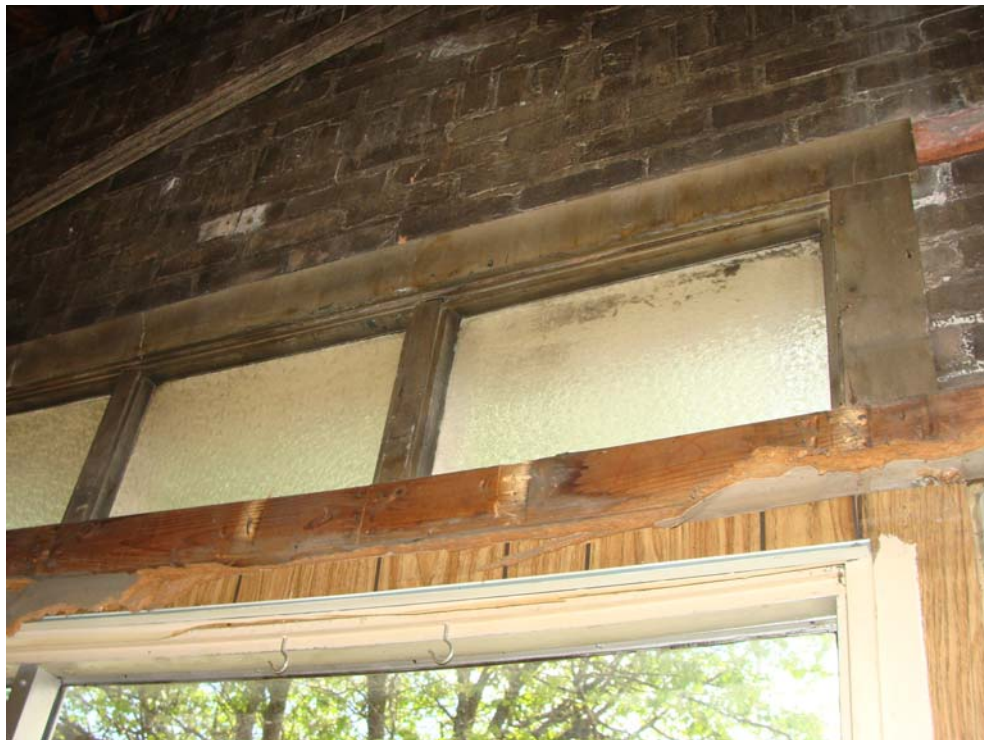
Above: View of transom window from the exterior
Below: View of transom window from the interior
