Background of Property

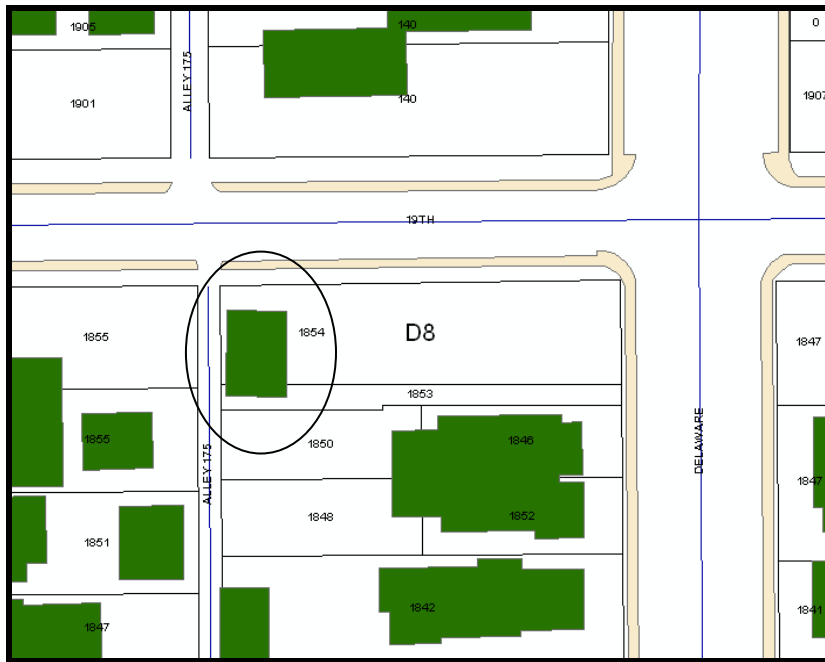
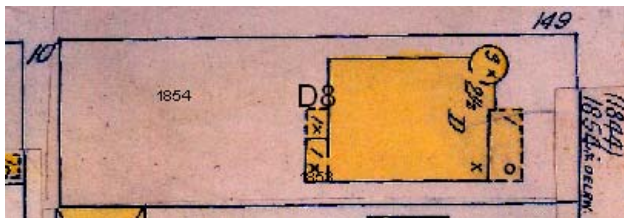
Above: View of site in 1898 (no garage)

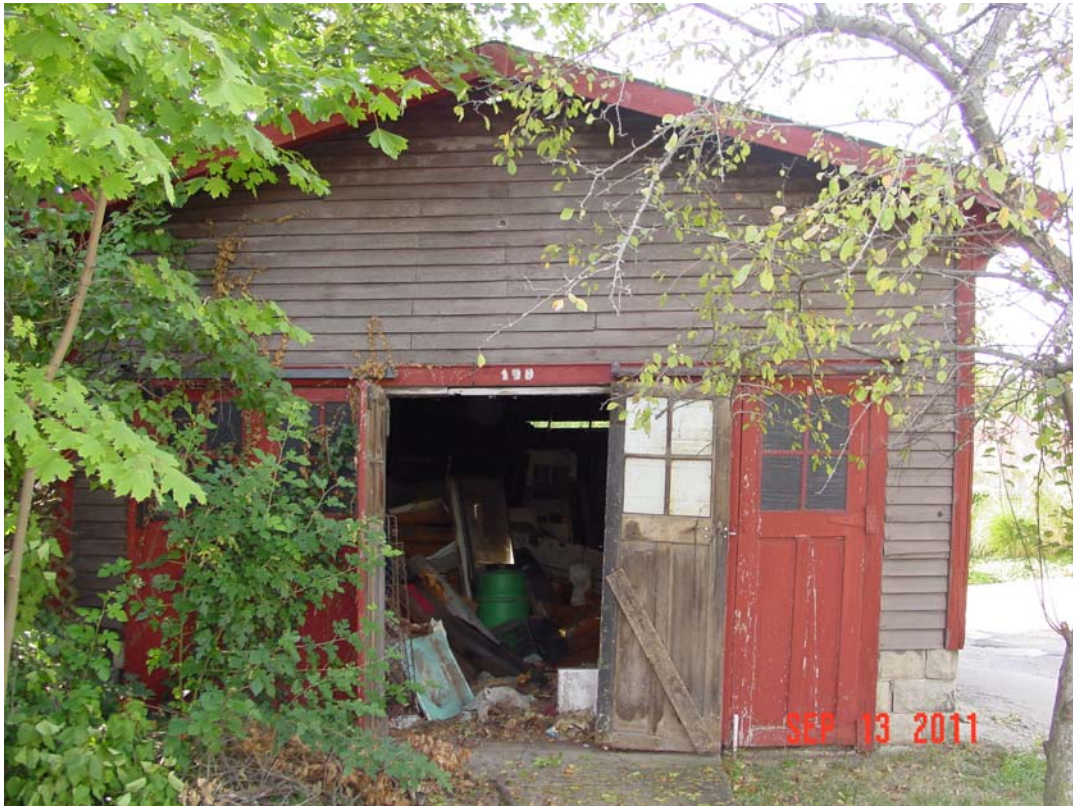
Above: View of north side of garage as seen from 19th Street. Notice lean at right.

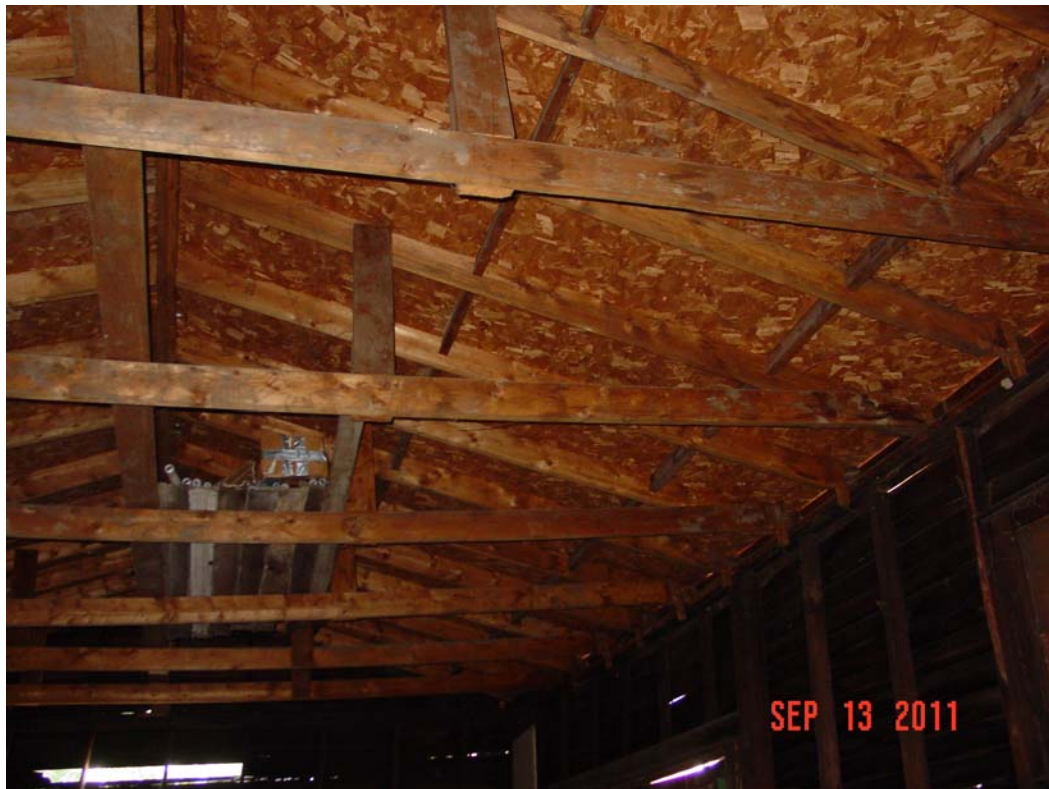
Below: View of replaced roof structure from the interior of the garage. Roof sheathing and trusses have been replaced

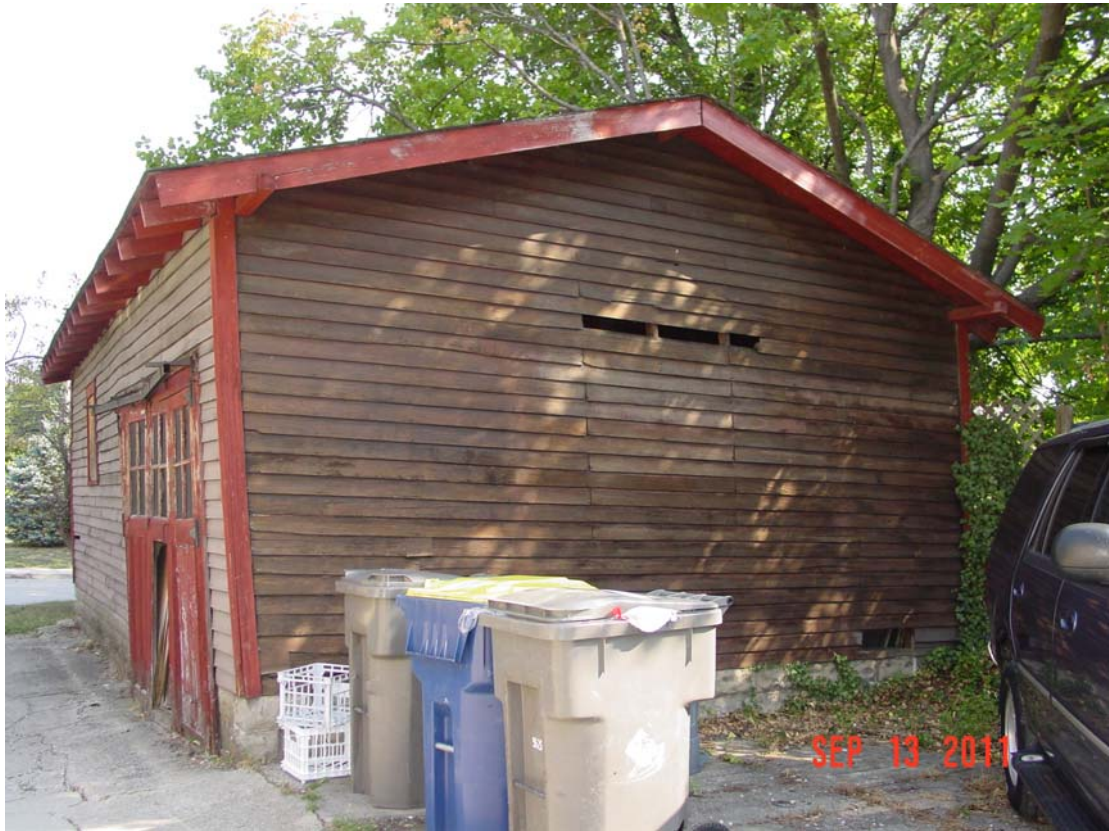
Above: View of south elevation of garage. Notice lean in wall at alley side.

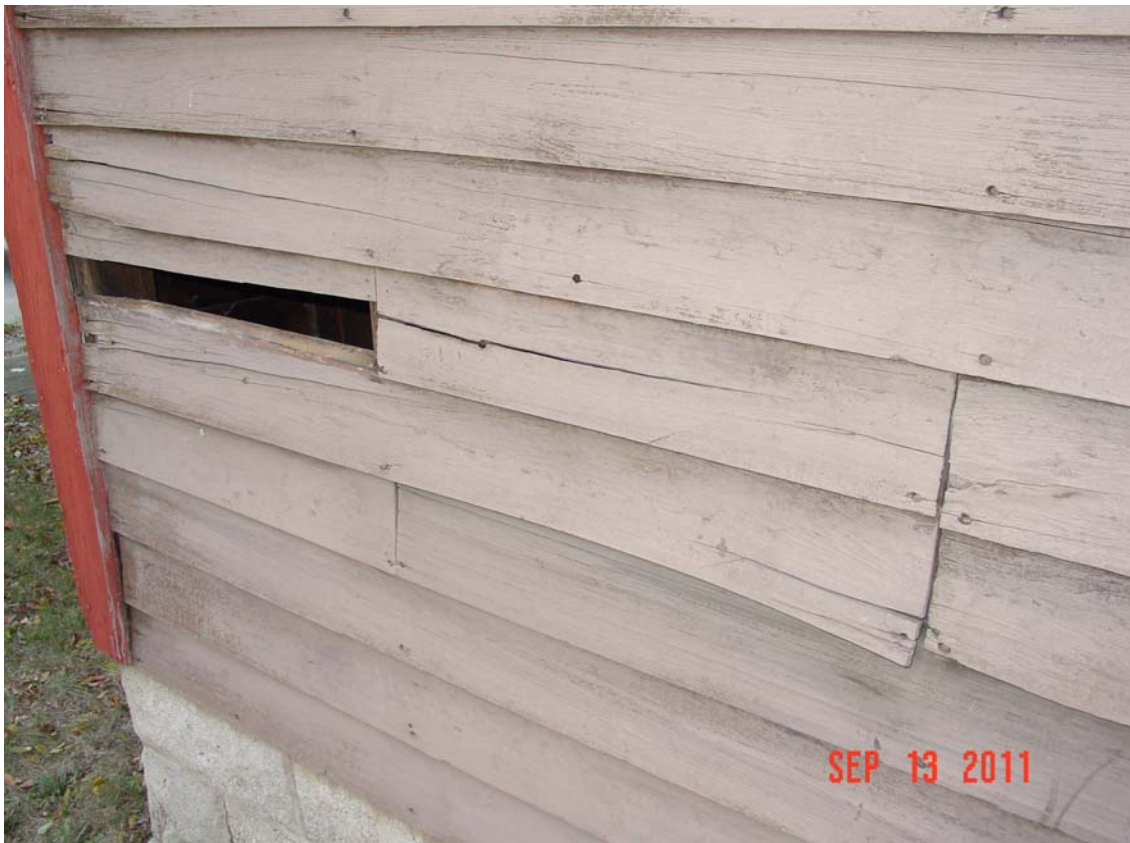
Below: Siding is dry, curling and brittle with many splits. Siding is not the original siding on the structure.

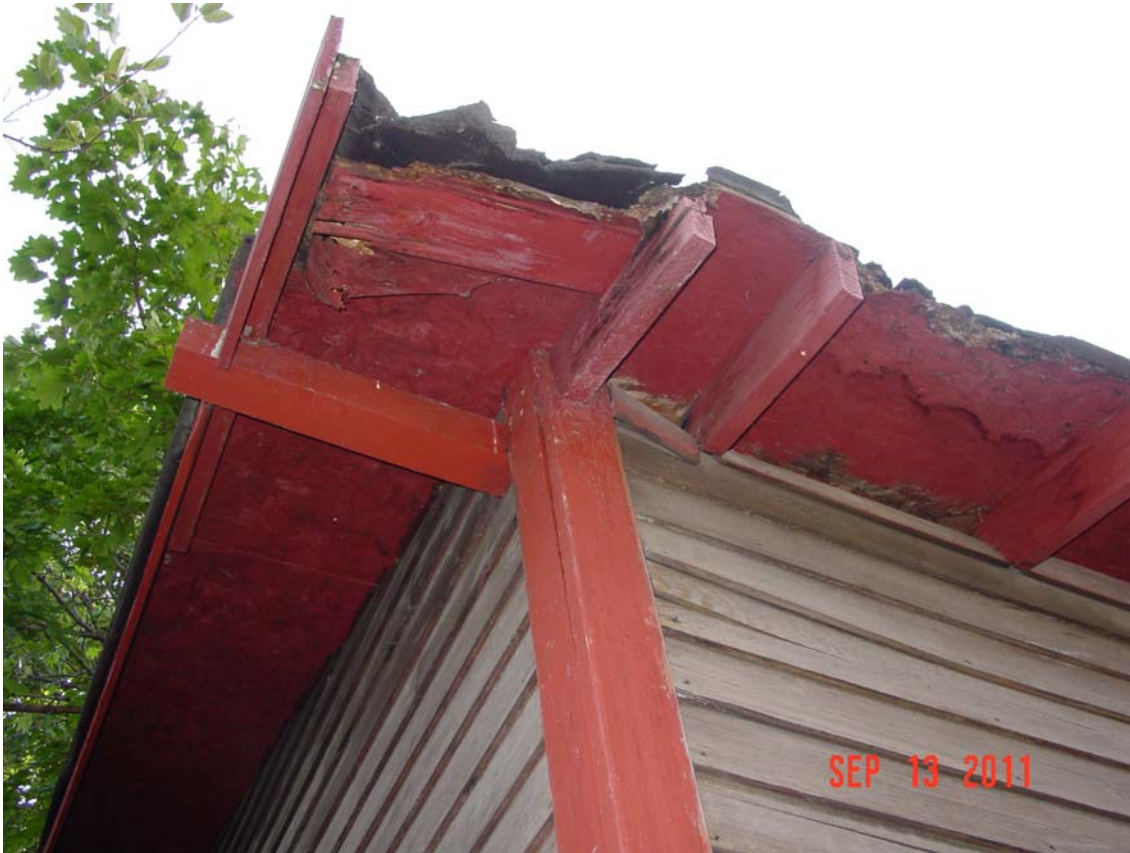
Above: View of non-original plywood at eaves and deterioration of eave material.

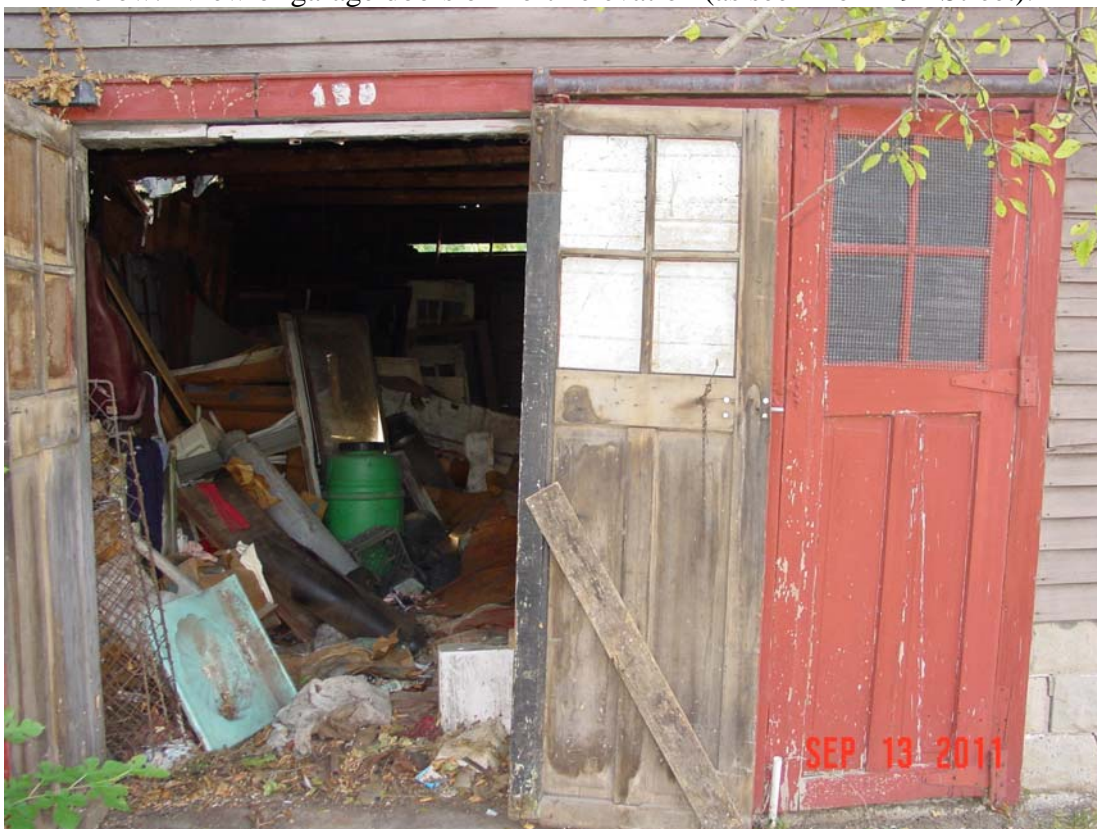
Below: View of garage doors on north elevation (as seen from 19th Street).

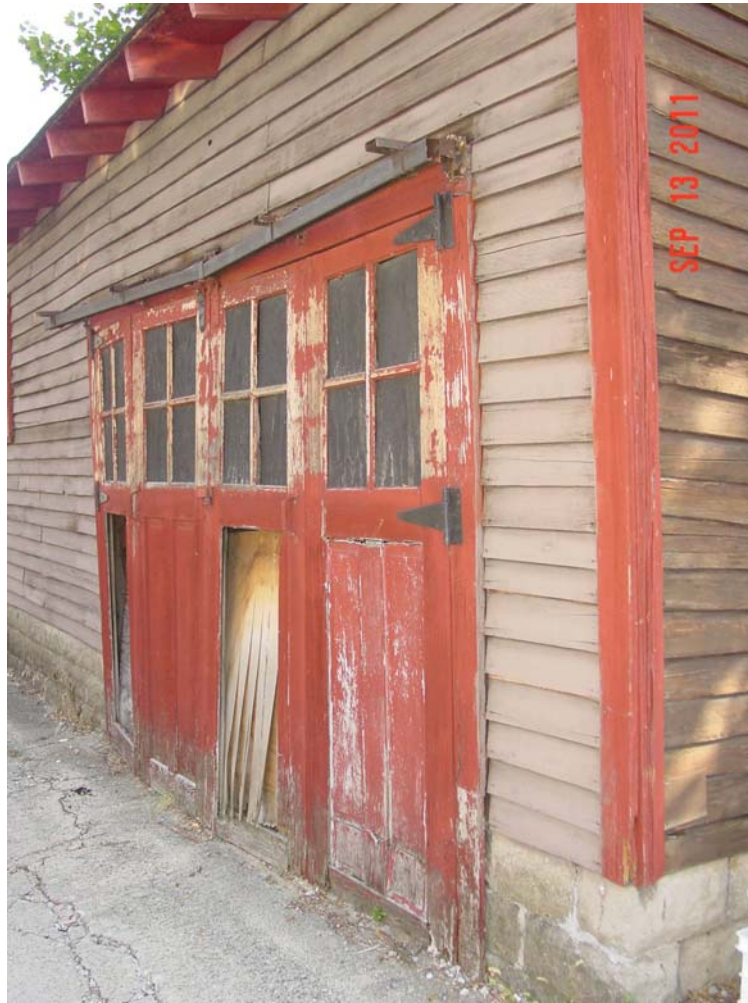
Above: View of doors on alley side. Doors appear to be historic, but are in poor condition.
