<b>CASE #</b> <b>2011-COA-397 (WP)</b>	<b>INDIANAPOLIS HISTORIC PRESERVATION COMMISSION</b> <b>STAFF REPORT</b>	Hearing Date <b>NOVEMBER 2, 2011</b>
<b>811 Woodruff Place East Drive</b> <b>WOODRUFF PLACE</b>		NEW CASE
<b>Applicant: BRENT ROBERTS</b> mailing address: 811 East Drive Indianapolis, IN 46201		Center Township Council District: 16 Brian Mahern
<b>Owner: Same as above</b>		
<b>CASE</b>		
<b>IHPC COA: 2011-COA-397 (WP)</b> Demolish historic accessory structure (workshop)		
<b>STAFF RECOMMENDATION: Approval of a Certificate of Authorization</b>

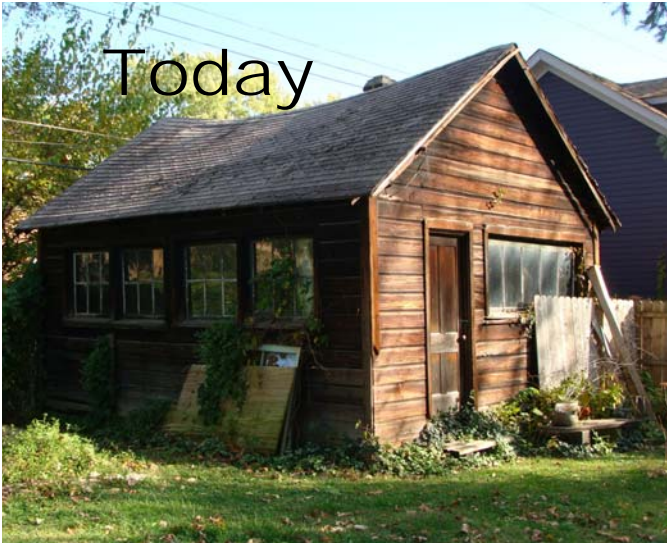
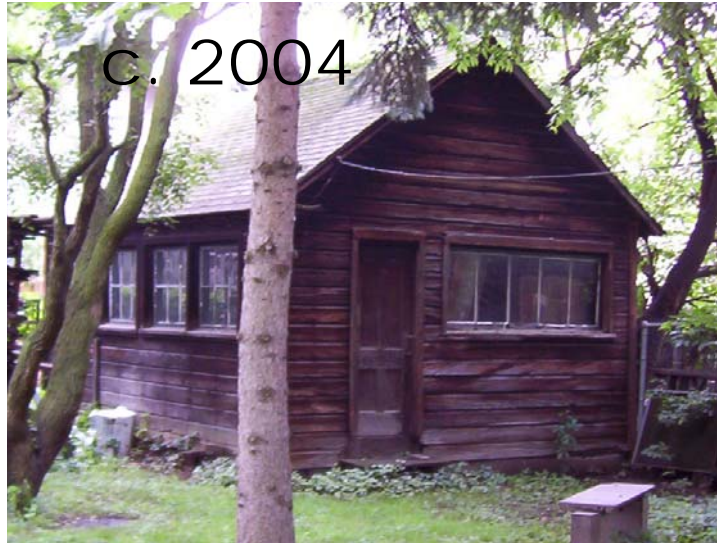
**View of workshop, looking southeast**

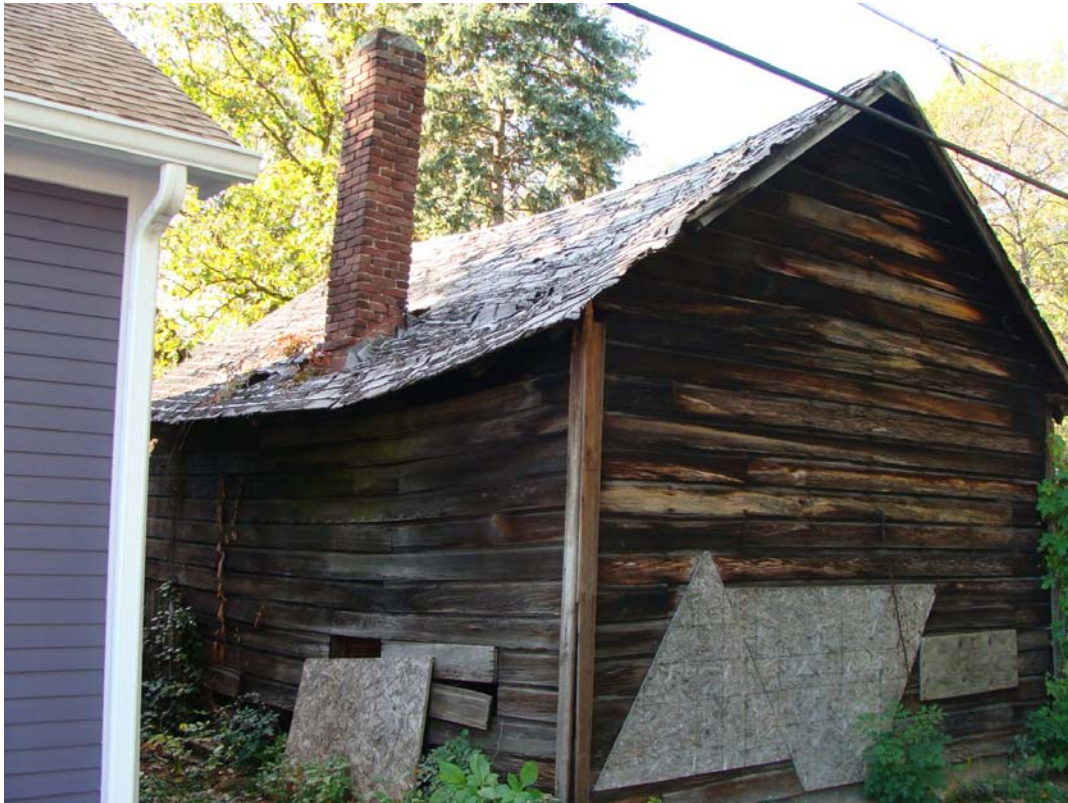
**View of workshop from alley, looking northwest**

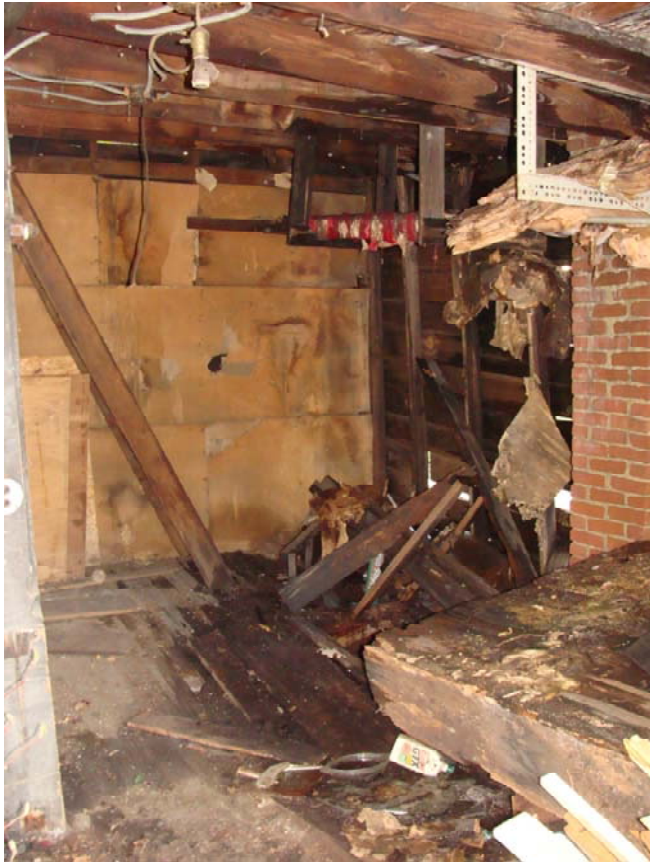
1. Partial roof structural failure including large holes in the roof surface, several roof rafters have splintered.
2. The eaves, particularly on the south side, are rotting, and pieces are missing.
3. There is missing siding on the south and east walls where rotten siding was kicked in during a break-in.
4. The interior floor has rotted and there is failure throughout.
5. The south wall is bowing inward and sags slightly, likely caused by the roof failure.

**Interior deterioration**

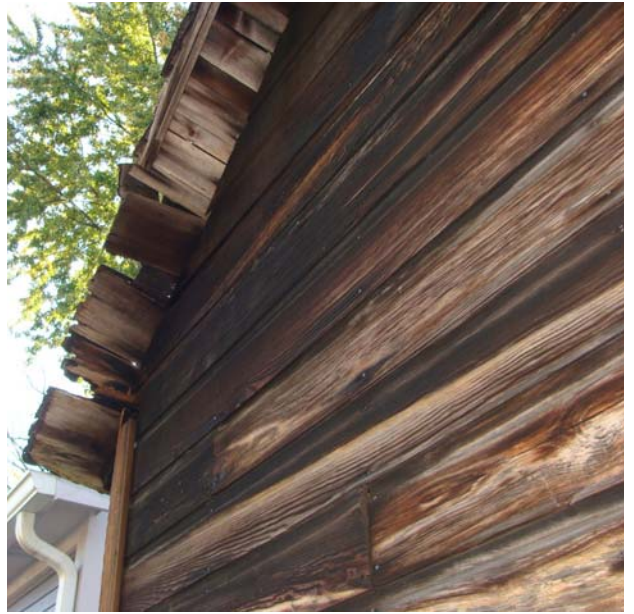
**Deterioration at eaves**
