COA # 2011-COA-409 (IRV)	INDIANAPOLIS HISTORIC PRESERVATION COMMISSION STAFF REPORT	Hearing Date NOV. 2, 2011
41 N WHITTIER PLACE IRVINGTON		NEW CASE Warren Township Council District: 21 Benjamin Hunter
Applicant GROVER B. DAVIS, attorney for SHATAWN LOWHORN mailing address: 235 N. Delaware Indianapolis, IN 46204		
Owner: same		
VIOLATION CASE (WORK STARTED WITHOUT APPROVAL)		
IHPC COA: 2011-COA-409 (IRV) <ul style="list-style-type: none"> • Retain inappropriate wood siding on front gable installed without approval • Replace inappropriate rear steel door with wood door. • Replace inappropriate aluminum clad windows on north side and vinyl window at front porch with wood windows • Modify attached shed-like structure at rear of house constructed without approval. 		
STAFF RECOMMENDATION: Approval with stipulations if applicant agrees

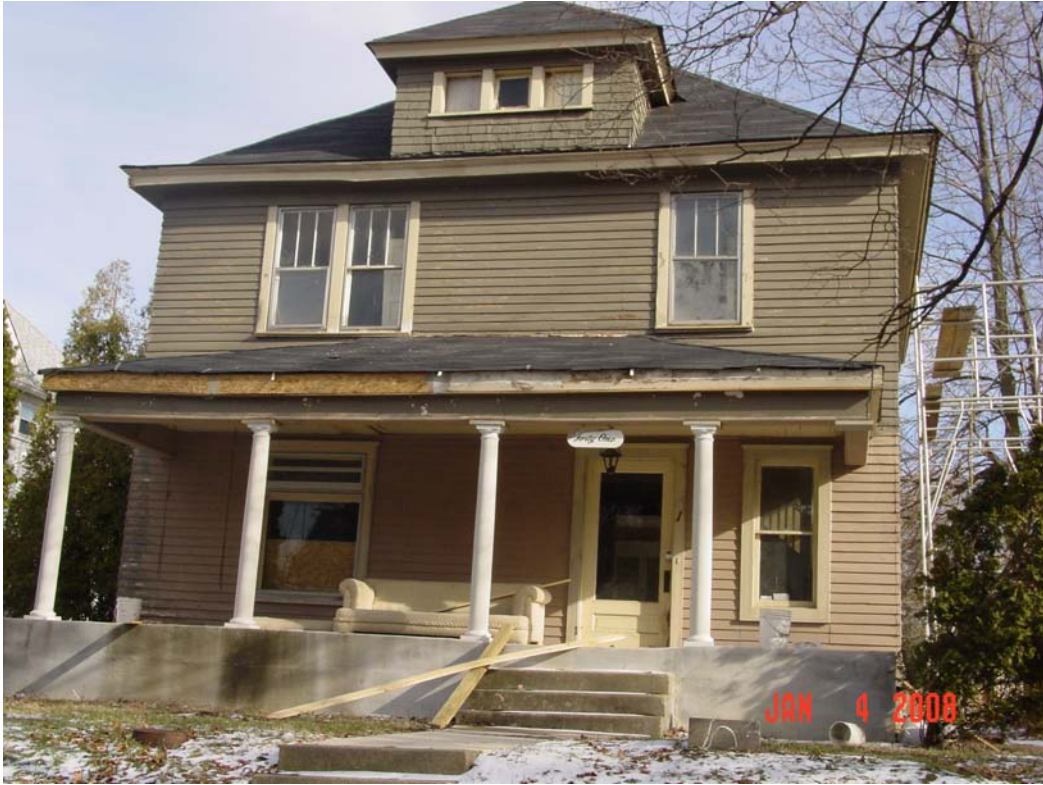
Above: View of house in January 2008
Below: View of house in August 2008 after violations occurred.

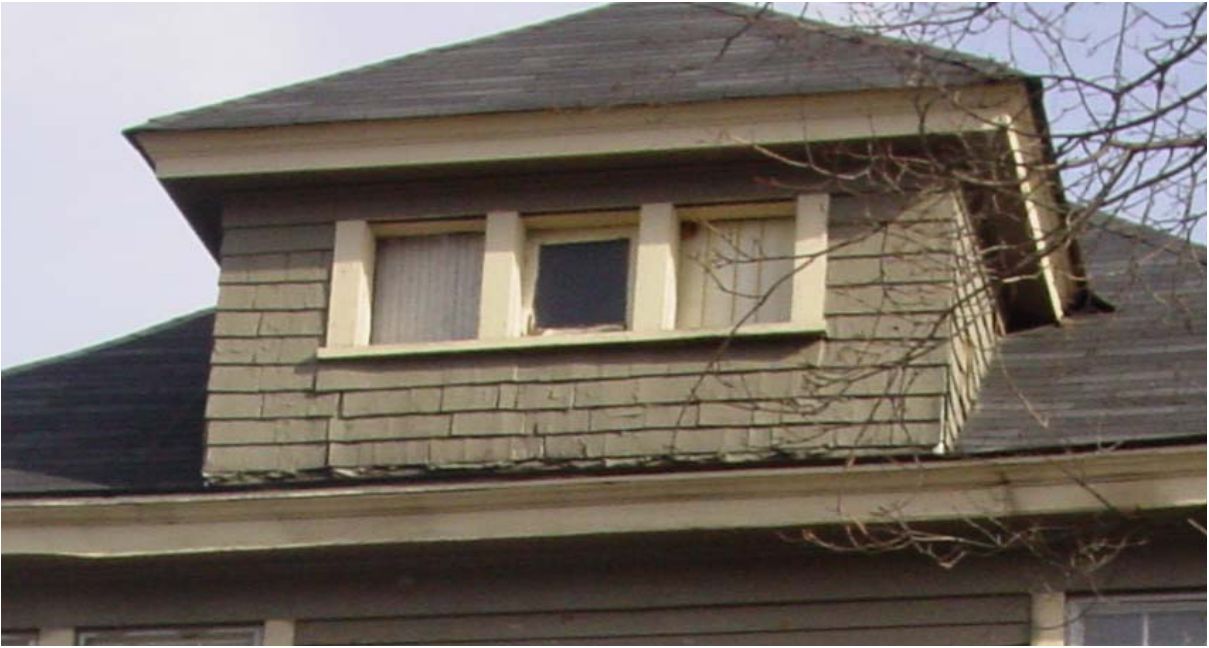
Above: View of original wood shingles in dormer
Below: View of wood lap siding used to replace shingles

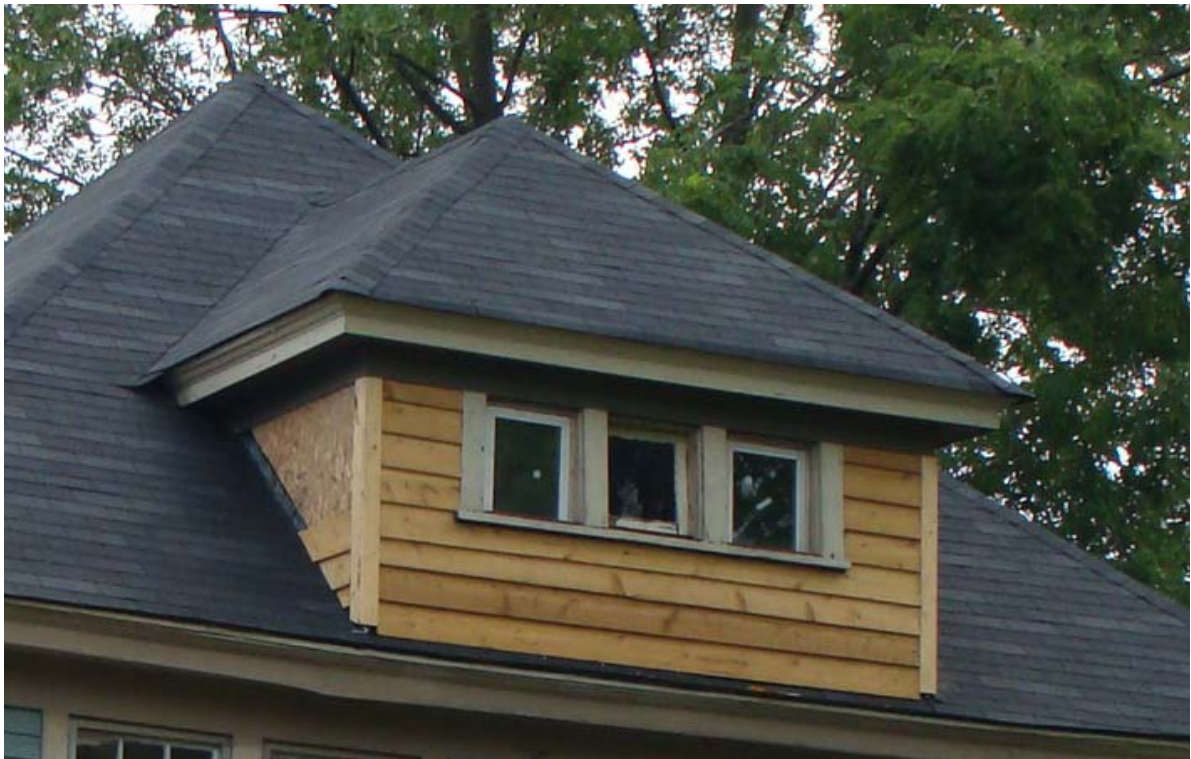
1. **Front Gable.** The applicant removed the original wood shingles and replaced them with wood lap siding. The lap siding should be removed and appropriate wood shingles to match the originals should be installed.
2. **One Window and Trim – South Side Stair Window.** The original wood double-hung window was removed and replaced with a vinyl double hung window. It should be replaced with an appropriately sized solid wood double-hung window.

- 2. New window and door selections must be approved by IHPC staff prior to purchase and installation. Approved _____ Date _____**
- 3. New shingles at front gable shall be real wood and match the shingles that were originally found on the gable as found in the photo documentation in the IHPC building file. Final shingle selection must be approved by IHPC staff prior to installation. Approved _____ Date _____**

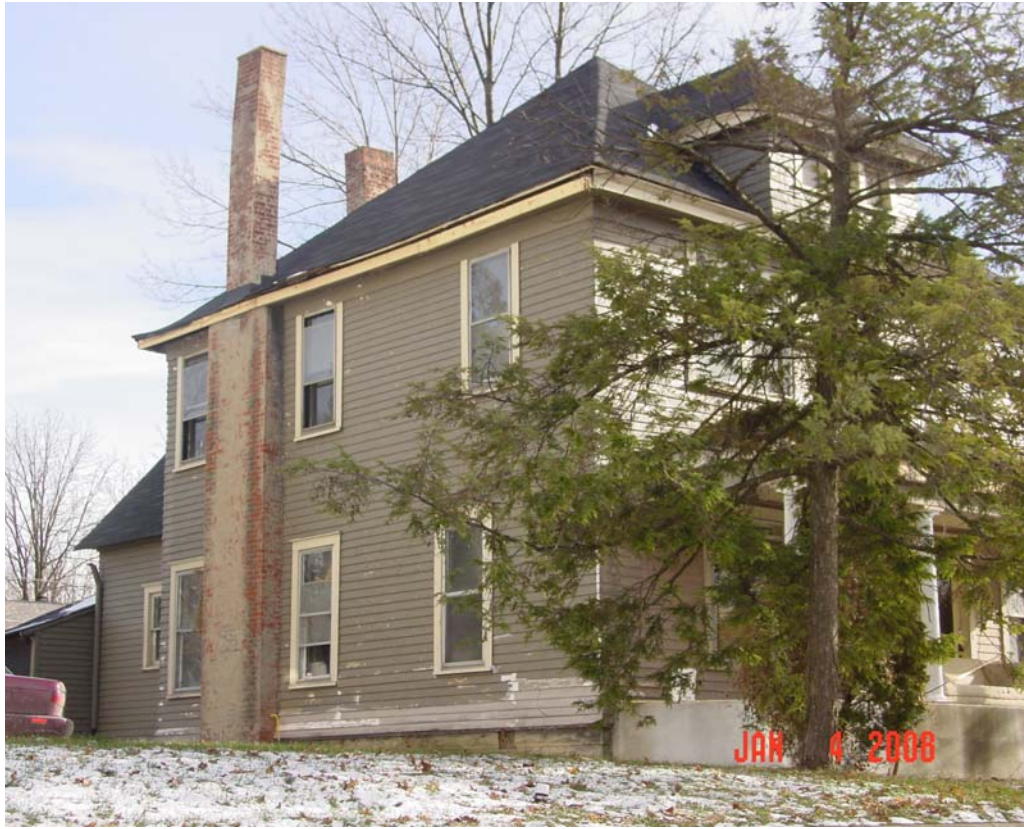
Above: View of house before Ms. Lowhorn purchased it (Jan. 2008)
Below: View of house five months after Ms. Lowhorn purchased it (August 2008)

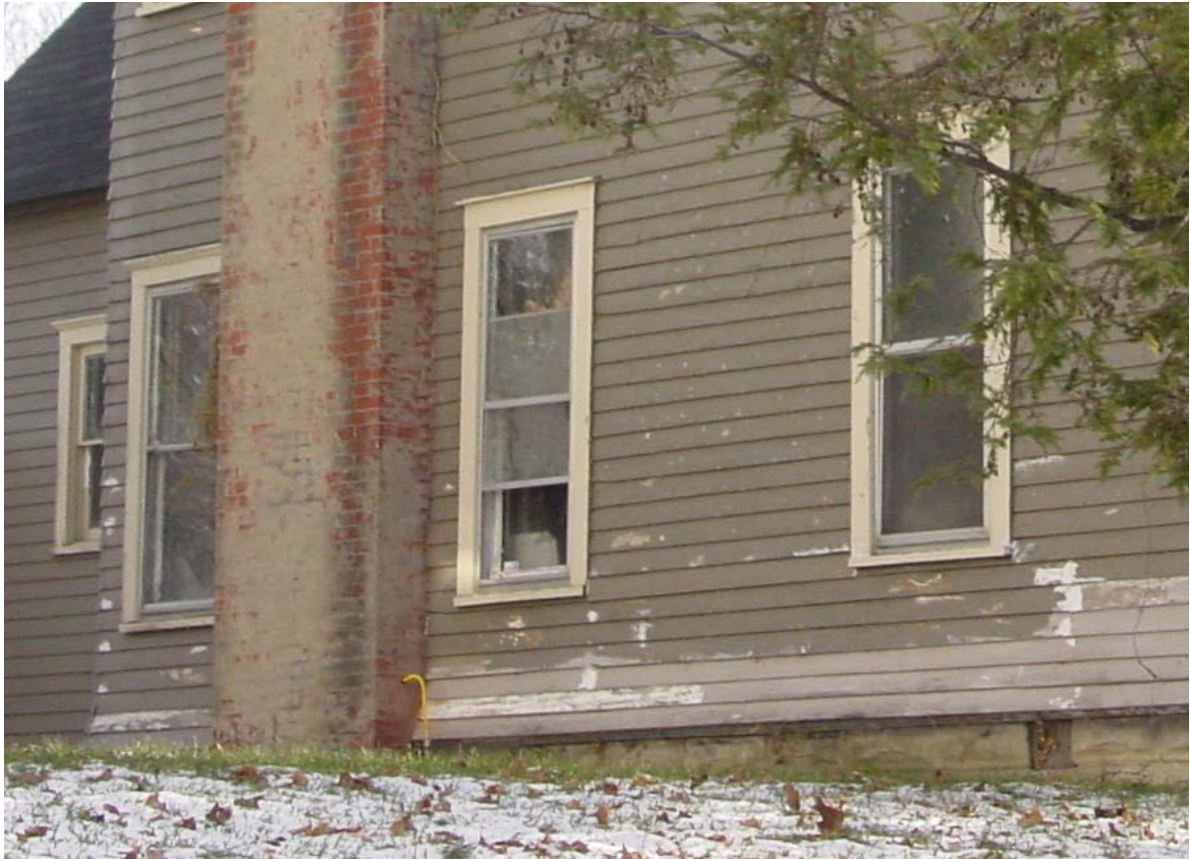
Above: View of wood windows covered by aluminum storms on north elevation before replacement.
Below: View of aluminum clad windows installed and new wood trim installed.

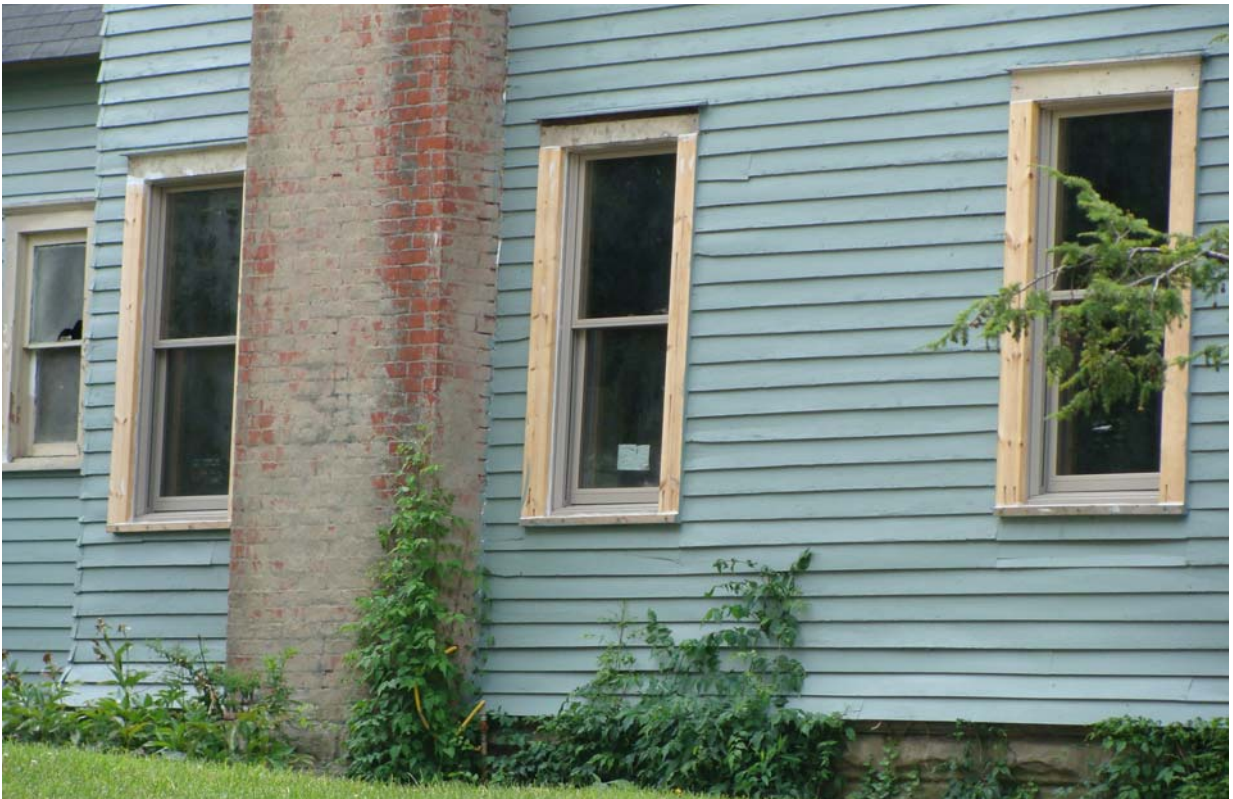
- a. **Three Windows on North Side.** Original wood double hung windows were replaced with aluminum clad windows. New wood double hung windows should be installed.

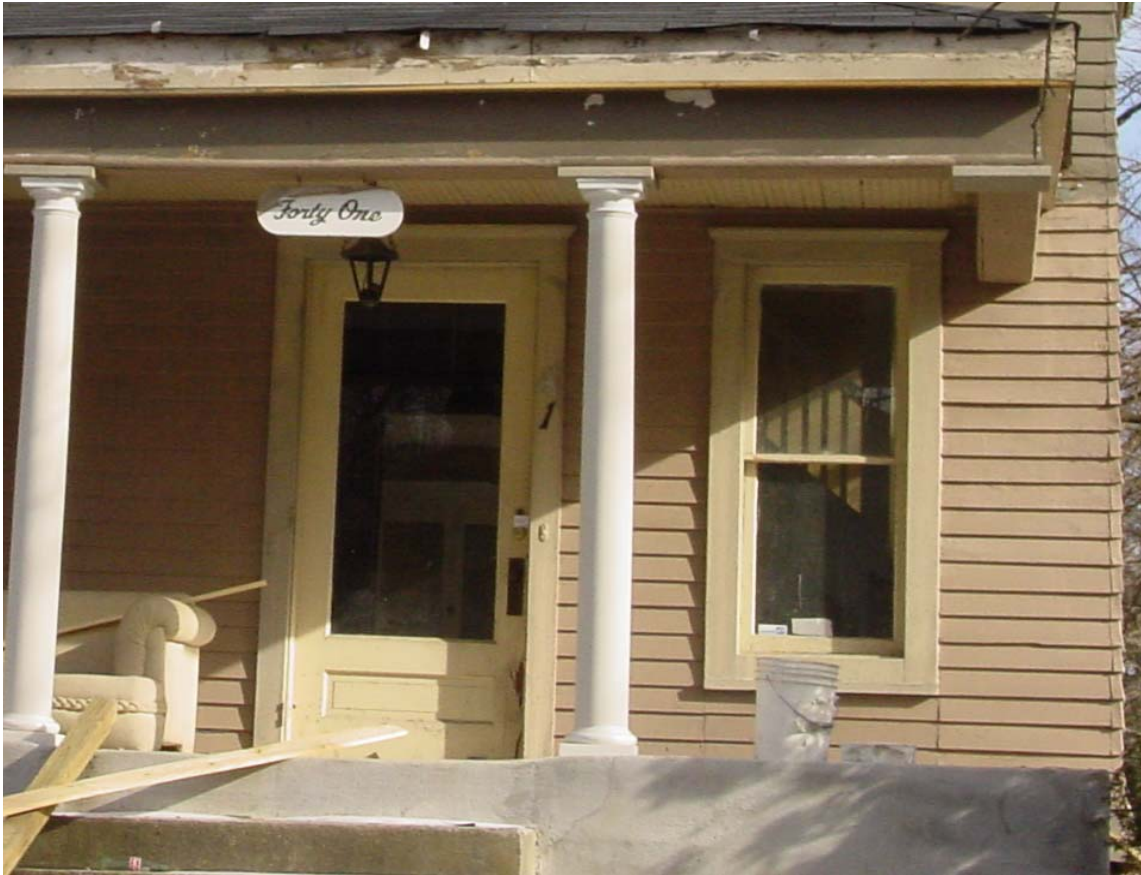
Above: View of original window and trim at front porch window
Below: View of new vinyl window and wood trim. Window is shorter and wider than the original.

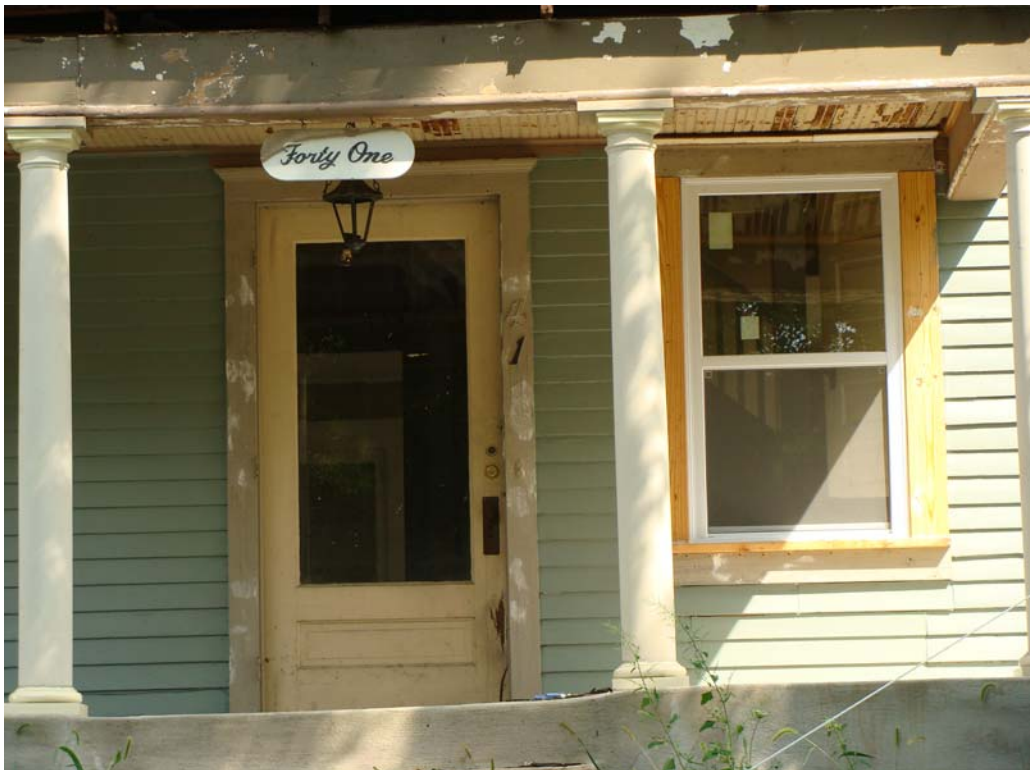
- b. **One Front Porch Window and Trim.** The porch window that was replaced was also modified in size and trim. This window should be replaced with a new wood window and wood trim to match the IHPC file photo of the original.

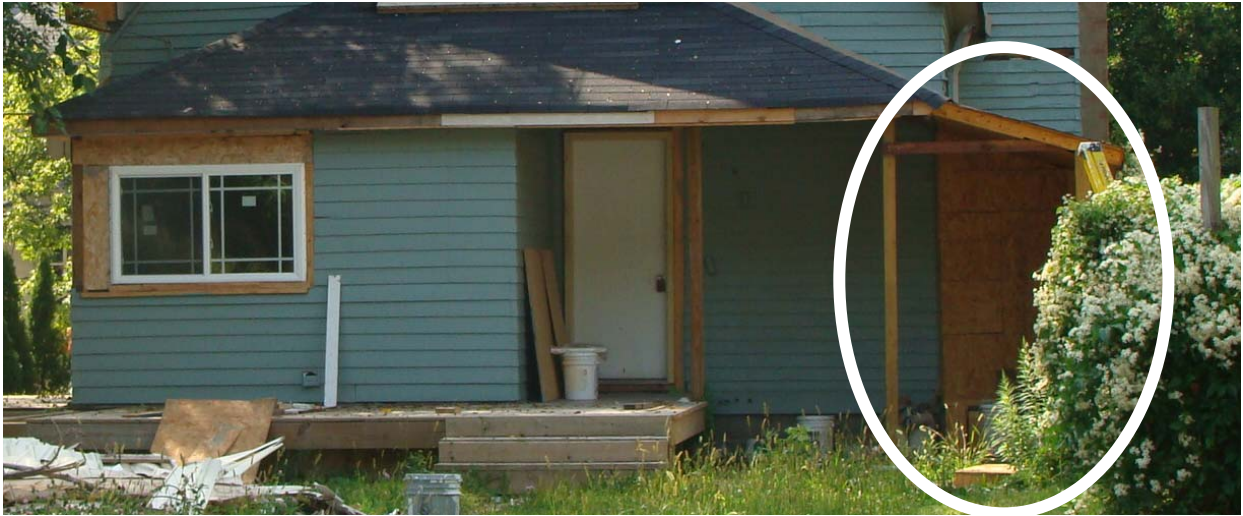
3. **Rear Shed-like Structure.** The structure could be appropriate if finished properly. However, staff would need to see a drawing of how the structure would be completed. Photos seem to indicate that this structure was there before Ms. Lowhorn purchased the property, but she has since altered and modified it without a COA.

Above: View of shed-like structure as it appears today

- 1. Final drawings showing how rear porch attached rear shed-like structure is to be designed and built shall be submitted to IHPC staff for final approval. Approved _____ Date _____**

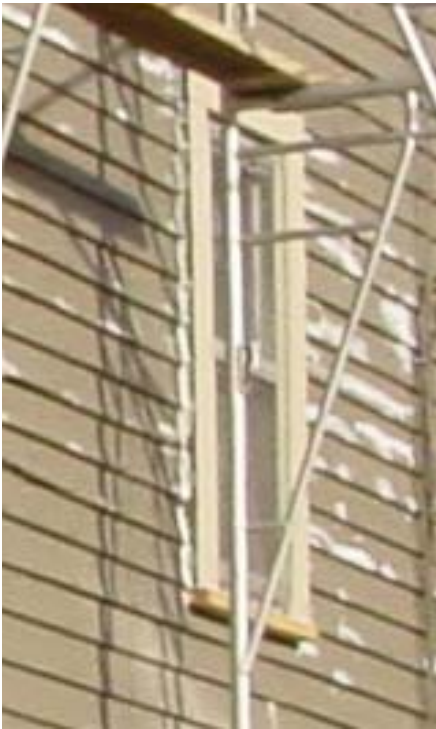
Below left: View of wood double-hung window at south elevation
Below right: View of vinyl window on south elevation (stair landing area)
