COA # 2010-COA-283 (HMP)	INDIANAPOLIS HISTORIC PRESERVATION COMMISSION STAFF REPORT	Hearing Date AUG. 4, 2010
		NEW CASE
1826 N ALABAMA STREET HERRON-MORTON PLACE		
Applicant: 1826, LLC mailing address: 1335 N Central Ave Unit 1 Indianapolis, IN 46202		Center Twp. Council District 15 Doris Minton-McNeill
Owner: same		
CASE		
IHPC COA: 2010-COA-283 (HMP)		<ul style="list-style-type: none"> • Demolish historic accessory structure • Construct a 3-car garage
STAFF RECOMMENDATION: Approval of a Certificate of Authorization		
STAFF COMMENTS

Building Review

**1826 Alabama Street
Indianapolis, IN**

November 16th, 2009

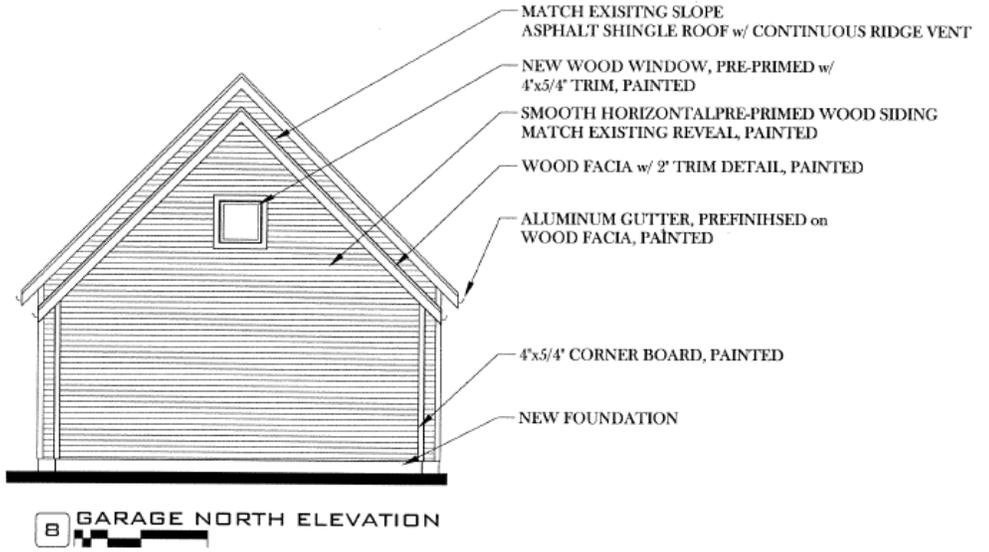
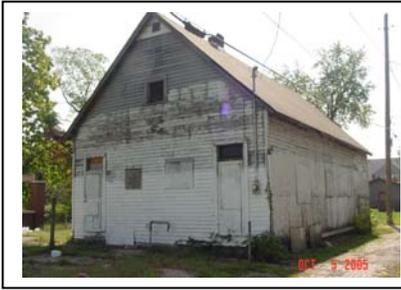
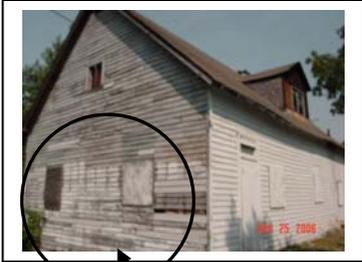
Windows have determined to be non-historic after investigating the framing inside the structure. Applicant is proposing to eliminate the openings.

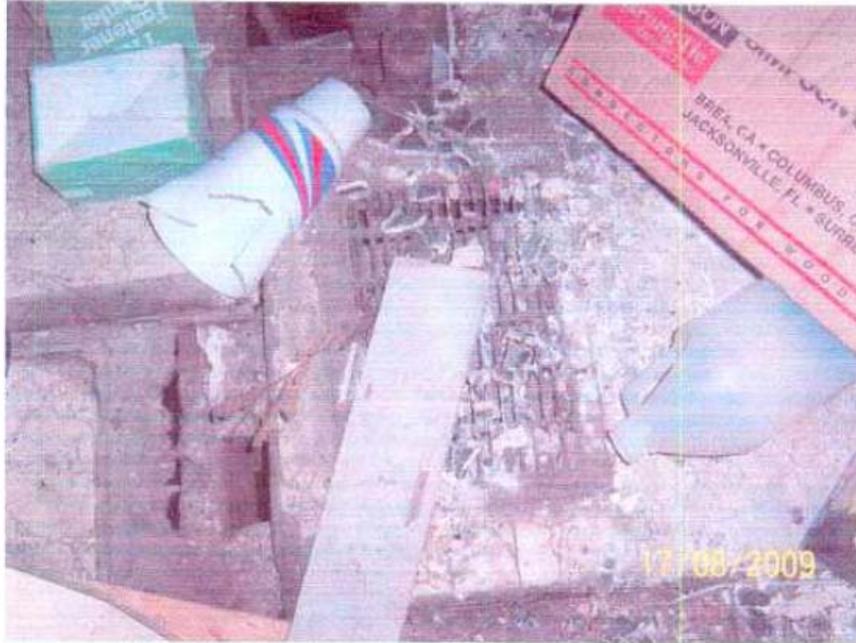
Figure 4. Holes in the floor boards

be removed including the basement floor slab. The existing wood first floor will have to be removed so that a future slab can be replaced.

To reuse the remaining building; the structure will be required to be torn down and sorted into usable and non-usable wood.

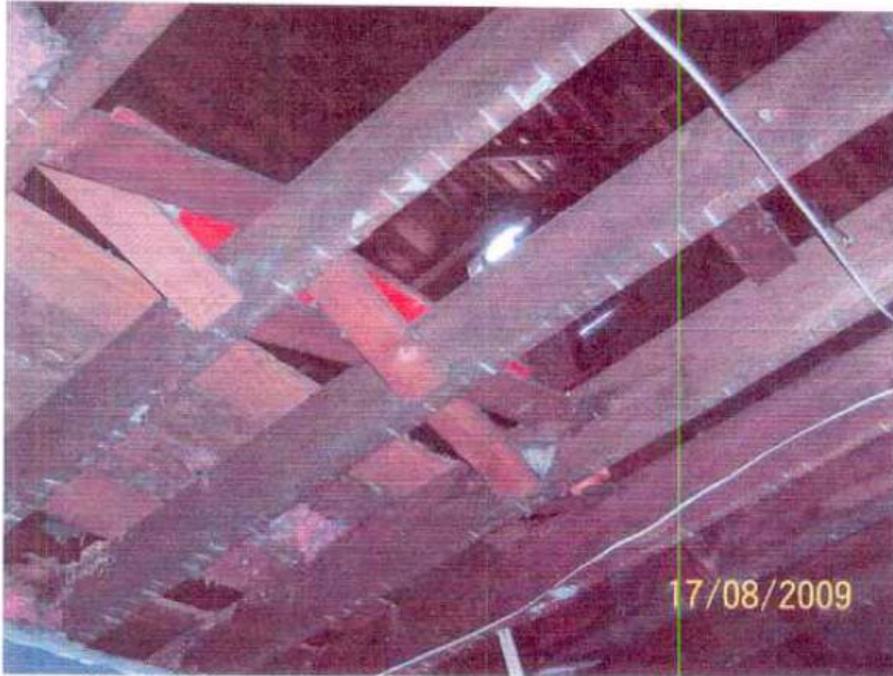
Figure 7. Existing second story floor joist

The existing second floor was removed and only the joists are showing now. The joists appear to be in fair condition and could be reused after cleaning and removal of the nails and other attached stuff.
