COA # 2010-COA-584 (IRV)	INDIANAPOLIS HISTORIC PRESERVATION COMMISSION STAFF REPORT	Hearing Date APRIL 6, 2011
5802 UNIVERSITY AVE. IRVINGTON		Continued from: Feb. 2, 2011 March 2, 2011
Applicant mailing address:	BRETT SCHUBERT – FIDELITY BUILDERS & KURT SCHLEBECKER 9567 Valparaiso Ct. Indianapolis, IN 46268	
Owner:	Kurt Schlebecker 5802 University Ave. Indianapolis, IN 46219	<i>Center Twp. Council District 21 Benjamin Hunter</i>
CASE		
IHPC COA: 2010-COA-584 (IRV) Retain windows installed and opening created without a COA.		
STAFF RECOMMENDATION: Approval of a Certificate of Authorization with stipulations		
STAFF COMMENTS

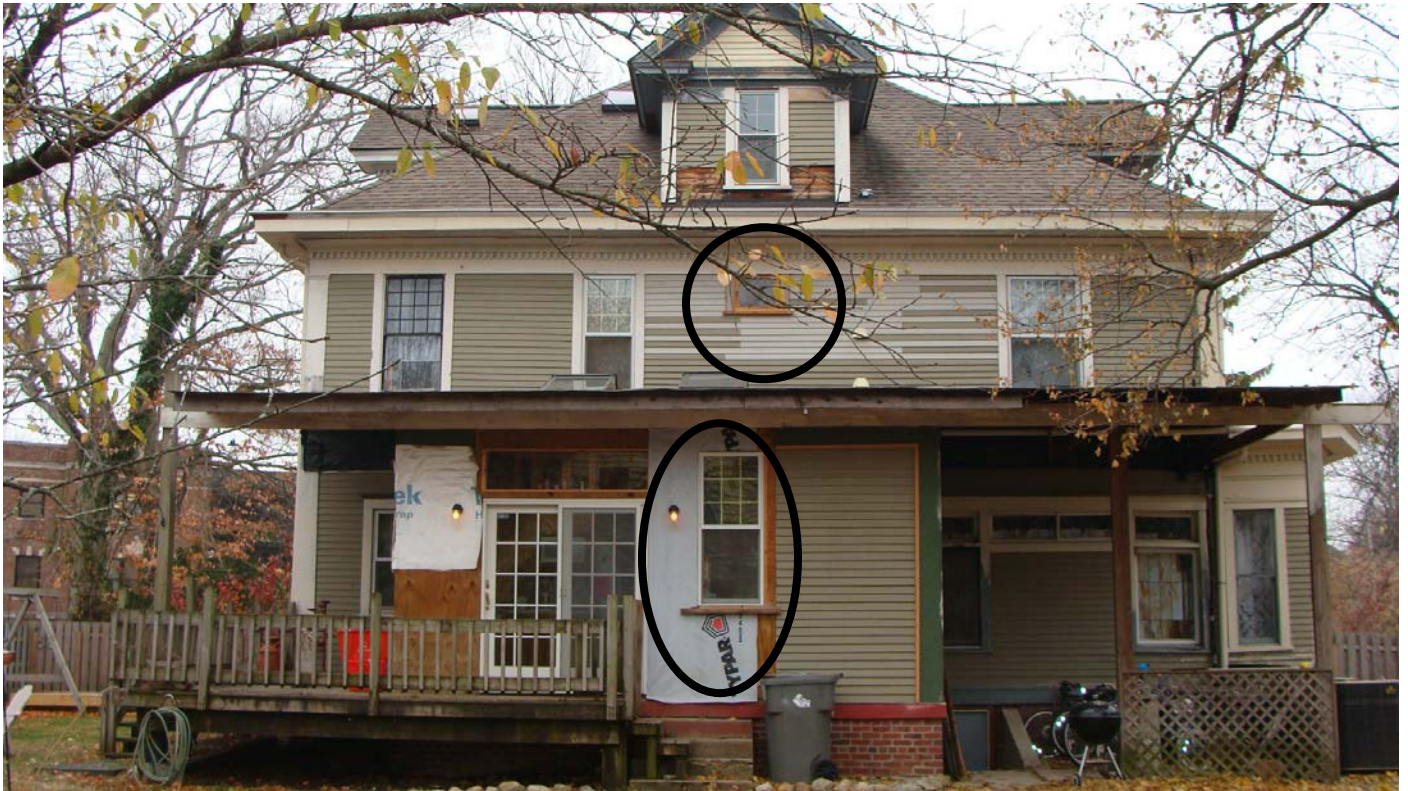
Rear of House – Nov 2010

2. One rear, 2nd floor window reduced in size
Between January 2007 and November 2010, the size of a 2nd story window on the rear/east elevation was dramatically reduced and a fixed window unit was installed without a COA.
3. One rear, 1st floor window opening added
Sometime between January 2007 and November 2010, a new window opening was created on the first floor of the rear elevation and a Pella Pro Line Enduraclad aluminum-clad double-hung window with 9-over-1 interior removable grille was installed without a COA.

- After designation the original window opening was significantly reduced in size and a fixed window was installed.
- The commission has often approved such alterations to rear windows and staff believes it would have recommended approval in this case.

SOLUTION: *Keep altered window as is.*

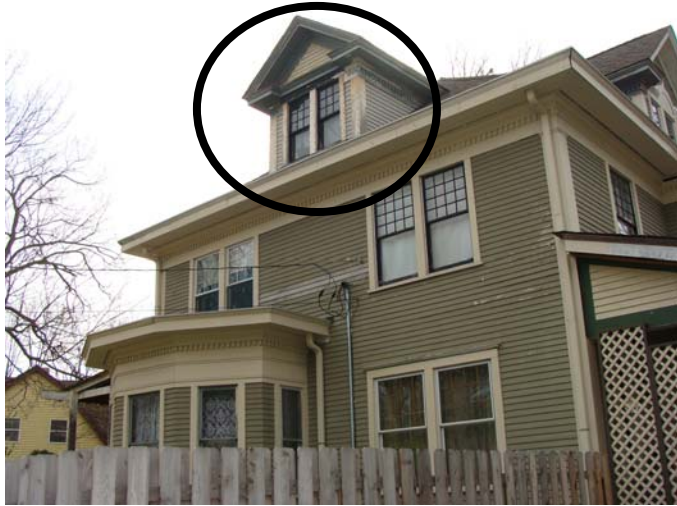
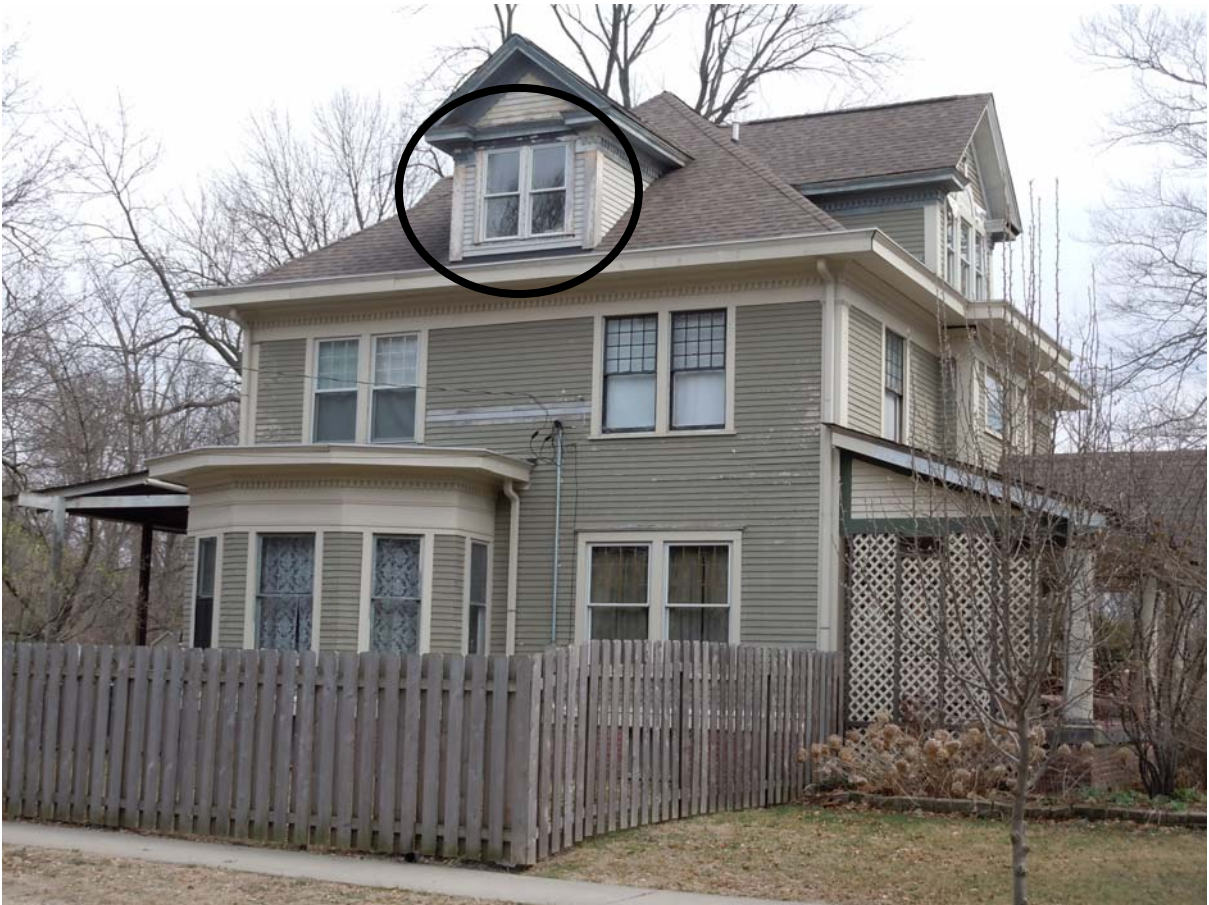
Above: North side of house – April 2009
Below: North side of house- March 2011

This house has attic dormers on all four elevations. The windows in the front and rear dormers were replaced before designation. Sometime between April 2009 and November 2010 (*after district designation*) the four original windows (2 in each dormer) were replaced on the two side dormers without a COA. Original windows in these dormers were solid wood, 9-over-1, true divided lite double hung windows. The owner replaced them with Pella Pro Line Enduraclad aluminum-clad double-hung windows with 6-over-6 interior removable grilles.

- ***Keep the white aluminum clad windows,***
- ***Install new interior snap-in grilles with a 9 simulated panes in the upper sashes,***
- ***Paint grilles white,***
- ***Paint exterior trim around window either white or a contrasting color (yet to be decided), and***

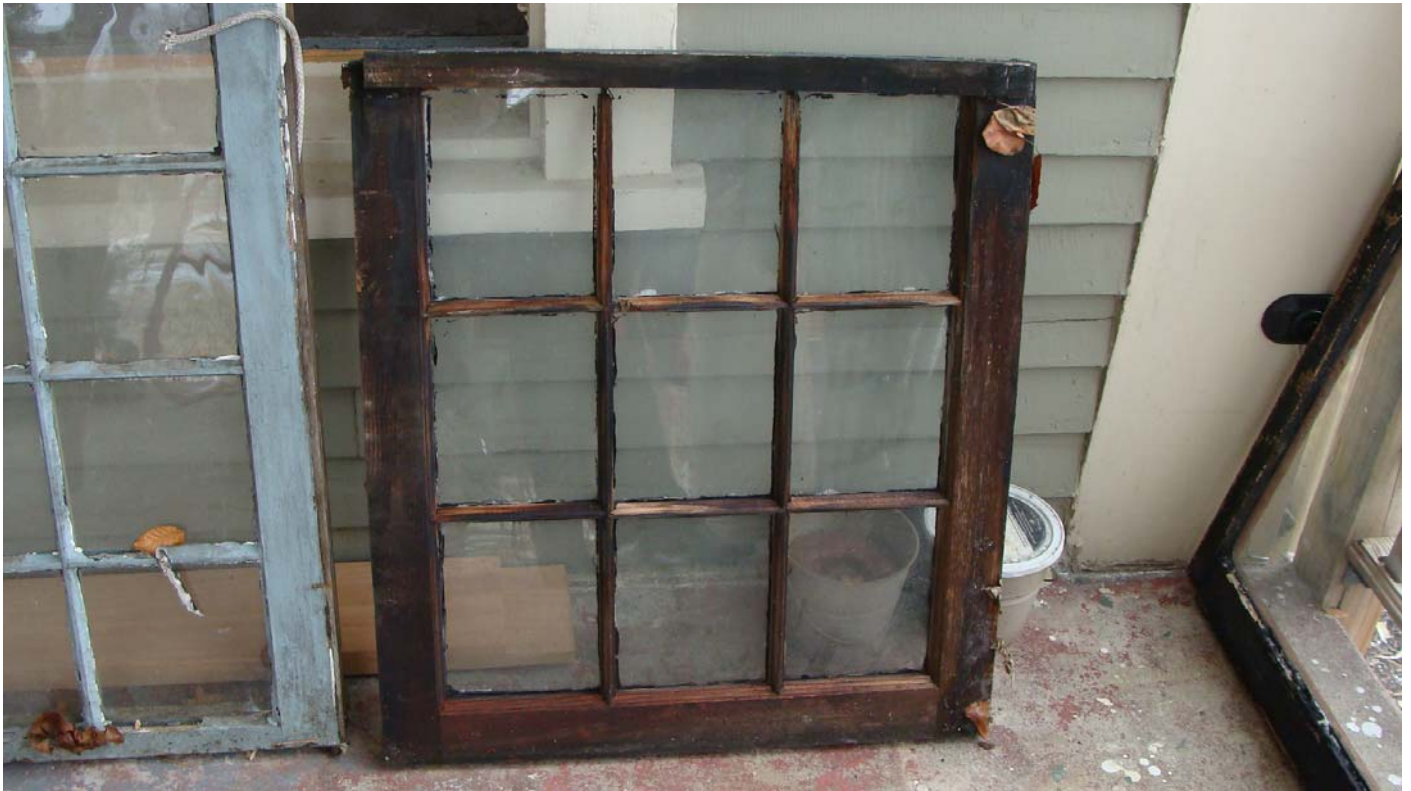
Original upper and lower dormer sashes still on site

- *Store original wood windows in house for future use.*
