COA # 2011-COA-185 (WD)	INDIANAPOLIS HISTORIC PRESERVATION COMMISSION STAFF REPORT	Hearing Date JULY 6, 2011
255 S. Meridian Street WHOLESALE DISTRICT		New Case
Applicant TODD TEMPERLY – TEMPERLY COMMERCIAL CONSTRUCTION, INC. Mailing address: 2068 Berry Road Greenwood, IN 40143		<i>Center Twp.</i> <i>Council District 19</i> <i>Dane Mahern</i>
Owner: Bruce Pallman 255 S. Meridian Street Indianapolis, IN 46225		
CASE		
IHPC COA: 2011-COA-185 (WD)	Removal of front façade upper story double-hung sash and transoms, replacement with fixed sash and internal grid design; recover three awnings with new canvas; remove existing aluminum storefront and door, replace with new to match existing.	
STAFF RECOMMENDATION: Approval of storefront, door and awning work; Denial of second story window proposal		
STAFF COMMENTS

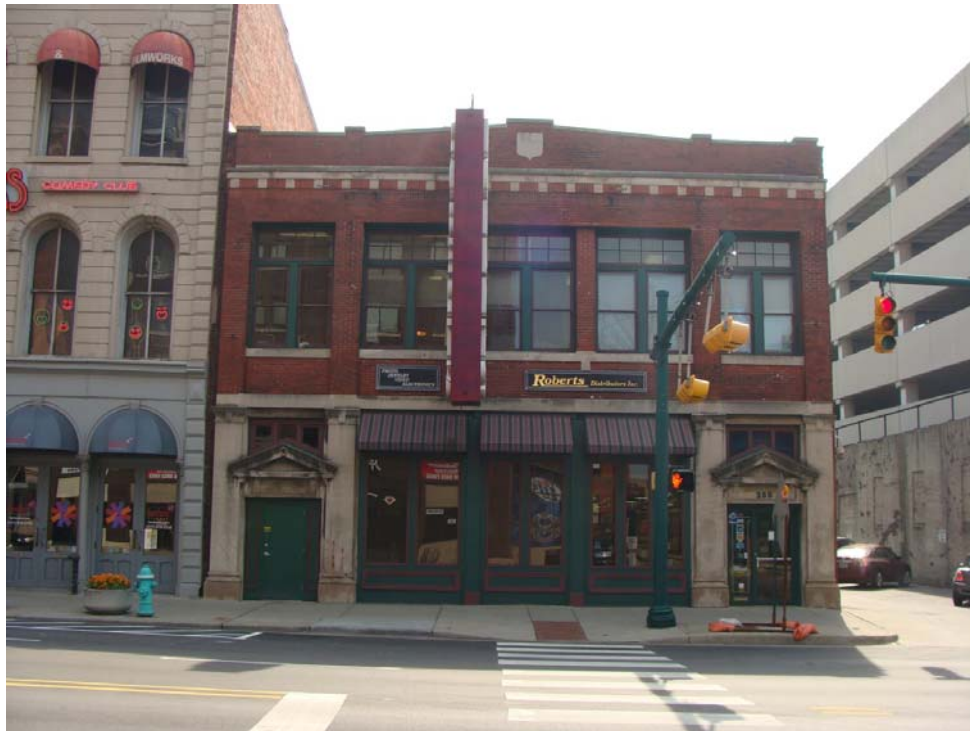
Front Façade - current

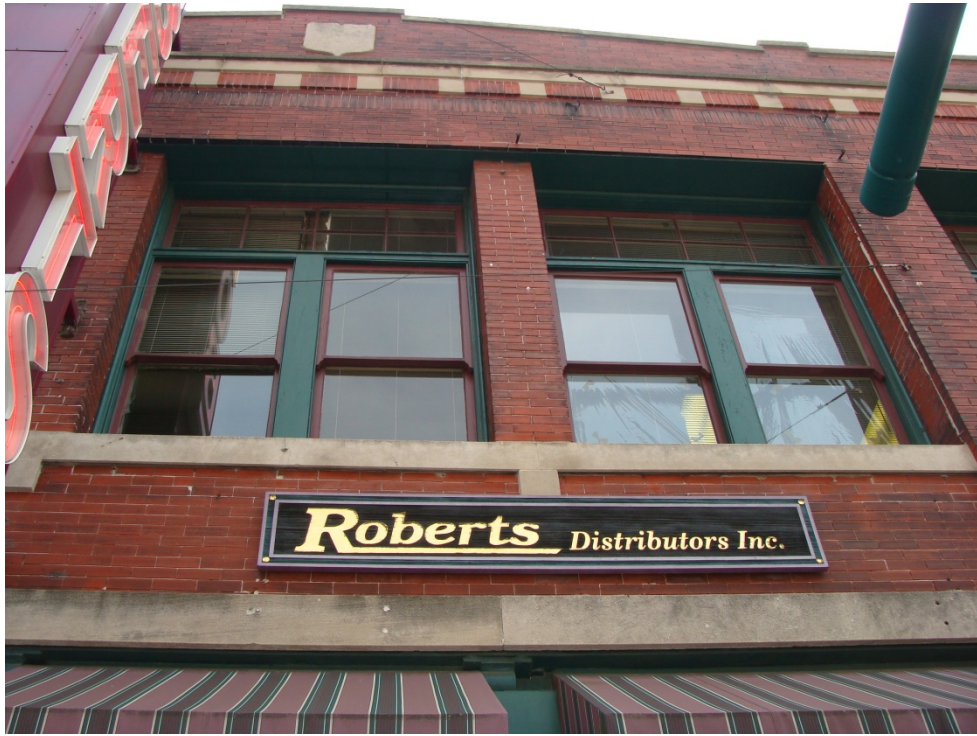
The existing double-hung wood windows have been reworked and/or replaced. They do show significant deterioration (see photos), although the sills are in good repair. Even with demonstrated deterioration, the proposed replacements are in conflict with the Plan, as the fixed unit does not offer a similar dimension or design. Having a single pane with a false divider will give the one-dimensional appearance of a storm window instead of the depth of a double-hung. The most appropriate strategy would be reworking the existing units, or replacing with new wood units to match. Because it appears these are not the original windows, replacement with an appropriate aluminum-clad wood double-hung unit can also be recommended.

Double-hung sash and transoms on second story

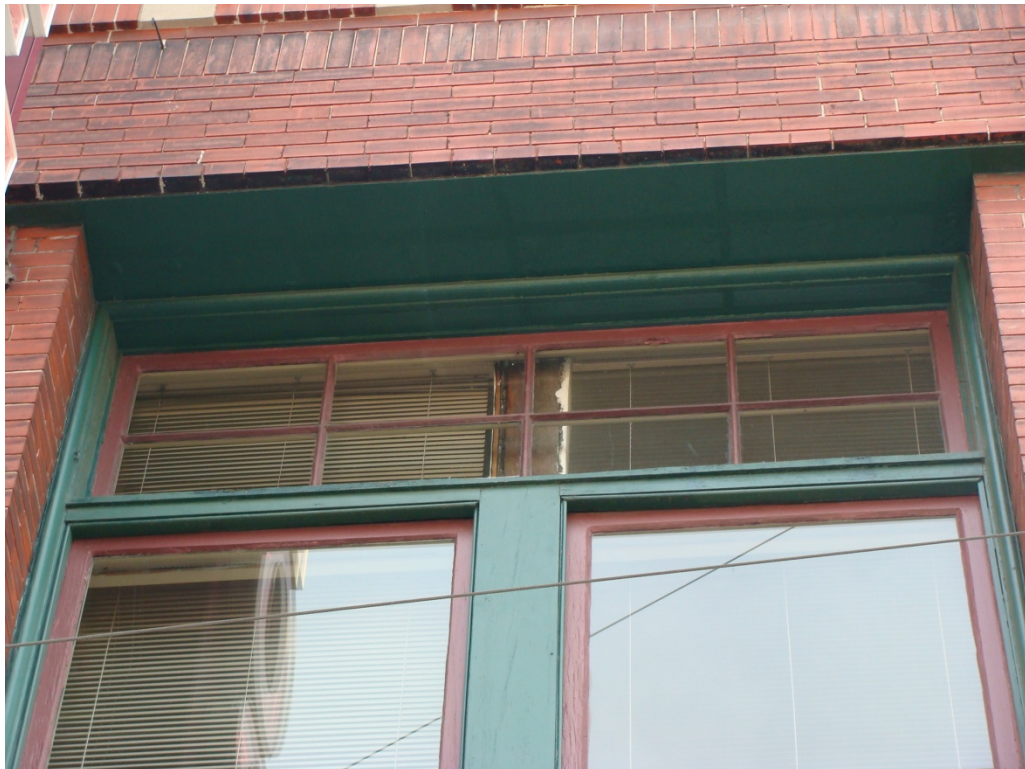
The transoms as existing appear to be in good condition, and do not necessarily warrant replacement. The most appropriate strategy is to simply retain and perform minor repairs on the transom windows. However, an appropriately designed external muntin system may be acceptable considering that only one unit is original, but we do not have documentation as to which unit that is.

Transom detail

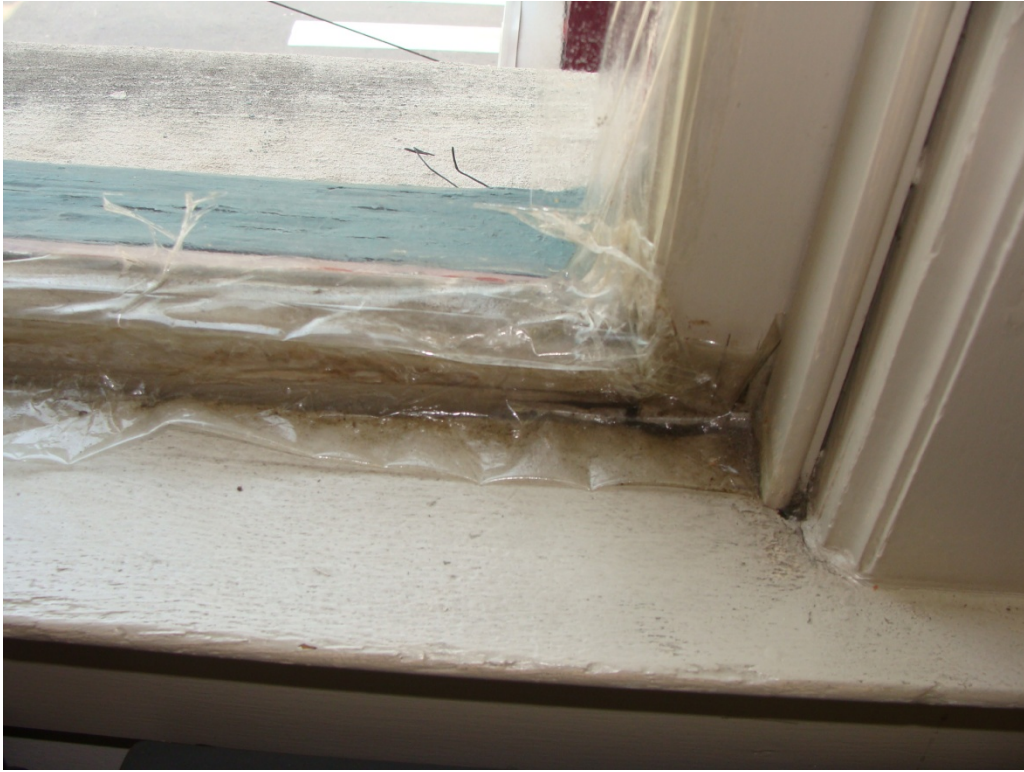
Interior window detail

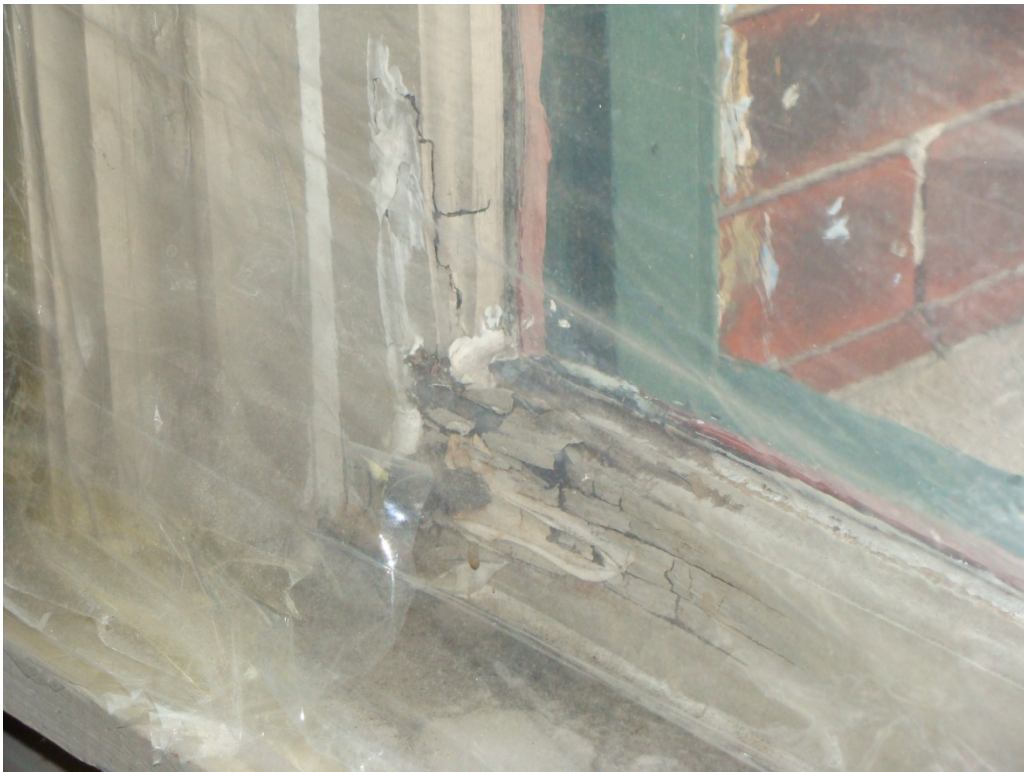
Interior window detail
