<b>COA #</b> <b>2014-COA-059</b> <b>(ONS)</b>	<b>INDIANAPOLIS HISTORIC PRESERVATION</b> <b>COMMISSION</b> <b>STAFF REPORT</b>	Hearing Date <b>APRIL 2, 2014</b>
<b>231 E. 16<sup>th</sup> STREET</b> <b>OLD NORTHSIDE</b>		New Case   Center Twp. Council District 9 Joseph Simpson
<b>Applicant</b> <b>WILLIAM W. BROWN</b> mailing address: 1528 N. Alabama Street Indianapolis, IN 46202		
<b>Owner: SAME AS ABOVE</b>		
<b>CASE</b>		
<b>IHPC COA: 2014-COA-059 (ONS)</b>	<ul style="list-style-type: none"> <li>• Remove existing transom windows; install new windows in multiple sections</li> <li>• Install beam above storefront windows and below transom windows</li> <li>• Install new frames around storefront windows</li> <li>• Remove existing bulkheads; install bulkheads made of Azek trim and fiber-cement panels</li> </ul>	
<b>STAFF RECOMMENDATION: Approval of a Certificate of Authorization</b>

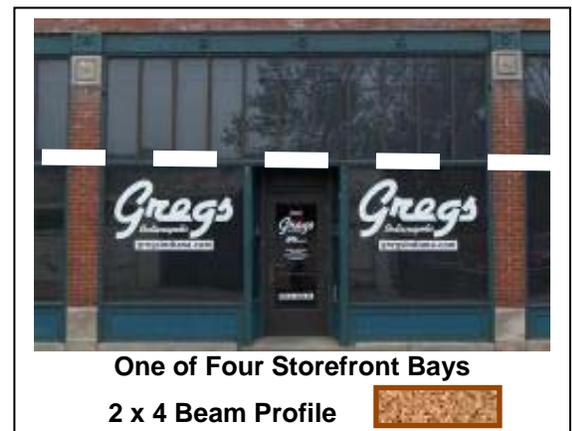
The owner wishes to rebuild the transoms over four storefront bays because there are structural deficiencies with the way they are presently built. The transom over each bay is built as one unit and rests on a 2 x 4 wood beam, which is meant to carry the weight. However, the beams were installed horizontally and are not sufficient to carry the weight. Over time they have flexed and the weight is being transferred to the storefront window frames below. This is causing serious problems such as gaps developing between the frame and the plate glass windows below.

The solution being proposed is to remove the four large transom window units and replace the deficient beam with a new wood beam made of two 2 x 4s laid vertically, which would have significantly more strength. New molding would cover the wider beam. In order to accommodate the wider beam, slightly shorter transom windows would be built and installed above the new beam. They will be built to look very similar to what is there today, but in multiple sections rather than one large piece. New wood frames would be installed for the large plate glass storefront windows below the transoms.

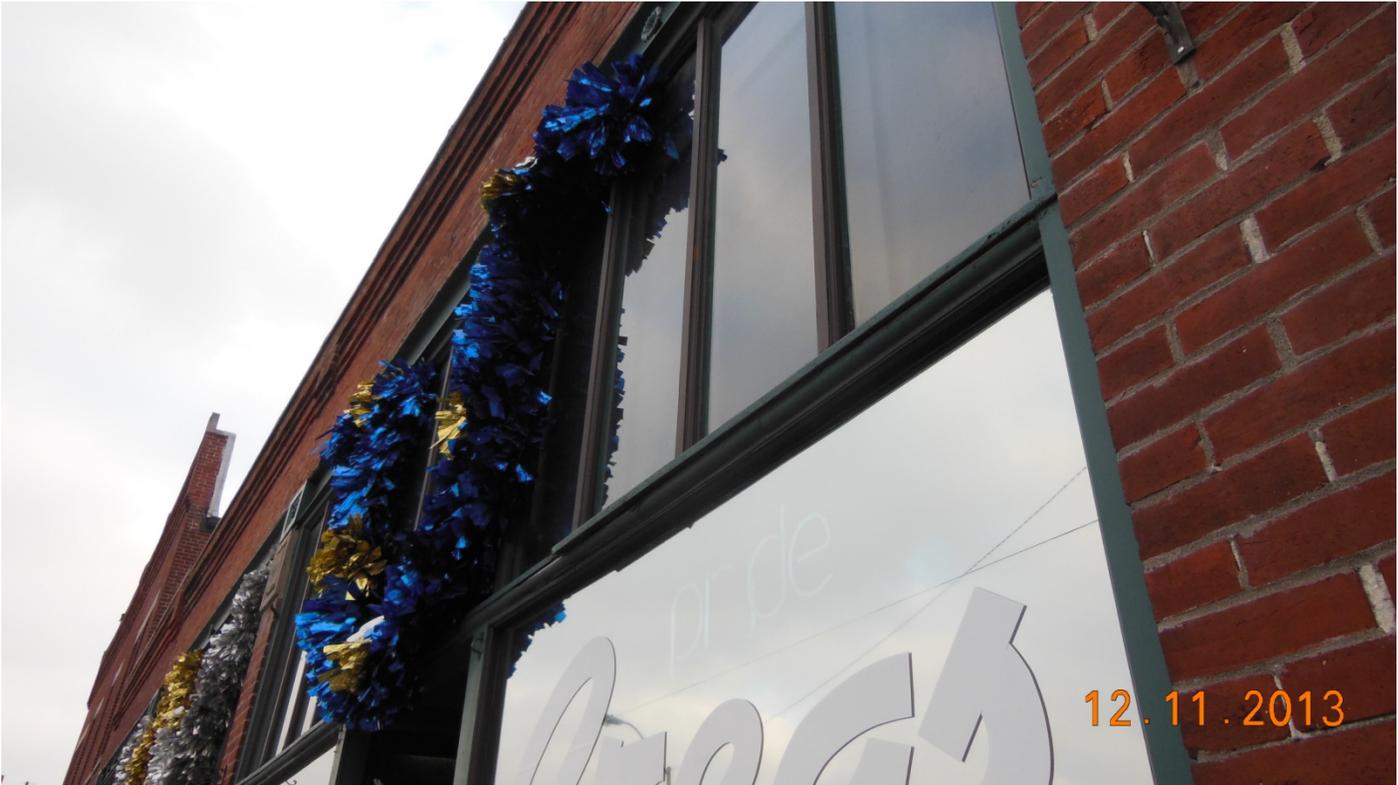
**Multi-light transoms**

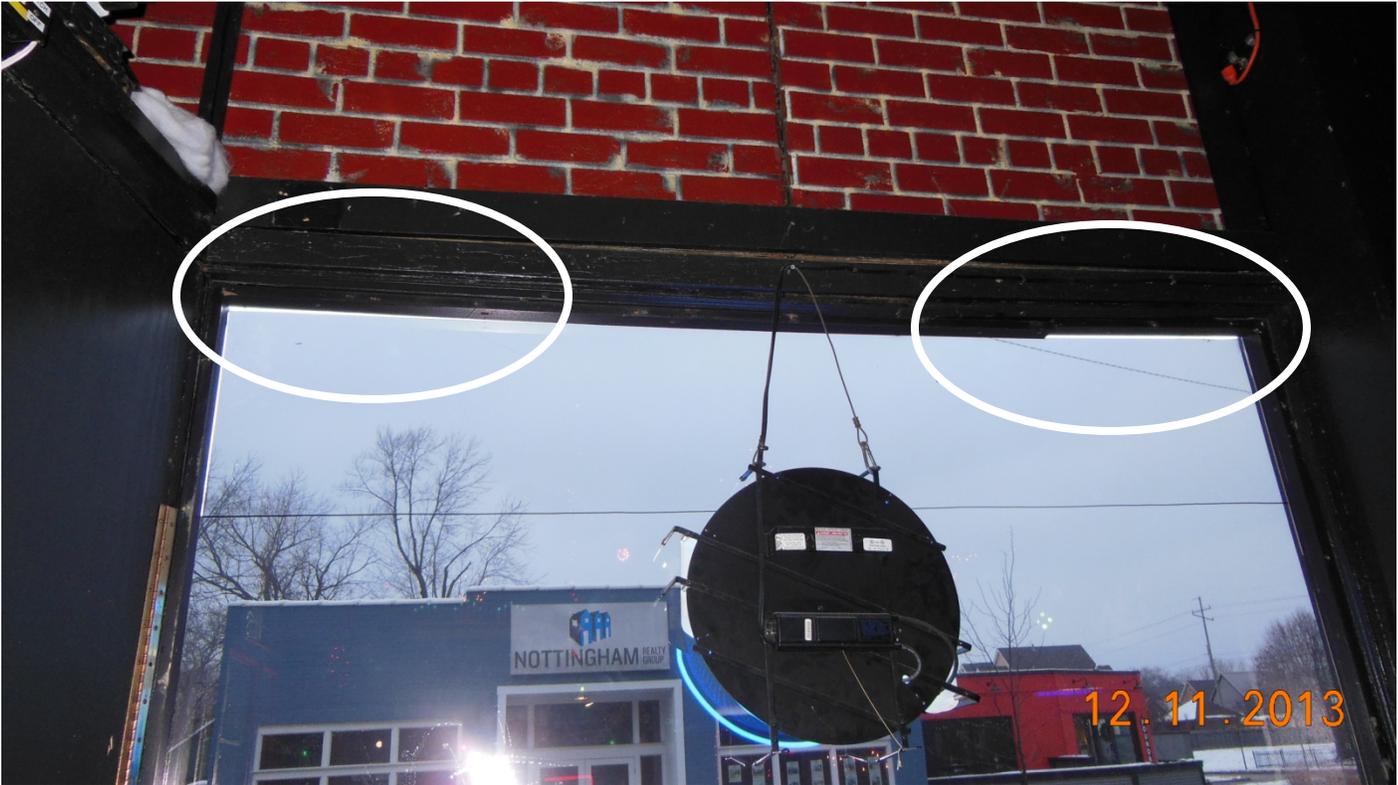
**Gaps appearing in between storefront window and lintel**

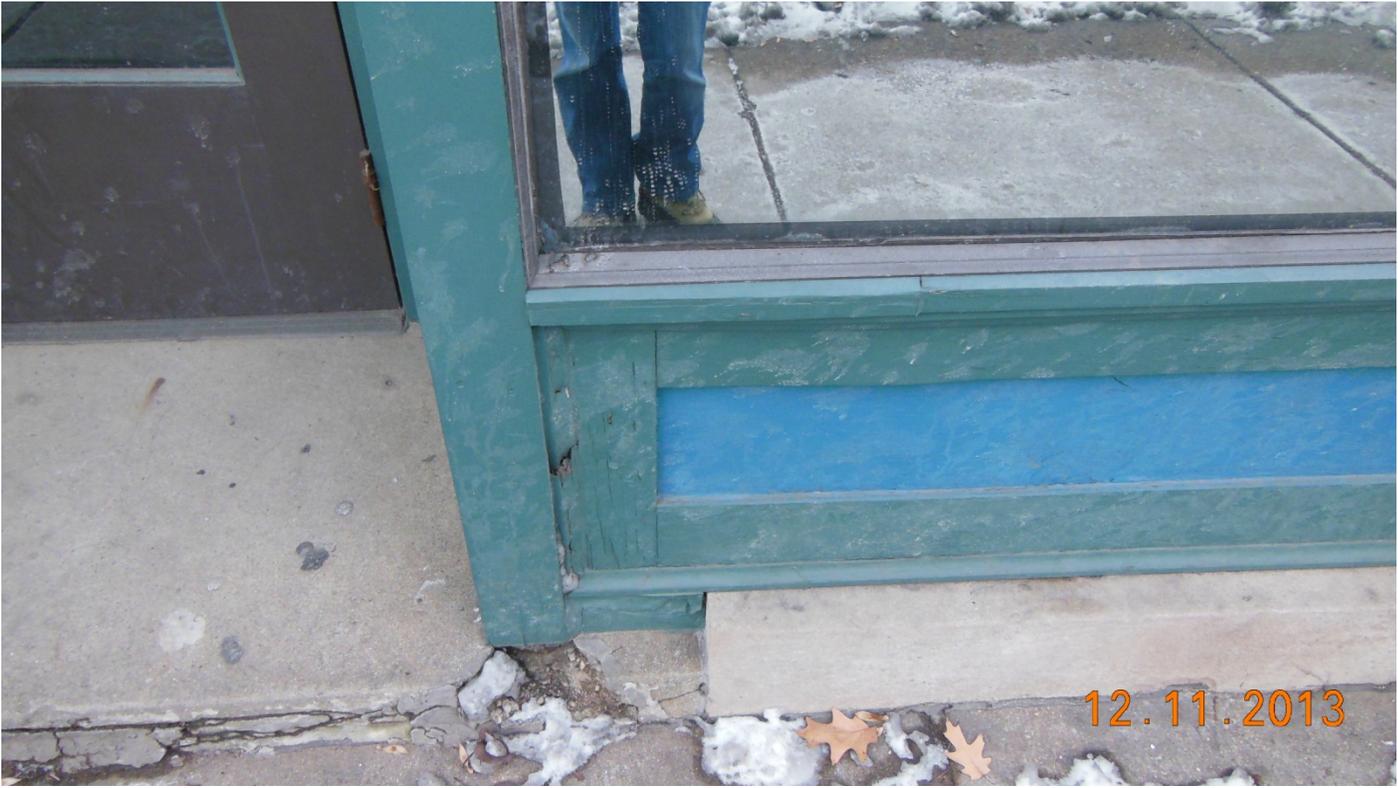
Under each plate glass storefront window is a simple wood and plywood bulkhead panel probably constructed in 1985. The owner experiences a lot of rot along the bulkheads due to vehicle splash up during rain and snow piling up after 16<sup>th</sup> St. is plowed during the winter. The contractor is proposing to replace the existing bulkheads with new bulkheads that duplicate the dimensions and trim profile of the existing bulkheads. However, due to the unavoidable problems with water and snow, he is proposing to build them out of Azek trim and fiber cement panels.

**Bulkhead details**

The mock-up supplied to staff lacks the trimwork found on the existing bulkheads, and staff will need to see a panel once installed to make certain that the work has a finished appearance and appropriate moldings. The trim looks very much like wood, with the same finish and feel. Staff's biggest concern lies with the finish on the fiber-cement. It is rough-textured, and unless a smoother product is available, will need to be treated with a smoothing agent such as an elastomeric compound to smooth out the rough texture.

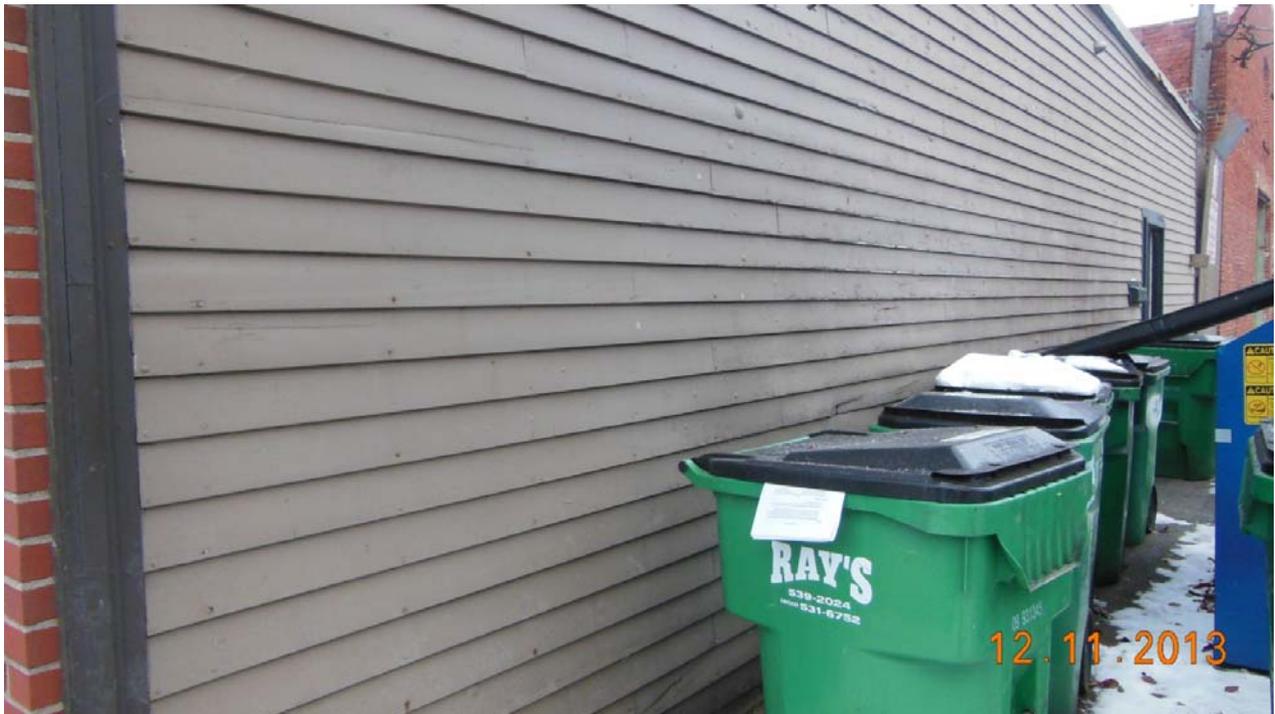
The applicant would like to install smooth-finish fiber-cement siding on the west wall of westernmost building. There is wood siding there now, and it regularly experiences rot and paint failure.

West wall of "new" building showing existing wood siding

Staff supports this request because the existing siding was added to cover up damage caused to the wall when the neighboring building was demolished. It is not original to the building, and will have little to no visual impact.
