<b>COA # 2010-COA-412 (WP)</b>	<b>INDIANAPOLIS HISTORIC PRESERVATION COMMISSION STAFF REPORT</b>	<b>Hearing Date DEC. 1, 2010</b>
<b>915-917 Woodruff Place West Drive WOODRUFF PLACE</b>		Continued from: November 3, 2010  Center Township Council District: 16 Brian Mahern
<b>Applicant</b>	<b>TAD BOHLSEN FOR PINE FINANCIAL</b>	
<b>Mailing address:</b>	151 N. Delaware, #1835 Indianapolis, IN 46204	
<b>Owner: Same as above</b>		
<b>CASE</b>		
<b>IHPC COA: 2010-COA-412 (WP) Demolish fire-damaged house</b>		
<b>STAFF RECOMMENDATION: Approval of a Certificate of Authorization</b>

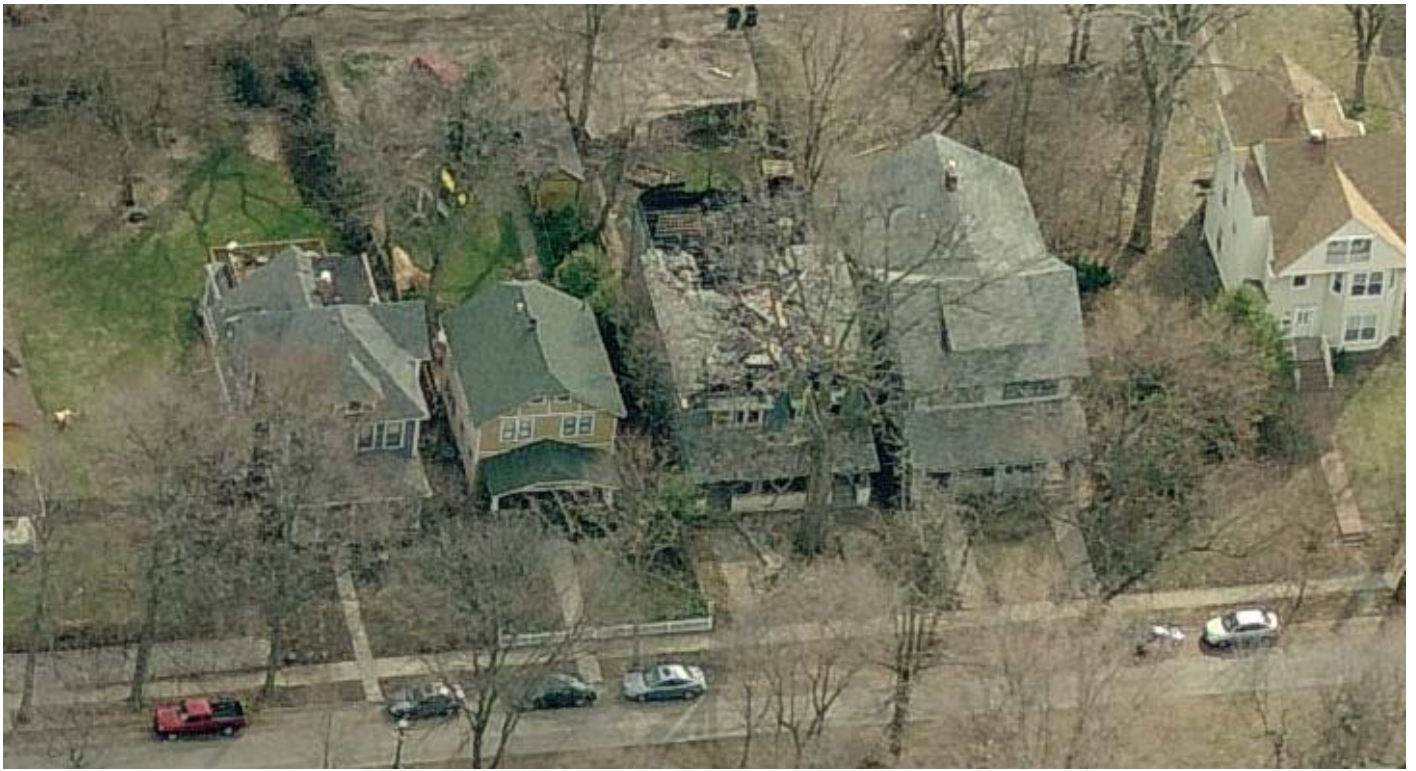
**Aerial photo looking east toward the front of the house**

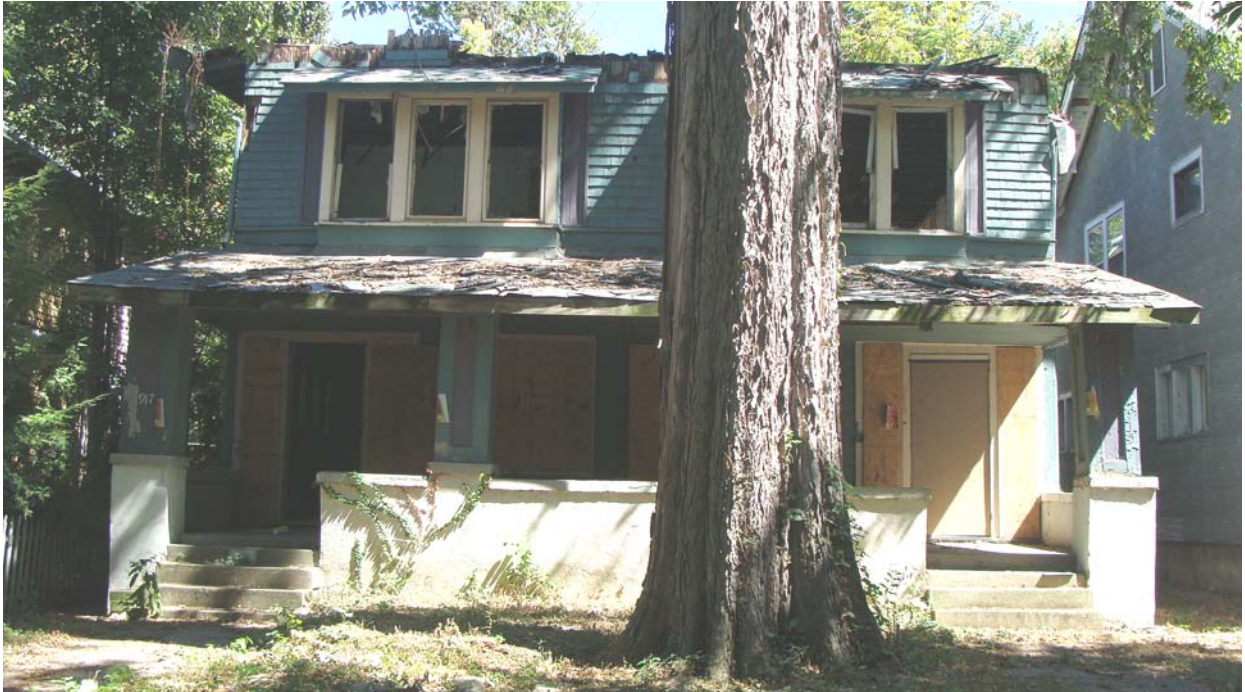
- The roof structure and attic have been completely burned and removed.
- Much of the framing was burned and/or destroyed in the fire.
- Most of the windows and frames were broken out and damaged beyond repair.
- The floor structure on the second level exists, but is severely compromised.
- Holes exist from falling debris causing water to penetrate through the floor down to the first level.
- The first floor received significant water and smoke damage.
- Significant mold growth and water damage has occurred throughout the interior of the building as a result of putting out the fire and from the roof being open to the elements for 15 months
- The exterior siding on the lower portions of the house is still in-place, however, it appears that its condition prior to the fire was largely deteriorated.

**Front of house today**

**To approve a Certificate of Authorization to demolish the fire-damaged house in accordance with the court's order to demolish, per submitted documentation and subject to the following stipulations:**
