COA # 2010-COA-584 (IRV)	INDIANAPOLIS HISTORIC PRESERVATION COMMISSION STAFF REPORT	Hearing Date APRIL 6, 2011
5802 UNIVERSITY AVE. IRVINGTON		Continued from: Feb. 2, 2011 March 2, 2011
Applicant mailing address:	BRETT SCHUBERT – FIDELITY BUILDERS & KURT SCHLEBECKER 9567 Valparaiso Ct. Indianapolis, IN 46268	
Owner:	Kurt Schlebecker 5802 University Ave. Indianapolis, IN 46219	<i>Center Twp. Council District 21 Benjamin Hunter</i>
CASE		
IHPC COA: 2010-COA-584 (IRV) Retain windows installed and opening created without a COA.		
STAFF RECOMMENDATION: Approval of a Certificate of Authorization with stipulations		
STAFF COMMENTS

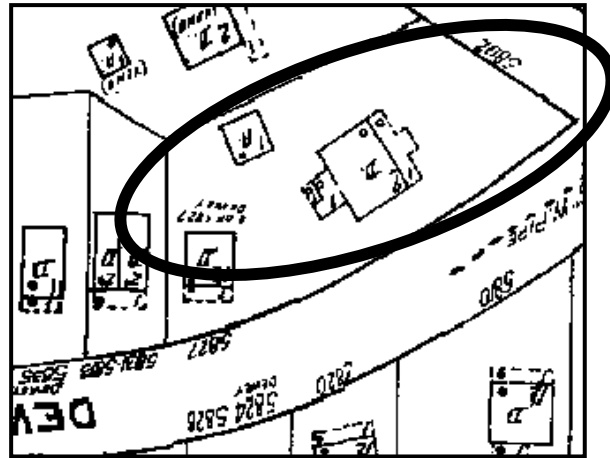
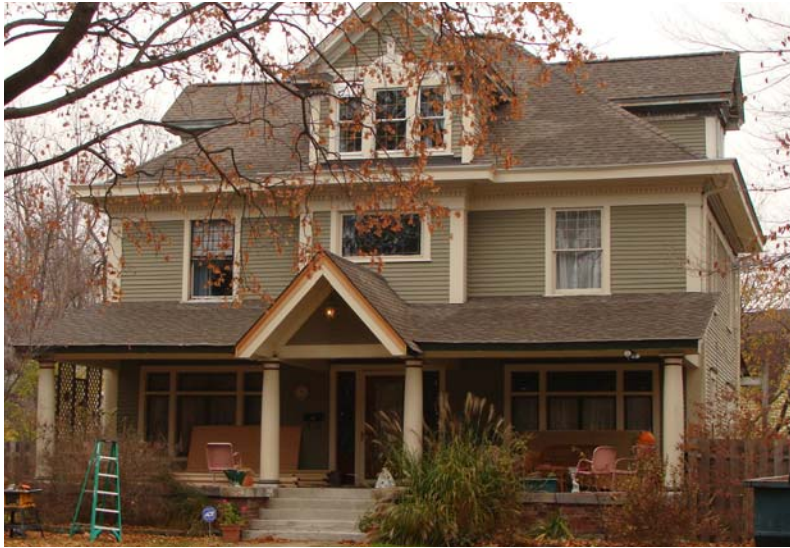
Above: Front of House – Nov 2010
Below: Front of House- March 2011

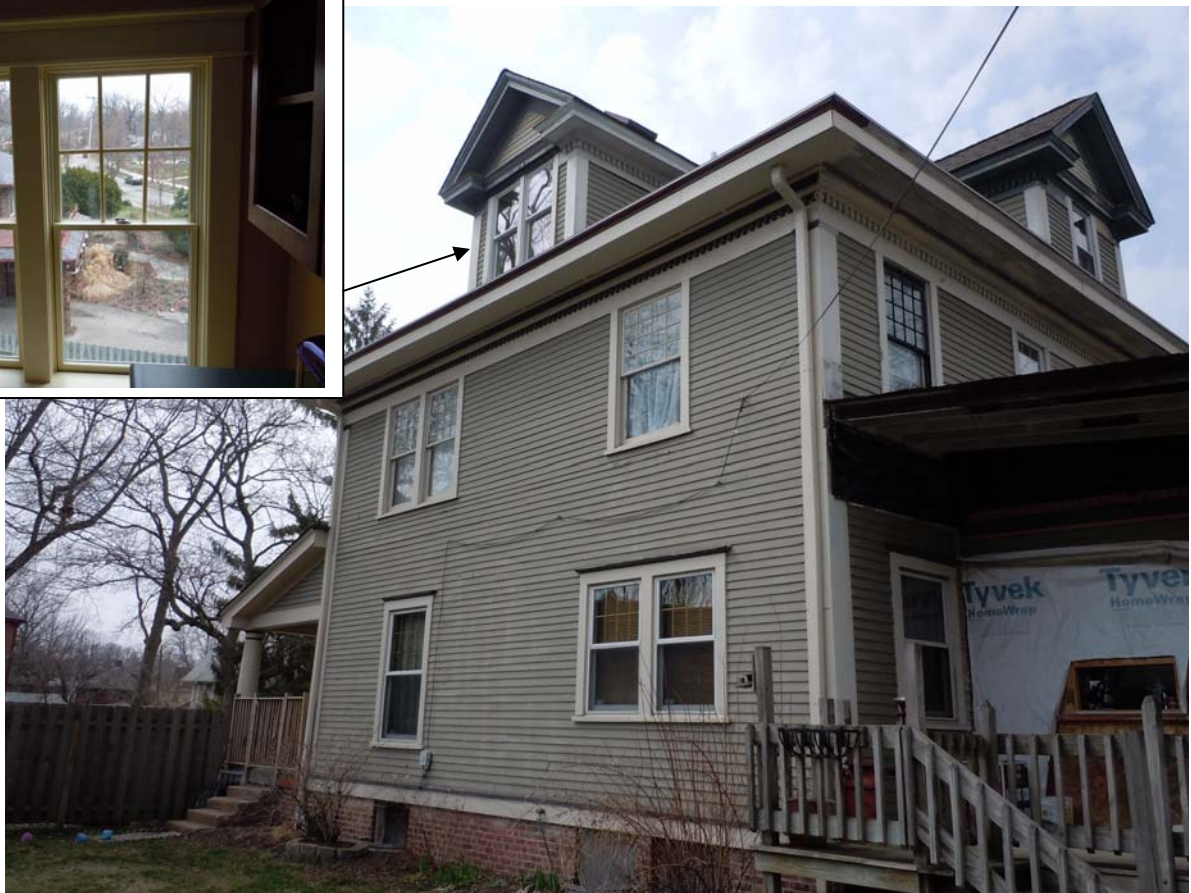
Original upper and lower dormer sashes still on site

- *Store any remaining original wood windows inside the house for future restoration and/or replication.*
- *Paint the remaining original window sashes white, to match the new windows. In the short term, that will make the windows appear more consistent until they are all replaced.*
