Case # 2011-COA-342 B (CH)	INDIANAPOLIS HISTORIC PRESERVATION COMMISSION STAFF REPORT	Hearing Date OCT. 5, 2011
608 HIGHLAND AVE COTTAGE HOME		NEW CASE
Applicant: MARY CORBIN mailing address: 608 Highland Ave Indianapolis, IN 46202		Center Township Council District: 9 Jackie Nytes
Owner: same mailing address:		
CASE		
IHPC COA: 2011-COA-342 B (CH)	<ul style="list-style-type: none"> • Install four new wood porch posts (work started) • Install wood porch rail (work started) • Install windows (vinyl) on house (work started) 	
STAFF RECOMMENDATION: Approval of a Certificate of Authorization with stipulations

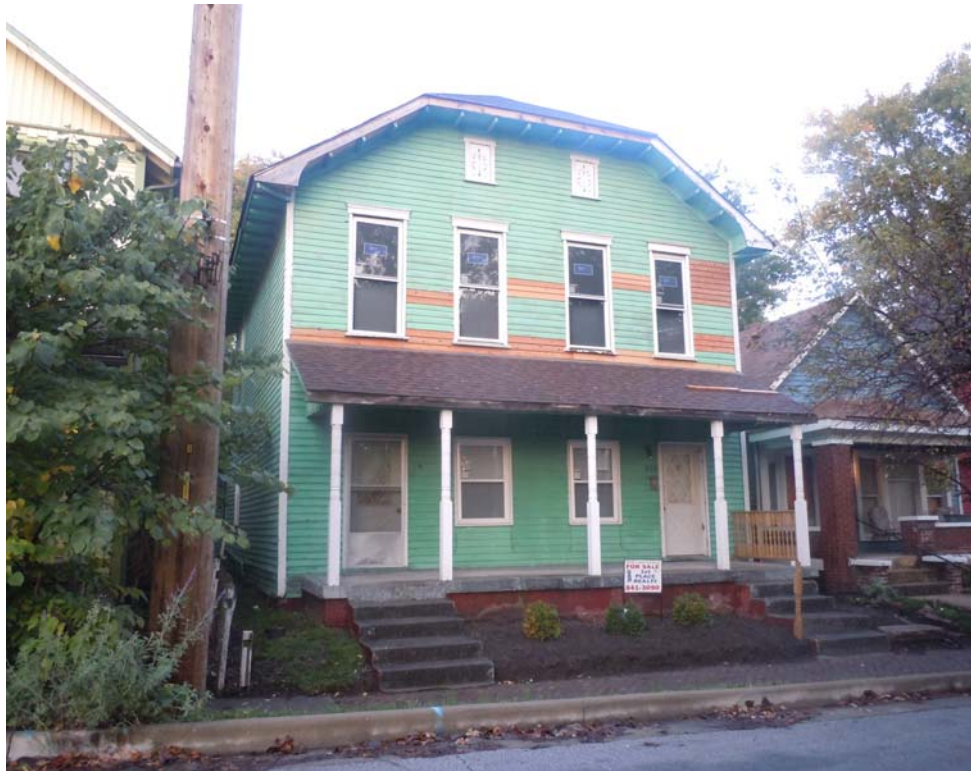
The windows on the front elevation have a more significant effect on the character of the house than those on the sides because the neighboring houses are so close, preventing the side windows from being highly visible. The first floor windows on the front were installed in altered openings where the original opening size is still evident, which further exacerbates the inappropriateness of the windows. The window openings were altered before designation of Cottage Home.

Above: Front Elevation
Below: Photo of space between houses

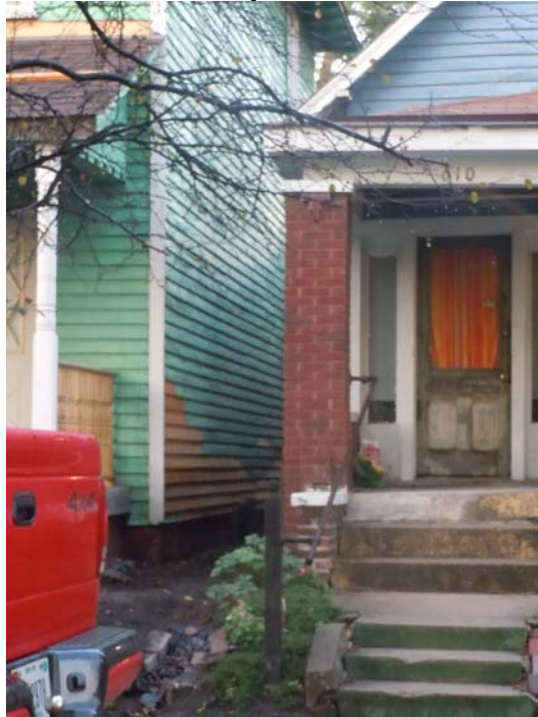
The two, first floor windows on the front elevation were reduced in size prior to designation. Therefore, the IHPC cannot require that they be re-opened to their original size. However, staff believes that restoring those two windows to their original size would do more to restore the original character of this house than any other action.

Above: Outline of original length of window seen in siding
Below: View of new porch posts (on left) View of typical porch post in Cottage Home

1. to restore the two first floor window openings in the front to their original size,
2. install appropriately sized wood or vinyl-clad windows in all front façade windows, and
3. reinstall window trim on the two front first floor windows to match the original.

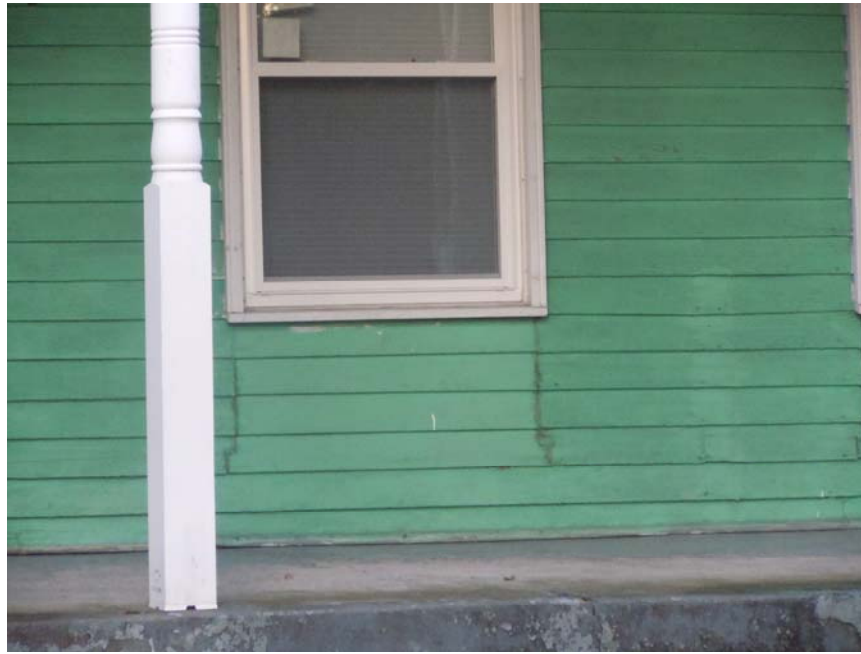
1. New Wood Porch Posts. The original porch posts were not replaced as they had disappeared long ago. The four new posts, although wood, contain a turned detail that is inconsistent with historic porch posts. However, staff does not believe that they deviate significantly enough to warrant replacing them. Also, it should be noted that the design of the original porch posts is unknown.

1. Retain four new wood porch posts installed on the front porch without a COA.
2. Rebuild the wood porch rail on front porch and complete the installation of remaining railing sections in accordance with a design approved by staff.

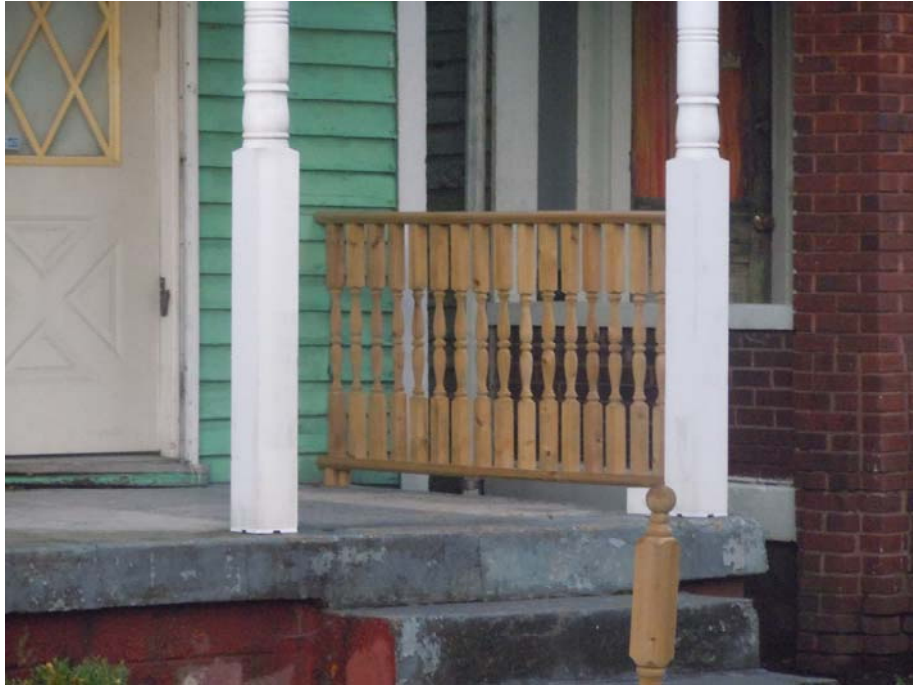
2. Wood Porch Railing (partial installation). The original porch railings were not replaced, and had disappeared long ago. The one wood porch railing section installed also has detailing that is not appropriate. Specifically, the spindles are too thin and the top and bottom rails are simple 1x's with no profiled shape. However, staff believes that a modification of the railing to have a more substantial top and bottom rail with a profiled detail and shorter spindles would significantly improve the appropriateness of the railing. The railing needs to be painted as well.

Above: View of porch railing installed
Below: View of extruded vinyl windows installed at second floor front elevation.

1. New windows must be reviewed and approved by IHPC staff prior to installation and purchase. *Approved* _____ *Date* _____
2. A mock-up of the modified railing must be approved by IHPC staff prior to completion of work. *Approved* _____ *Date* _____

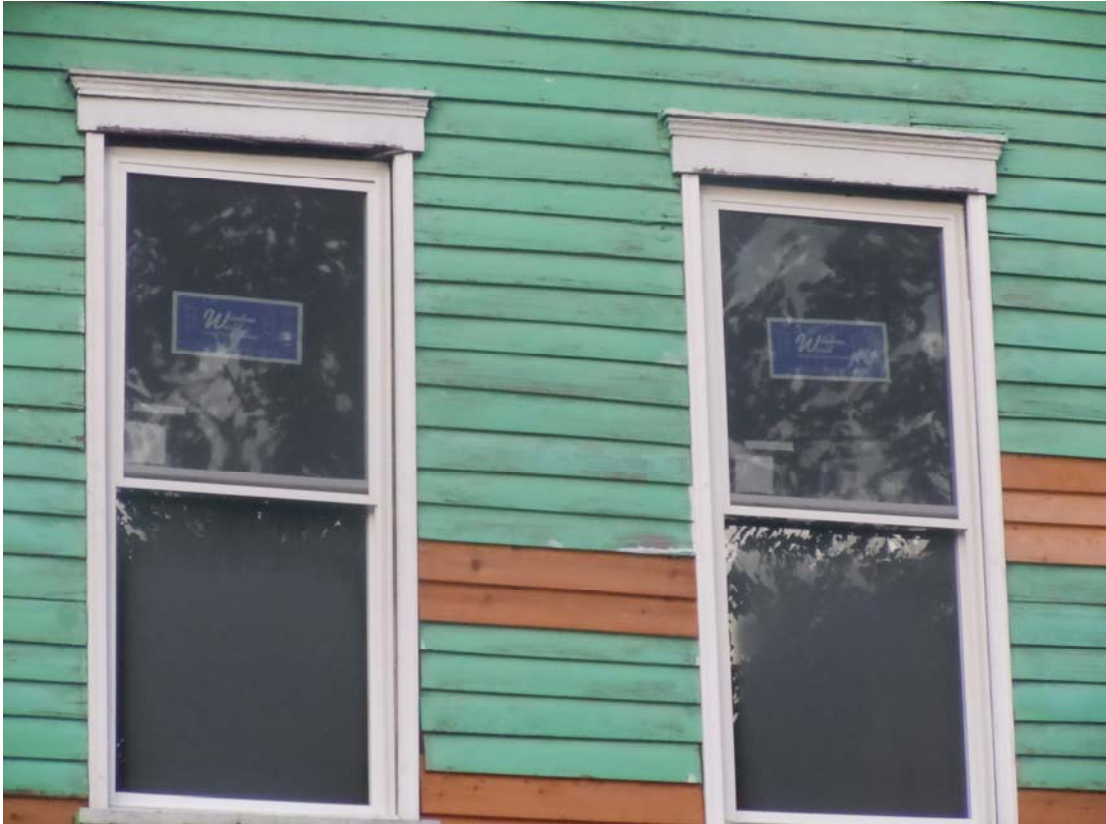
3. New Vinyl Windows (6 on the front, 3 on each side). Replacement of windows on rear elevations does not require approval in this Conservation District, so those windows are not in violation. The front and side windows that were replaced were not the originals. The windows installed are

extruded vinyl that does not mimic the profile and dimensions of typical historic wood windows and look significantly different.

3. Retain six vinyl windows installed on north and south side elevations without a COA.
4. Replace 6 vinyl windows installed on the front elevation without a COA, with appropriately designed and sized wood or vinyl-clad double-hung windows:
 - a. 2nd Floor Windows: Windows must correctly fit the existing openings.
 - b. 1st Floor Windows: The window openings must be restored to their original size, the new windows must correctly fit into those openings, and window trim to replicate the original shall be installed.
